# **Coastal Heritage Risk – Imagery in Support of Heritage Planning and Management in South-West England**

**‘CHeRISH’**

***FINAL REPORT FOR HISTORIC ENGLAND***

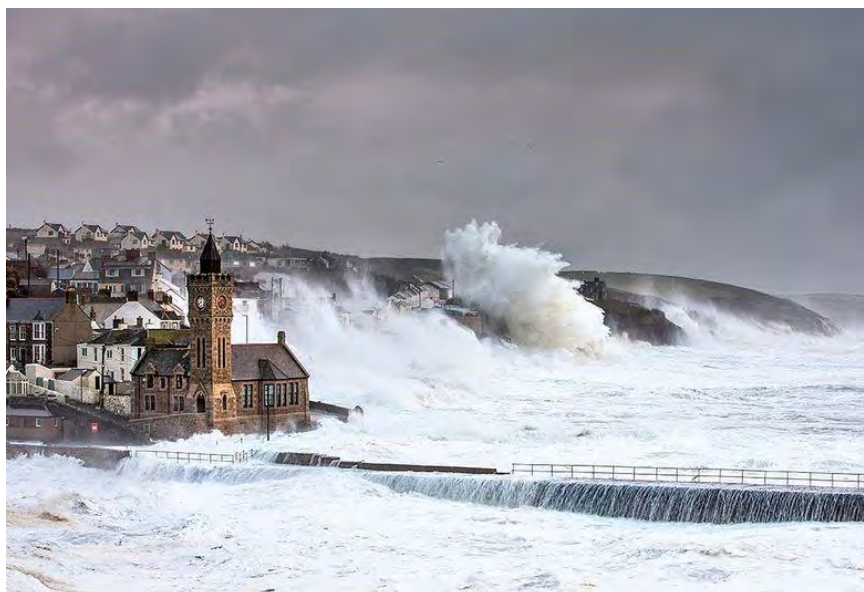
**Figure 3.1:** Severe storm waves at Porthleven, Cornwall in early 2014. Image Courtesy: Carla Regner, [carlaregner.com](http://carlaregner.com)

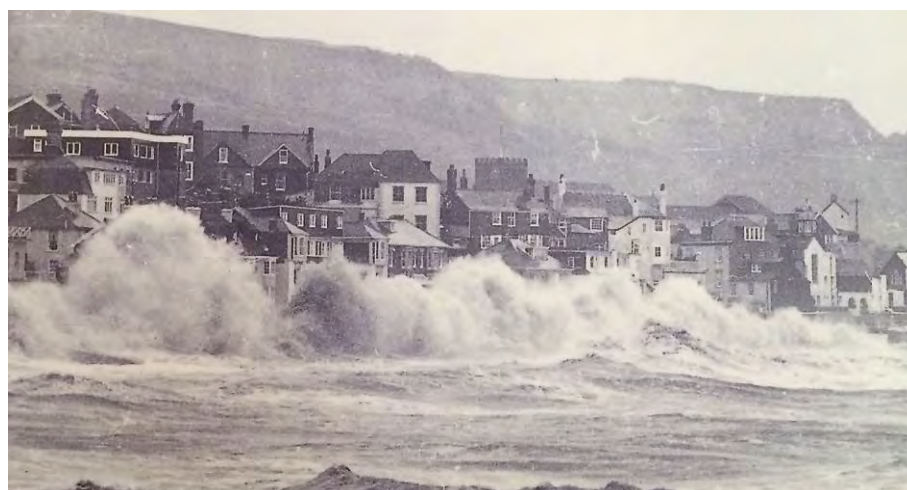
**Figure 3.2:** Storm waves attacking the Promenade at Lyme Regis, Dorset. Coastal defences here fulfil a vital role by protecting listed seafront properties and reducing the impact of landsliding in the town.

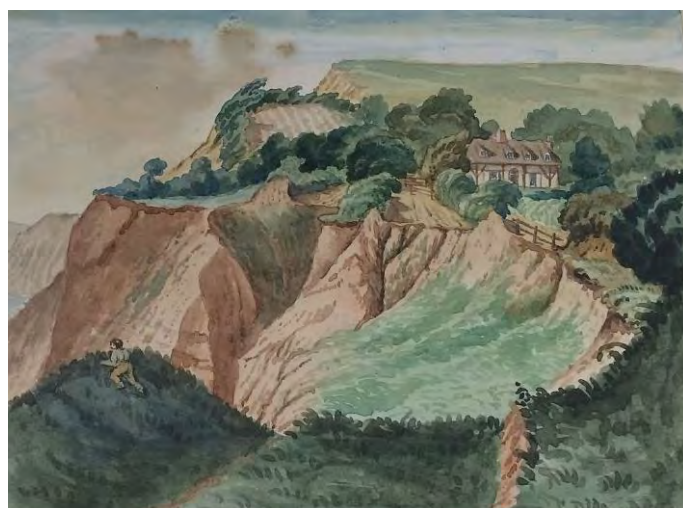
**Figure 3.5 (above):** 'Fall of the cliff near Peak Cottage, Peak Hill, Sidmouth' on 31<sup>st</sup> August 1847. One of many detailed watercolours contained in the journals of antiquarian, Peter Orlando Hutchinson. Image Courtesy: Devon Archives and Local Studies Service.

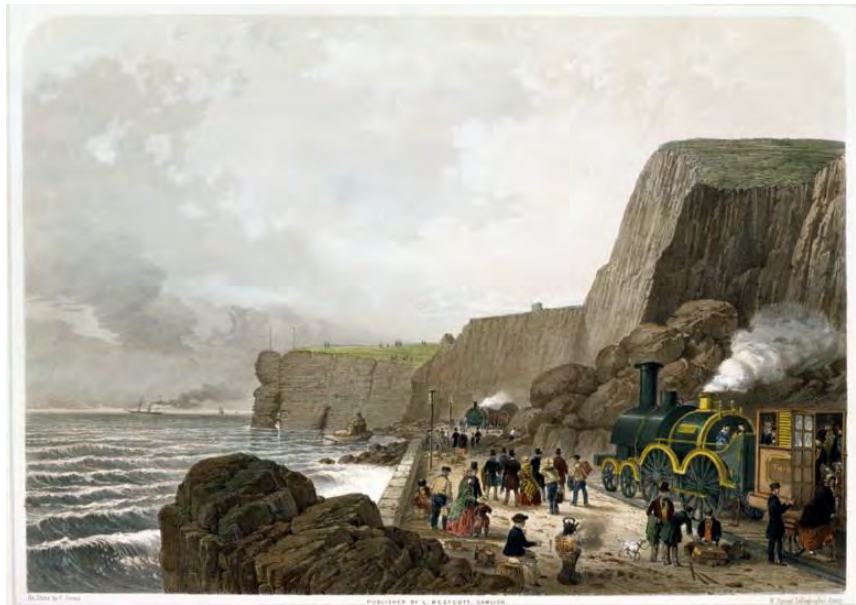
**Figure 3.6 (left):**  
*'Landslip near the  
 Parson and Clerk Rock  
 on the South Devon  
 Railway on 29<sup>th</sup>  
 December 1852'.*  
 Coloured lithograph.  
 Image Courtesy:  
 Bridgeman  
 Images/Private  
 Collection

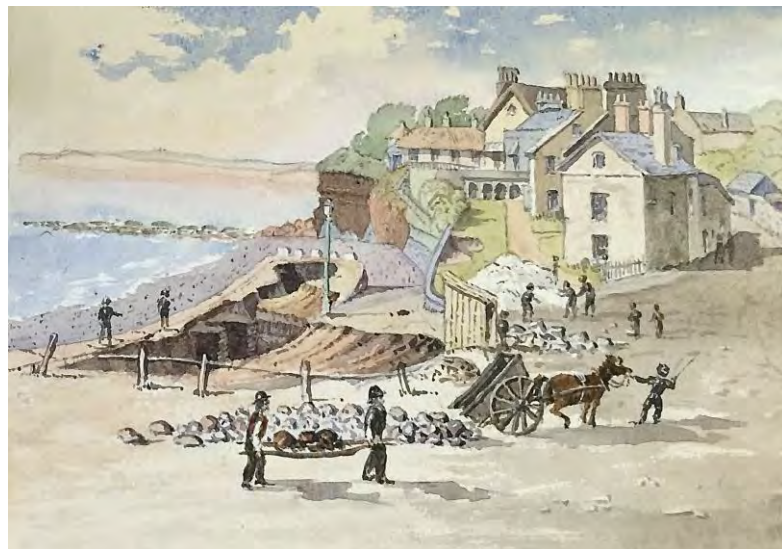
**Figure 3.7 (right):** *'Repairing  
 storm damage on Sidmouth  
 Esplanade in January 1873'.* A  
 watercolour by P. O.  
 Hutchinson. Image Courtesy:  
 Devon Archives and Local  
 Study Service.

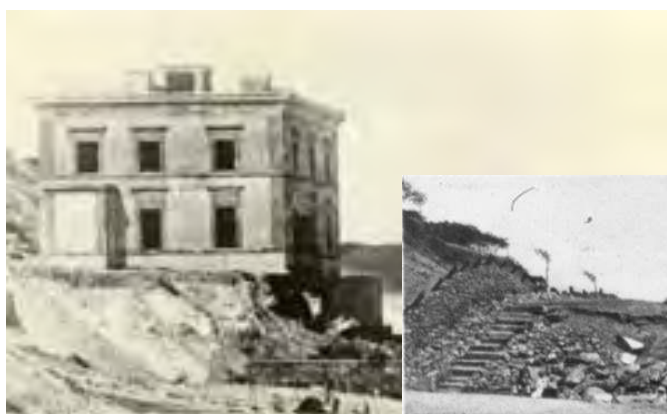
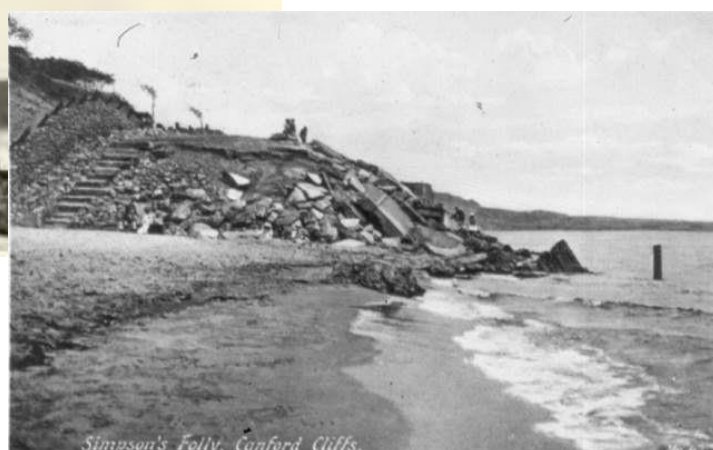
**Figures 3.8 and 3.9 (below):**  
*'Simpson's Folly' at Canford  
 Cliffs, Dorset was built in 1878  
 too close to the cliff edge.  
 Within six weeks it became  
 unsafe and had to be  
 demolished. The debris was  
 incorporated within later  
 coastal defences.*

Along the Canford Cliffs frontage two examples of the impacts of coastal erosion and cliff instability on heritage are illustrated. In 1874, a landowner, Captain John Hawkins Simpson, decided to build a row of seaside villas on the shore at Canford Cliffs between Flaghead Chine and Shore Road. Having obtained the permission of the landowner, and of the local authority the first of these houses was built (see Figure 2.1). The square flat-roof structure took four years to build and was completed in 1878 with a large seawall protecting it. However, the house had been built on a foundation of clay and sand and the sea quickly washed under the defences, making it unstable. The foundations were undermined and Captain Simpson was forced by the local authorities to abandon the property within weeks of its occupation. The property stood empty and the sea continued to undermine the property (Figure 2.2). By 1889 the whole property was collapsing. Poole Corporation ordered the demolition of the building for safety reasons and in 1890 the local authority blew up the remains of the property with gun powder. A high pile of concrete blocks and rubble was left in this location for many years until, in 1957, Poole Corporation was given the foreshore, and between 1960 and 1961 they constructed a promenade between the Shore Road promenade and the one at St Anne's, incorporating much of the rubble in the foundations of the new promenade, which was completed in 1962.

**Figure 2.1 (left):** *'Simpson's Folly'* was built at the foot of Canford Cliffs near Bournemouth in 1878. Insufficient consideration was given to coastal erosion and the property had to be demolished soon after its occupation.

**Figure 2.2 (left):** The remains of *'Simpson's Folly'* remained on the shore for many years until it was incorporated within a new promenade.

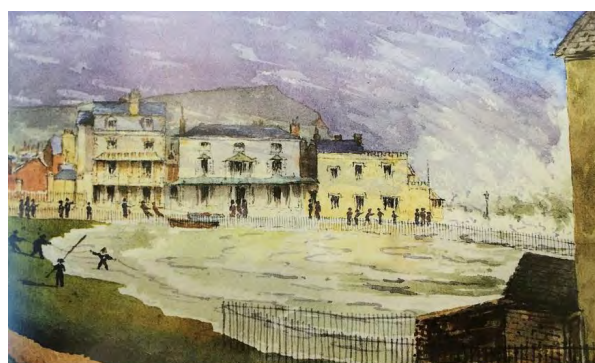
**Figure 3.10 (left):** Flooding at Sidmouth on 4<sup>th</sup> December 1876. A watercolour by J. O. Hutchinson showing the fine buildings at risk from flood waters. Image Courtesy: Devon Archives and Local Studies Service.

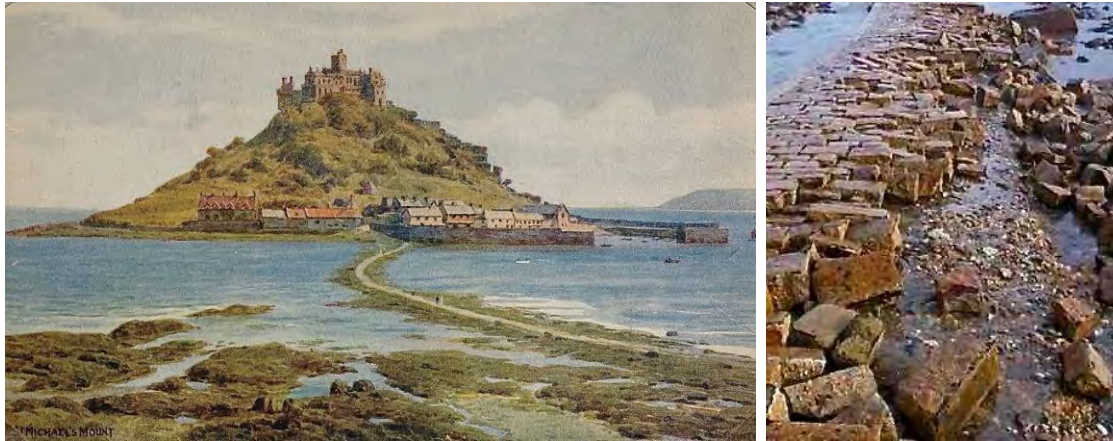
**Figure 3.11 (above left):** A view of 'St Michael's Mount, Cornwall' by Alfred Robert Quinton (c.1920) showing the causeway, which was badly damaged in the 2013/14 storms (see **Figure 3.12 (above right)**). It was subsequently repaired. Image Courtesy: Emma Little.

The most significant storm event in recent years was the winter storms that occurred in January and February 2014. The six major storms hit the south-west coast over a period of three days within a wider sequence of storms that extended from mid-December 2013 to early January 2014. Strong winds and huge waves made conditions extremely dangerous around exposed coastlines and caused widespread disruption. This included severe damage to the south-west main railway line at Dawlish, Devon during the storm of the 4-5 February, whilst many coastal communities in Dorset, Devon and Cornwall experienced coastal flooding and damage to infrastructure, buildings and sea defences. The storms also resulted in major coastal erosion affecting defence structures, beach profiles and coastal access. This was exacerbated through a cumulative effect of the sequence of storms in rapid succession. For example, the storms severely damaged the National Trust site at South Milton Sands, Devon, the coast at Rockham near Martinhoe in North Devon, part of the seawall at Penzance, the causeway leading to St Michael's Mount, Cornwall (Figure 3.12) and the harbour wall at Port Wrinkle.

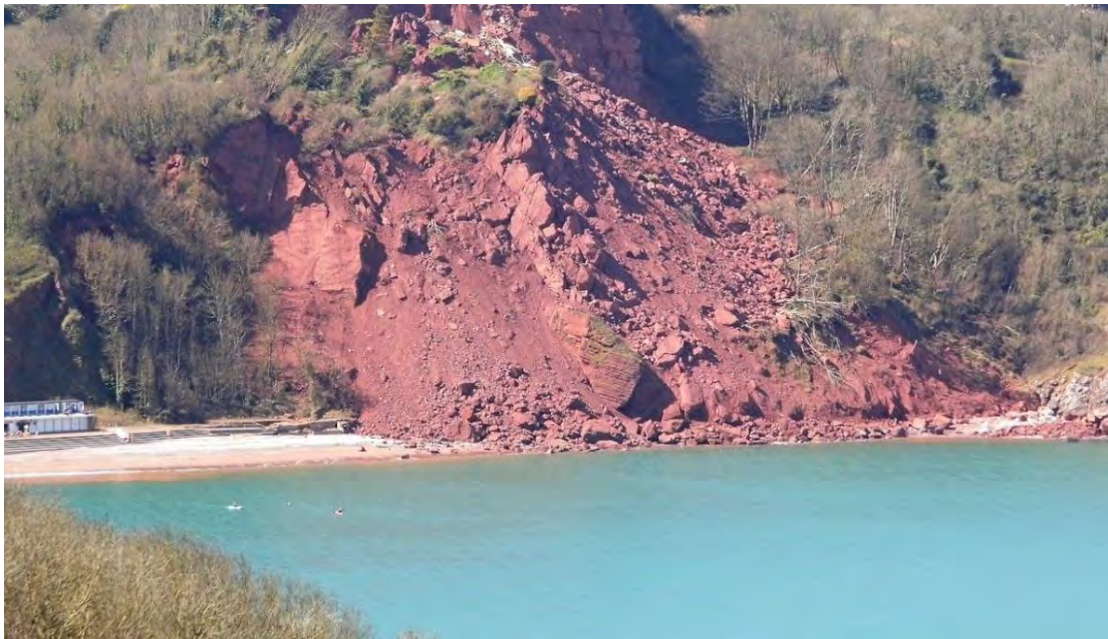
**Figure 3.13 (above):** A massive cliff failure below Ridgemont House near Torquay in 2013. Image Courtesy: Nikolett Csarvasi ©2013.

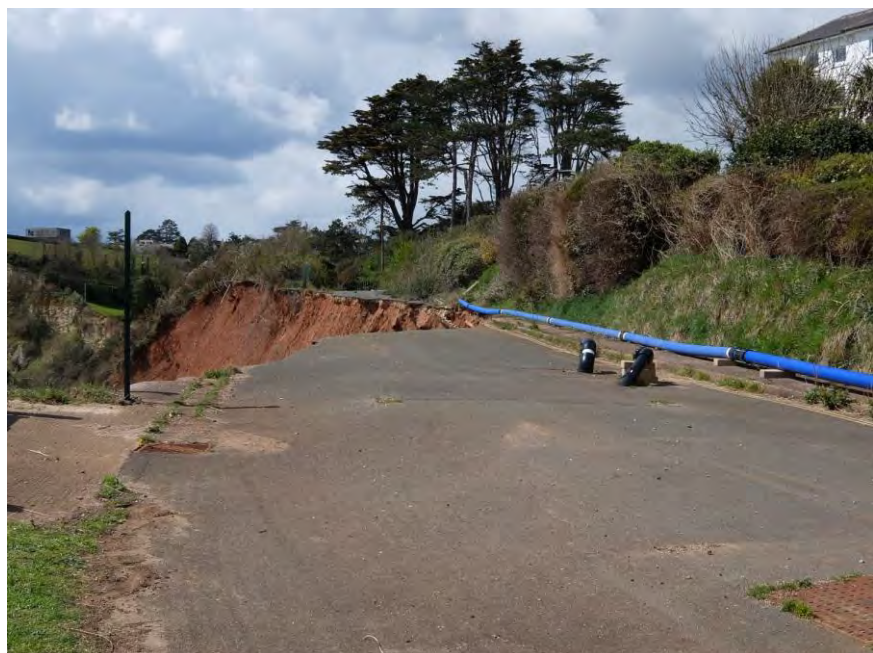
**Figure 3.14 (right):** Coastal instability at Old Beer Road between Seaton and Beer in South Devon, June 2016.

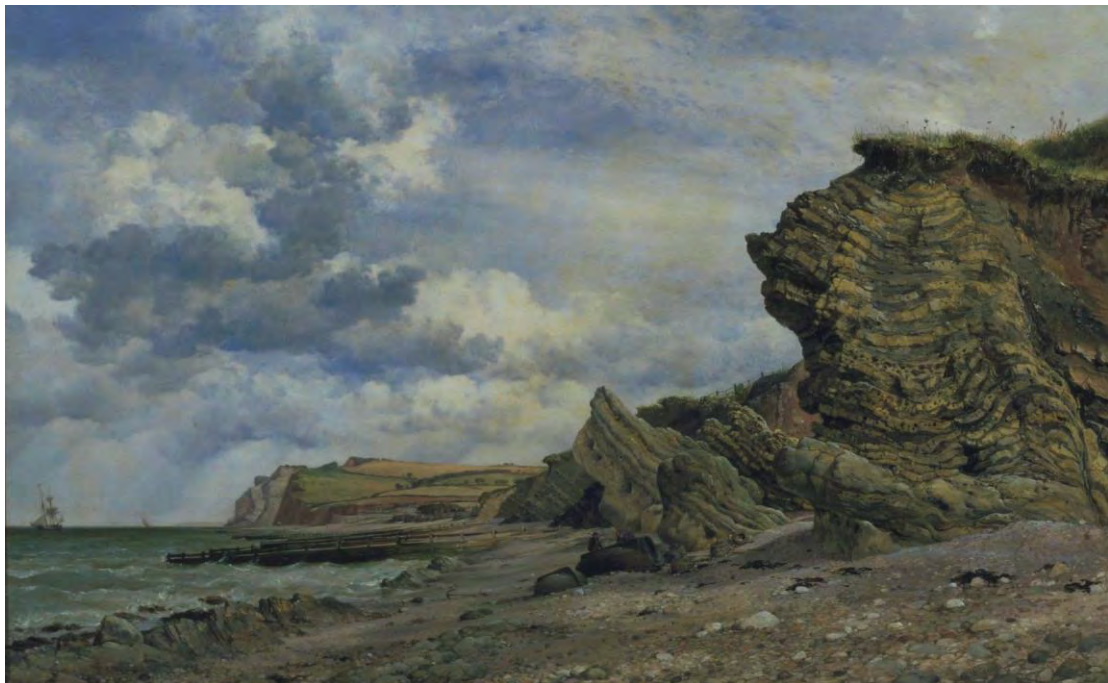
**Figure 3.17:** *'Triassic Rocks near Blue Anchor, North Somerset looking towards Watchet'*. Oil on canvas, 1862. Edward William Cooke RA. Cooke followed the Pre-Raphaelite ethos of capturing nature in precise detail; combined with his keen interest in geology this ensured that his coastal depictions were very reliable. This part of the coast has been affected by extensive erosion and instability in recent years. Image Courtesy: Guildhall Art Gallery, London.

**Figure 4.15 (below):** Edward William Cooke RA produced some remarkably detailed paintings on the north Somerset coast including *'Triassic rocks, near Blue Anchor, North Somerset looking towards Watchet'* (Figure 3.17) and, here, *'The Breakwater, Porlock Weir, coast of Somerset'* in the 1860s. Cooke was fascinated with the geology of the coastline. He sought to depict the rocks, shingle and cliffs in the most accurate way possible, a technique advanced by the famous Victorian art critic and writer, John Ruskin (1819-1900). Image Courtesy: Martyn Gregory Gallery, London.

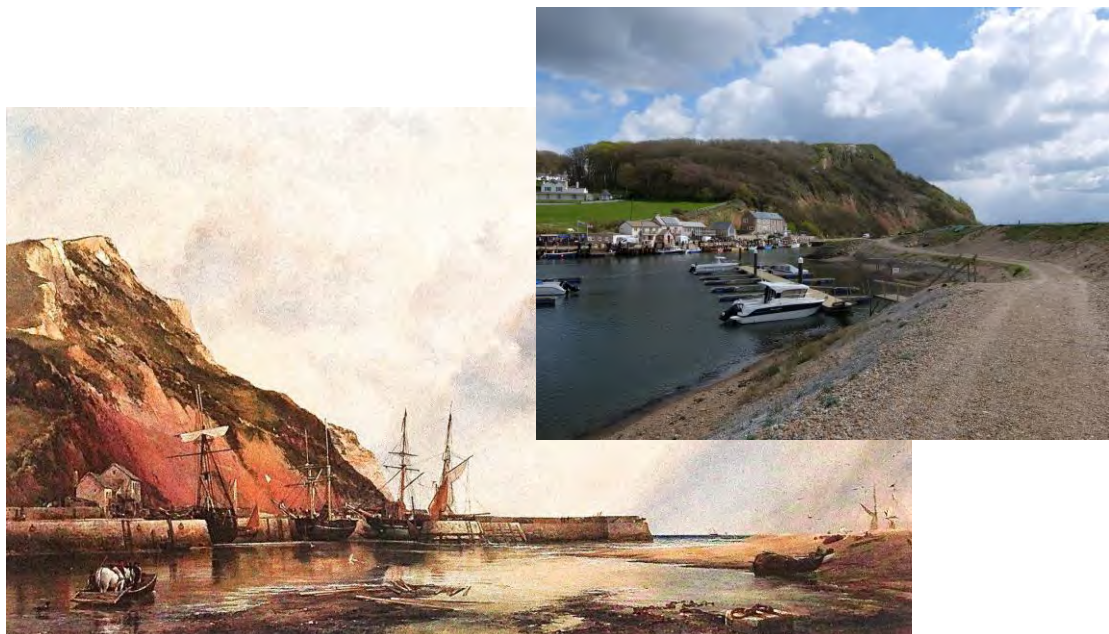
**Figure 4.9 (above):** 'Axmouth Ferry, Axmouth Harbour' by Edward William Cooke RA. Oil on canvas, 1858. Image Courtesy: Christie's, London. **Figure 4.10 (above right)** shows the harbour today with a high bank of shingle offering improved protection from south-westerly storm waves.

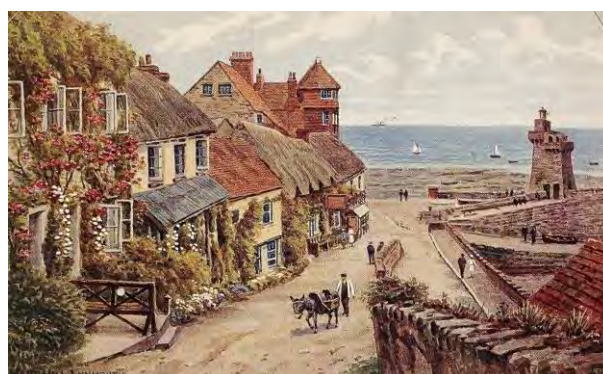
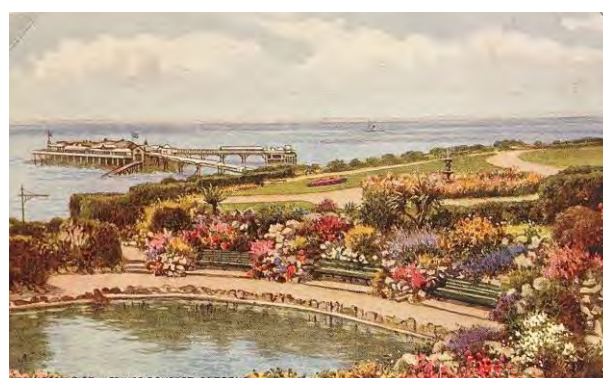
**Figures 4.16-4.18:** Views of the North Somerset Coast c.1920 by the watercolourist Alfred Robert Quinton. *'Porlock Weir'* (above), *'Mar's Hill, Lynmouth'* (top right) and *'Birnbeck Pier, Weston-Super-Mare'* (bottom right). Quinton's numerous and very precise views provide an accurate record of coastal conditions and heritage in the early twentieth century. Images Courtesy: J. Salmon Limited, Sevenoaks.

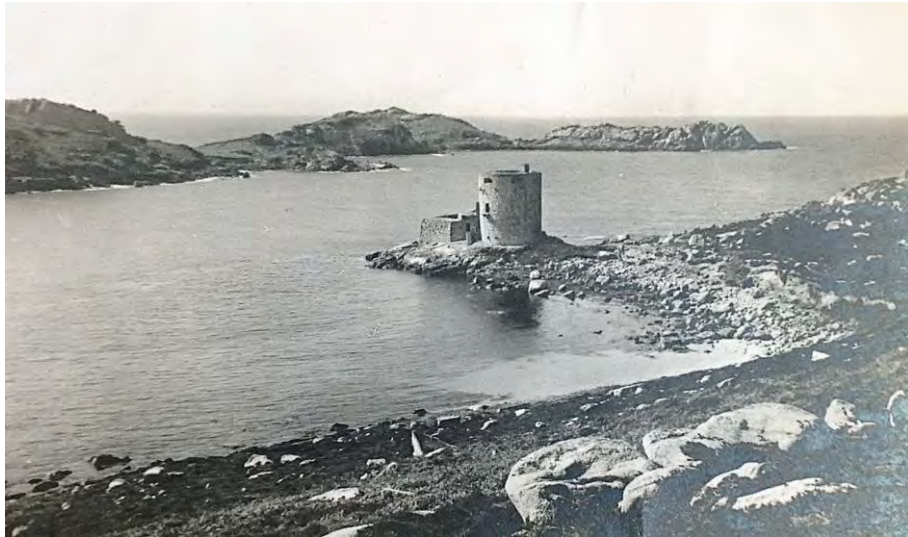
**Figure 4.21:**  
*'Cromwell's  
Castle, Tresco,  
Isle of Scilly'.*  
Replacing an  
earlier Tudor  
structure in the  
1650s, this castle  
forms part of the  
very extensive  
defences  
constructed on  
the Isles of Scilly.  
Image: Private  
Collection.

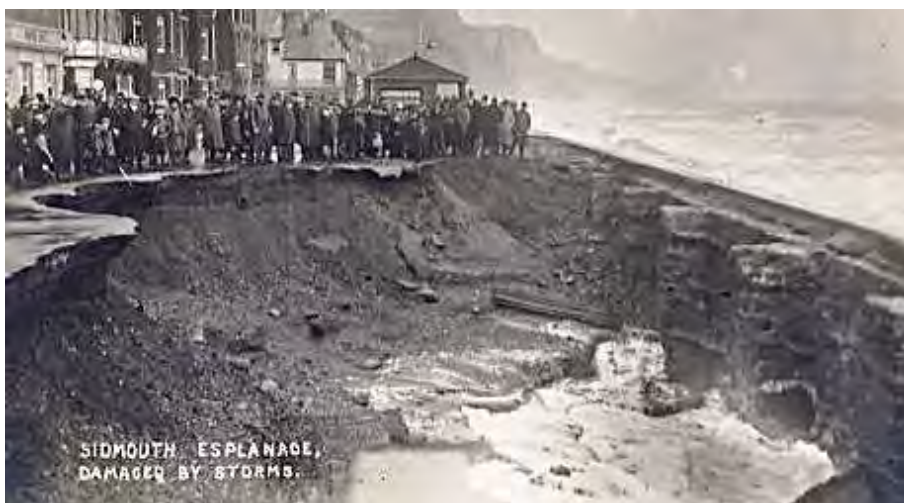
**Figure 4.23:**  
Collapse of part  
of Sidmouth  
Esplanade  
following severe  
storms. Image by  
kind permission  
of Sidmouth  
Museum.

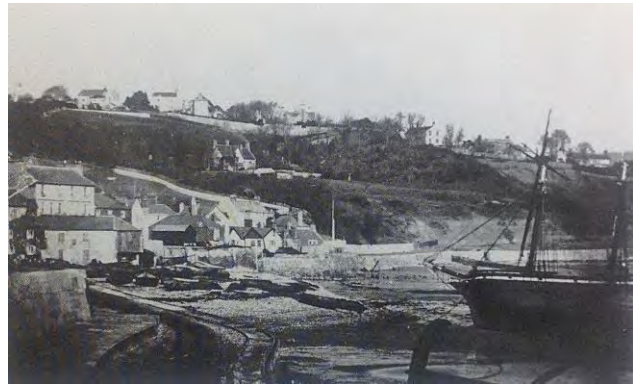
**Figure 5.30:** A typical Victorian coastal view of 'Anstey's Cove, South Devon' showing a recent major rockfall in about 1900. This photograph scores three points.

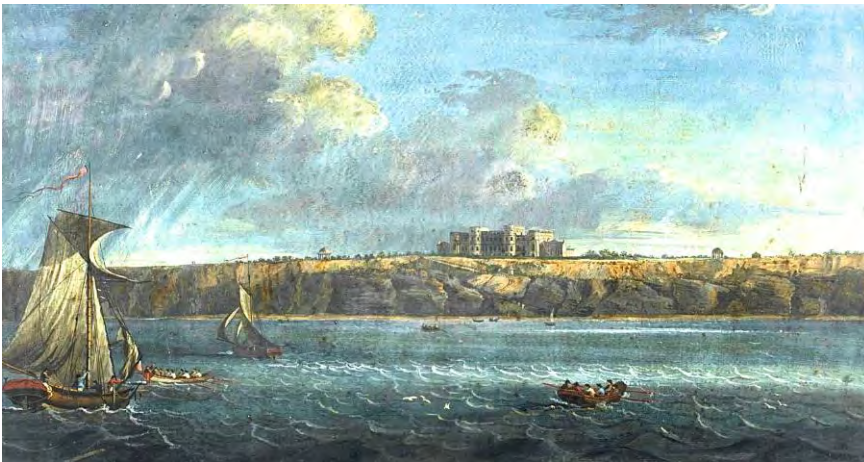
**Figure 1.1:** *'High Cliff from the Sea'* by Adam Callader. Oil on Canvas. 1783. This view shows the proximity of the mansion to the unstable cliffline. By 1813 the property had to be demolished.

Figures 1.1 and 1.2 overleaf show views of the old house from the sea and from the east, whilst Figure 1.3 shows the grand north façade. A pair of elegant circular temples and a gazebo adorned the cliff edge. (See Figures 1.4 and 1.5). The unstable nature of the cliff can be observed in Figure 1.5 and rapid coastal erosion led to the loss of the temples and necessitated the demolition of the property from 1813.

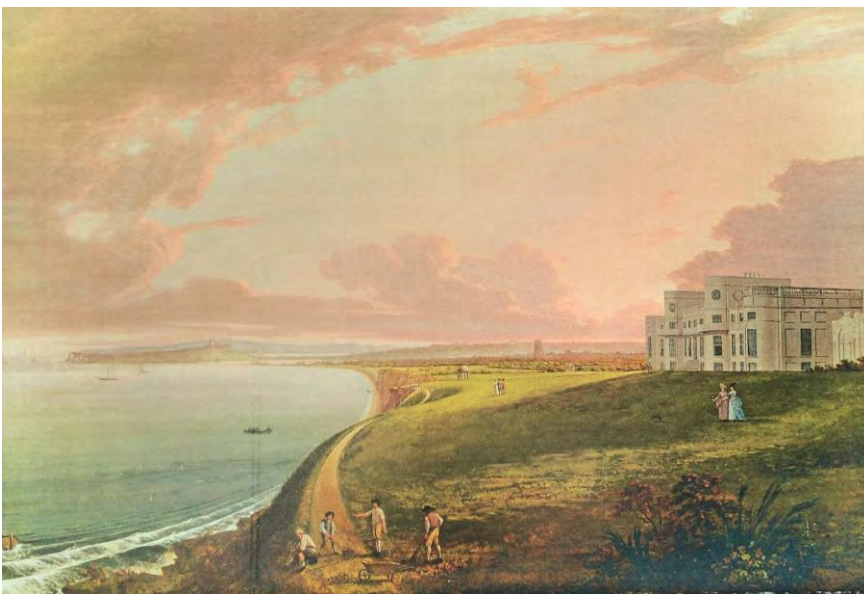
**Figure 1.2:** *'High Cliff from the East'* by Charles Stewart. Oil on Canvas. 1783. The view shows the relationship between the house and the cliff. Christchurch Priory and Hengistbury Head can be seen in the distance.

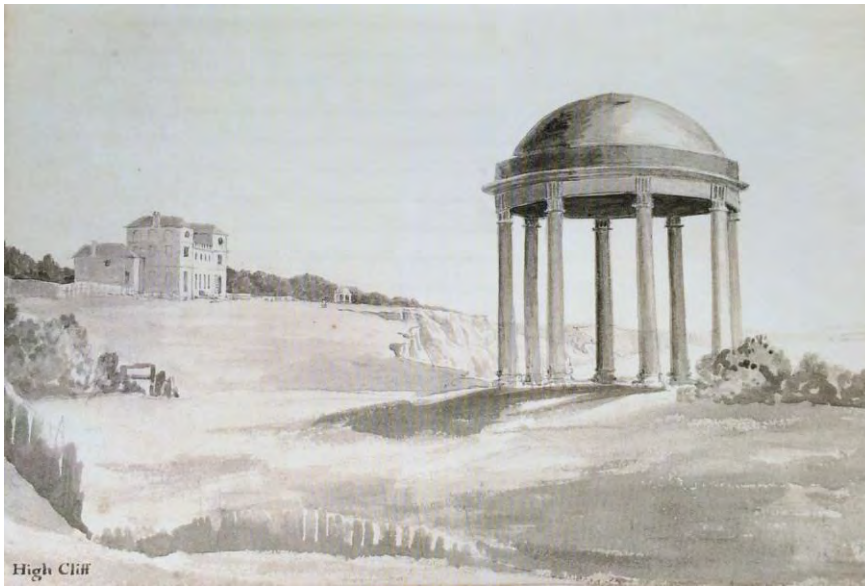
**Figure 1.4:** *'High Cliff Mansion'* after its wings had been removed to make the residence a more manageable size. Brown wash watercolour by Elizabeth Fanshawe. 1811. The pair of temples or gazebos may have been lost as a result of coastal erosion and instability.

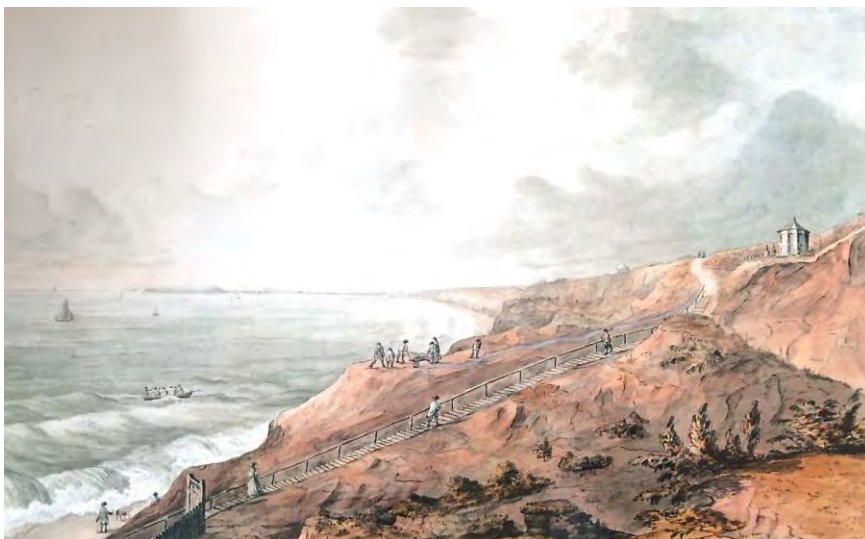
**Figure 1.5:** *'Capability' Brown's early Beach Hut* on the cliffs below High Cliff Mansion. Workers can be seen repairing the slope and path down the obviously unstable cliff.

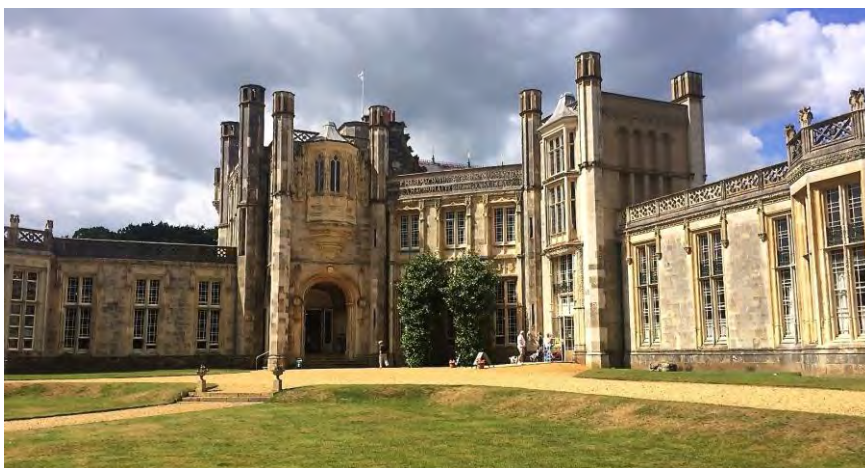
**Figure 1.6:** *'Highcliffe Castle'* today. The Grade I Listed Building is set well back from the cliff. The Castle represents an early example of adaptation to a rapidly changing coastline.

The new Highcliffe Castle (Figure 1.6), a Grade I Listed Building, was constructed by Baron Stuart de Rothsay from 1830, and was set back much further from the cliff edge. The relative positions of Old High Cliff House and Highcliffe Castle are plotted on the 1980 Ordnance Survey map and indicate the extent of erosion at that time (Figure 1.7).

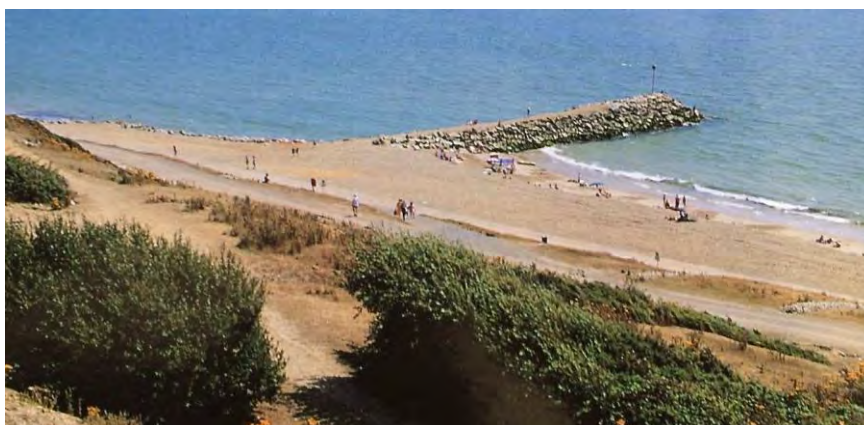
**Figure 1.8:** Highcliffe beach today. The rock breakwaters, beach replenishment and cliff works help to protect the frontage. The frontage has a 'Hold the Line' coastal protection policy for the next Century.

The frontage is now protected through cliff drainage works, together with rock groynes and beach replenishment (Figure 1.8).

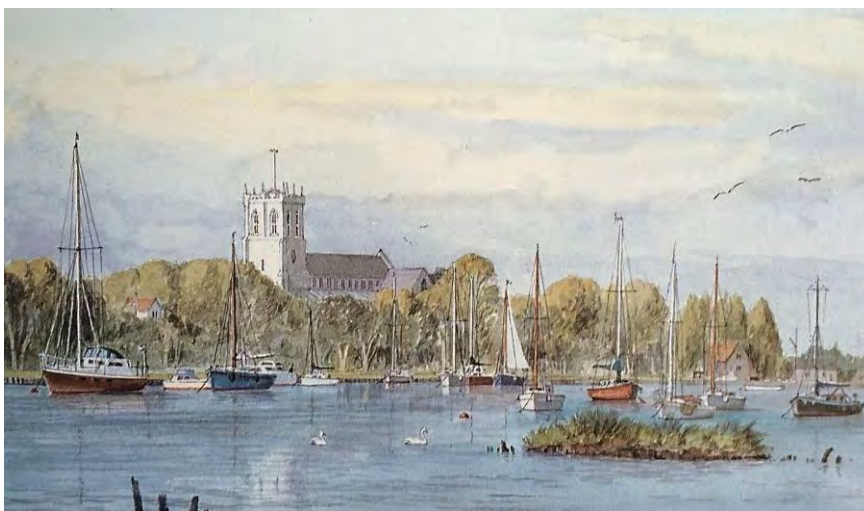
**Figure 1.14:** 'Christchurch Priory' by David Addey; a watercolour painted in 2002 replicating Daniell's view. The Priory and adjacent buildings are now largely obscured by trees although the eleventh century Place Mill, on the right, is still visible.

**Figure 1.9:** *'Christchurch'* by William Daniell RA. A hand-coloured aquatint engraving from his *'Voyage Round Great Britain'* (1825). Daniell was a fine, accurate draughtsman as well as a topographical artist. See also David Addey's view from the same location in 2002 (Figure 1.14 below).

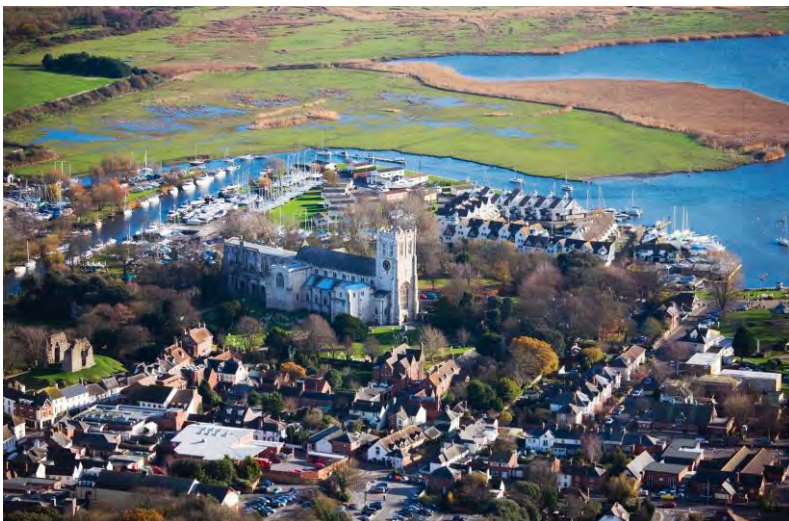
**Figure 1.17:** A view of Christchurch Priory showing the waterside location. Consideration is being given to upgrading flood defences in the vicinity.

This study site clearly illustrates risks to heritage from erosional processes as witnessed by the cliff retreat at Highcliffe, and highlights an apparent vulnerability to flooding at Christchurch Priory (see Figure 1.17). It emphasises the vital role played by coast protection structures and flood defence measures in terms of protecting such coastal heritage assets. Likewise, at Hengistbury Head, the site is protected by significant coastal defences supported by a substantial beach accretion. Whilst artworks can support understanding of past conditions at Highcliffe and Christchurch Quay the heritage interest at Hengistbury Head will be illustrated most effectively through aerial photography.

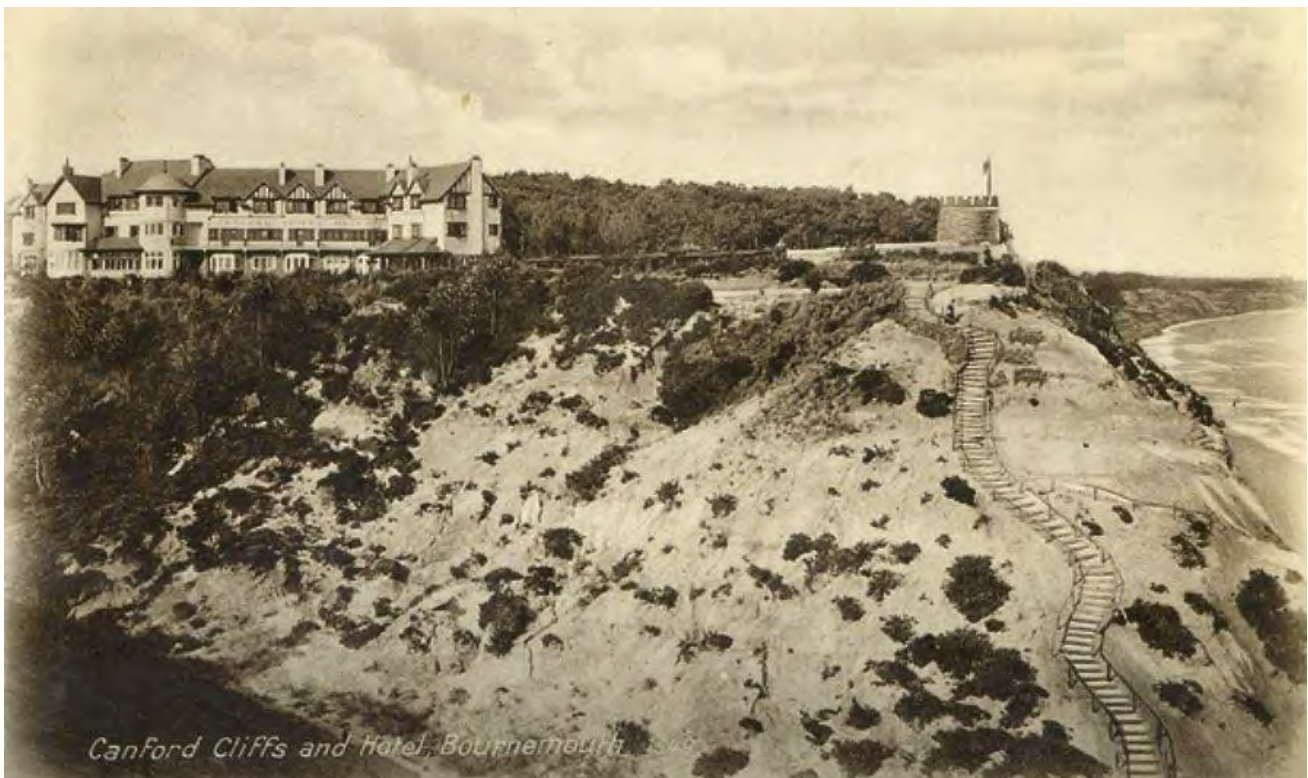
**Figure 2.3 (below):** The tower on the cliffs, which succumbed to coastal erosion despite having been located further from the coast.

Between Canford Cliffs and Poole Head retreating cliffs, as a result of coastal erosion of the soft sands and clays, have led to the loss of both Simpson's Folly at the foot of the cliff and a 'Martello Tower' on the eastern side of Canford Cliffs Chine (Figure 2.3). In Poole Harbour, Brownsea Island contains Brownsea Castle, originally a fort constructed by Henry VIII between 1545 and 1547 to protect Poole Harbour from French attack (Figures 2.6-2.8). In 1726 the castle was converted into a private residence and, together with adjacent historic properties, occupies a waterfront location on the Island's southern shore (National Trust, 1993<sup>2</sup>).

A structure known as a 'Martello tower' was situated on the eastern side of Canford Cliffs Chine; the stone for its construction is reputed to have been imported from Beaulieu Abbey. In fact, this structure was not a defensive Martello tower but was actually a gazebo/folly built in 1857 for Sir Charles Packe of Branksome Park. It was used as a smoking room for the owners of the Canford Cliffs Hotel in the 1930s, before serving as staff quarters for a time. It gave its name to a magnificent Edwardian house, Martello Towers, which was subsequently demolished to make way for the present block of flats. Although the old tower had been moved back previously from the retreating cliffs, eventually it succumbed following a cliff fall. These case study sites illustrate the vulnerability of properties constructed too close to eroding or unstable cliff lines. Although the tower had been relocated, this was insufficient to save it from further retreat of the sea cliff (Figure 2.3).

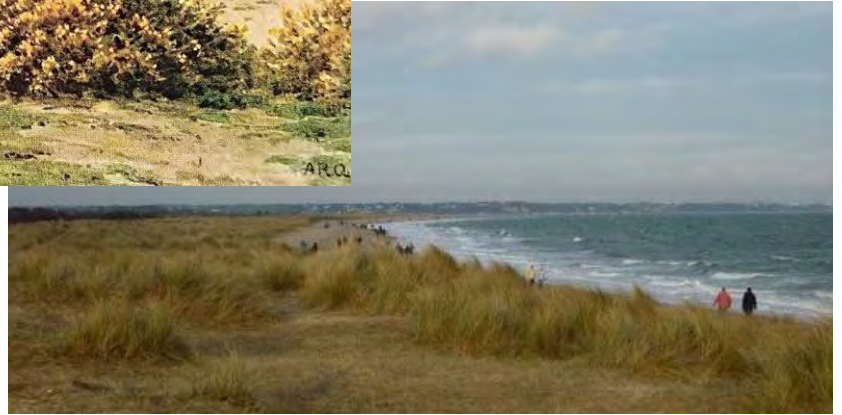
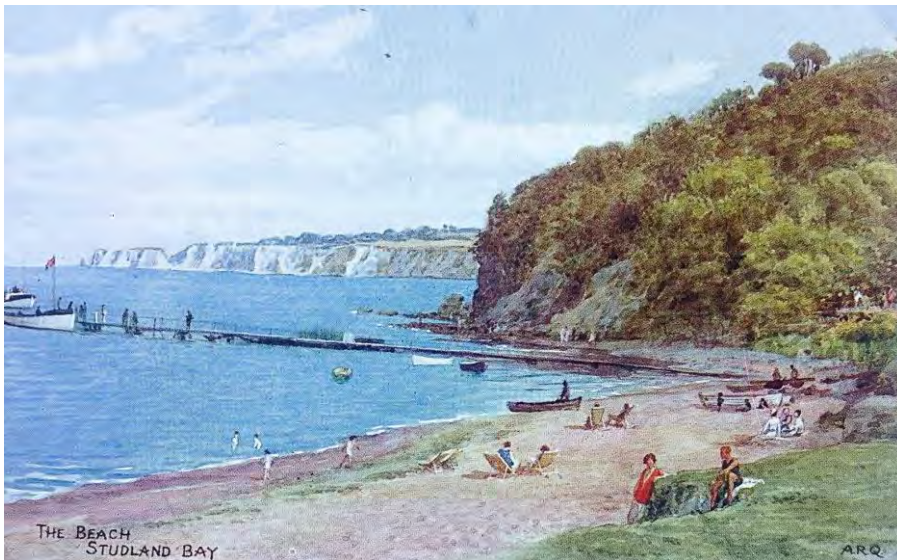
**Figures 2.13 (left):** In this view looking south along Studland Beach by Quinton Handfast Point can be seen in the distance. The beach here has been subject to significant coastal erosion and has necessitated changes in future management by its owner, the National Trust. **Figure 2.14 (below)** shows the view in the 1950s.

The Studland Bay frontage (Figures 2.11-2.14) has been included in this case study because, although there are no heritage assets in the immediate vicinity, the principles being established through the National Trust's approach at Swanage are likely to become more widely applied, in line with current government guidance, which is aimed at managing coastal change through taking a long-term perspective and working with natural processes (National Trust, 2014<sup>4</sup>; Environment Agency, 2014<sup>3B</sup>). This policy has heritage implications elsewhere across the CHERISH case study sites such as Mullion Harbour in Cornwall.

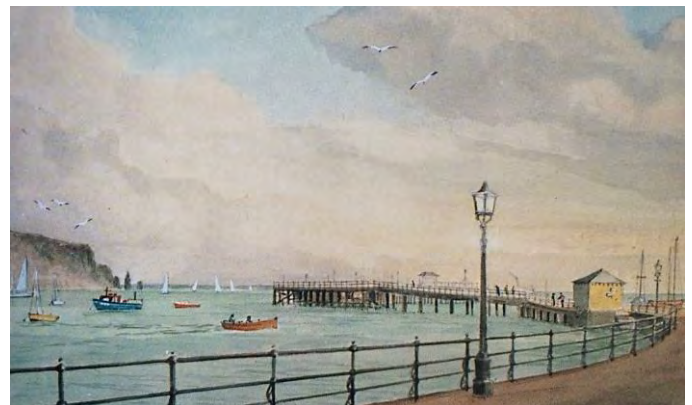
**Figure 3.4:** *'Swanage Pier'* painted in watercolour by David Addey in 1990. Now the award-winning, restored pier (Listed Grade II) forms a focus for water-based recreation.

In Swanage, the present pier, which replaced an earlier structure, required significant investment to maintain its integrity and this was completed recently as an award-winning scheme. Along the coastline to the south of Swanage, between Durlston Head and Anvil Point, two pairs of towers mark the extent of a '*nautical measured mile*'. These towers enabled various ships to be timed over that distance.

Early twentieth century postcards illustrated by the watercolour artists Henry Wimbush and Alfred Robert Quinton depict the coastal resort of Swanage in some detail; Swanage Pier is also featured (Figures 3.3 and 3.4). The quarrying industry and the major headlands including Handfast Point, Peverill Point, Tilly Whim Caves at Durlston Head and St Aldhelm's Head were engraved with views being published in important works such as Sir Henry Englefield's *'Geology and Antiquities of the Isle of Wight and the adjacent coast of Dorsetshire'* (Englefield, 1816<sup>3</sup>) – see Figures 3.5 to 3.8. Comparison of coastal artworks by artists such as Alfred Robert Quinton, a prolific Edwardian painter of coastal views, with recent photographs allow evaluation to be made of change of the reliability of art to inform us of the rate of change to coastal cliff lines over the last 200 years.

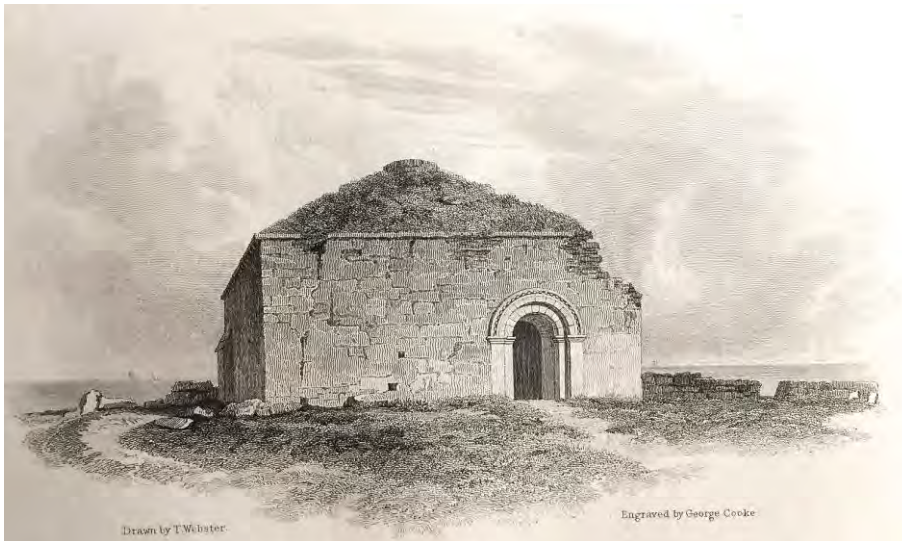
**Figure 3.6:** 'St Aldhelm's Chapel' by Thomas Webster (1816) is located close to the cliff edge at St Aldhelm's Head. Englefield (1816) said "Not many yards from the edge of the precipice stands the Chapel. The upper cliff is composed of immense fissures many of which are ready to fall. The whole of the base (of the cliff) is covered with vast blocks that have tumbled down and show how much of the headland has been destroyed by the furious sea to which it is exposed."

At Emmet's Hill near Worth Maltravers the bowl barrow is a Scheduled Monument (List Entry Number: 1017268) and the site is at risk from coastal erosion. At St Aldhelm's Head the ancient Chapel is close to the sea cliff and could be lost eventually unless, at some time in the future, the structure is re-located further inland. Continued rates of erosion over the next 100 years, estimated at between 0.5 and 0.7m per annum, are likely to see the loss of some of these features as a result of episodic cliff failure events.

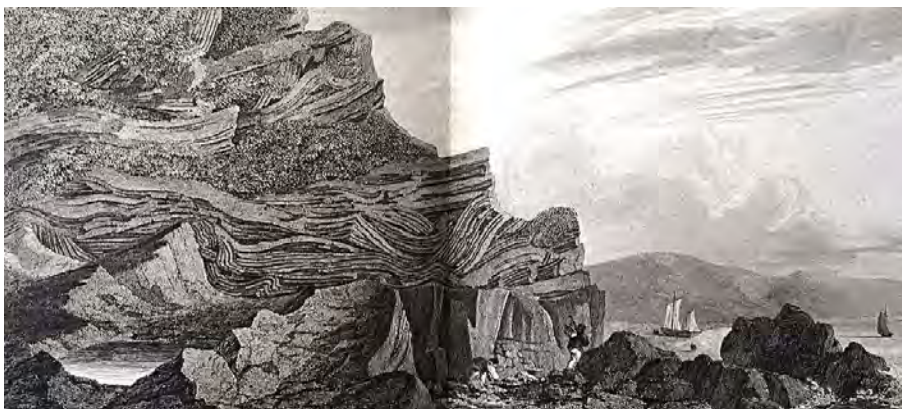
**Figure 3.7:** The distorted limestone formations at 'Durlston Head' are illustrated in this drawing by T. Webster, which was engraved by George Cooke in 1816.

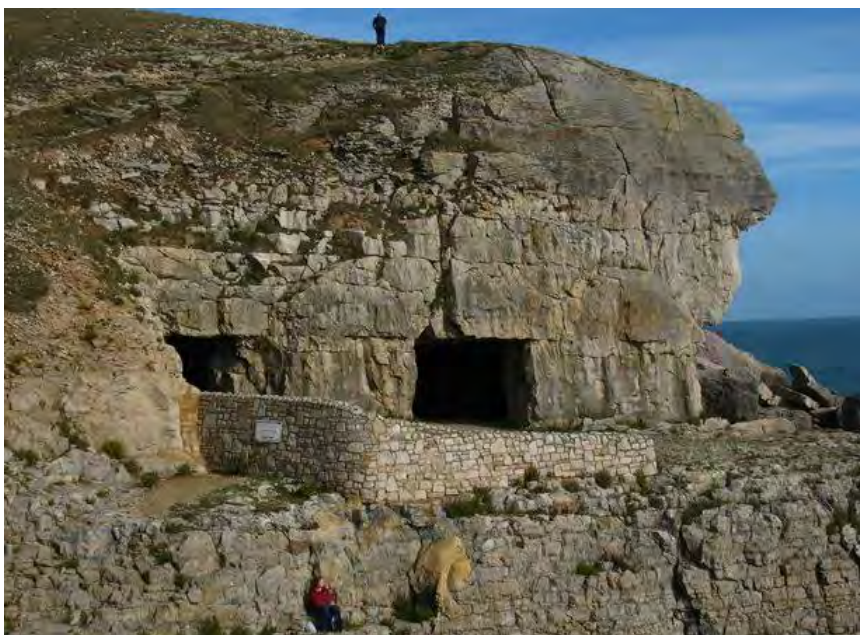
**Figure 3.10:** This present day view of Tilly Whim Caves compares very closely with Quinton's watercolour (above), including details of the jointing in the limestone.

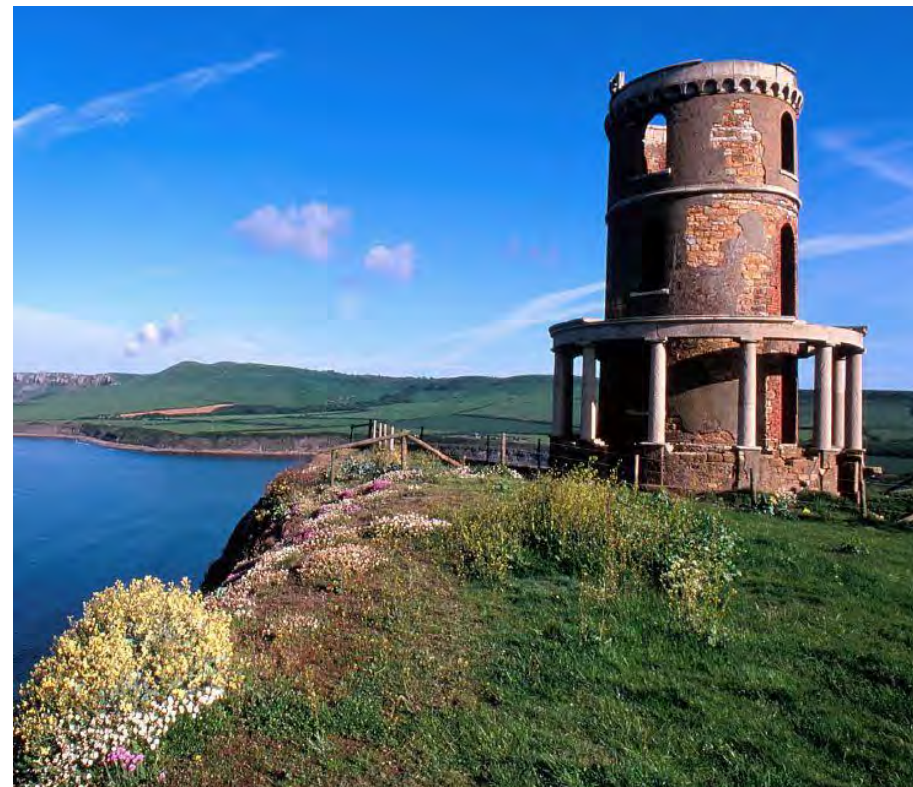
**Figure 5:** Clavell Tower prior to the commencement of its relocation twenty-five metres inland.

Clavell Tower (listed Grade II) was constructed as an observatory and coastal landmark by the Reverend J. Richards in 1830/31 (Figure 4.3). The frontage formed part of the Smedmore estate, which had been owned by the Clavell family since the 1420s. At the end of the nineteenth century, until about 1914, the Tower served as a lookout post for coastguards and was vacated as the structure started to deteriorate (Figure 4.4). Coastal erosion posed an increasing risk to the Tower and, in 2002, with the support and advice from the owner, the Landmark Trust commenced investigations into the possibility of relocating the tower further back from the coastline (Stanford, 2008<sup>3</sup>).

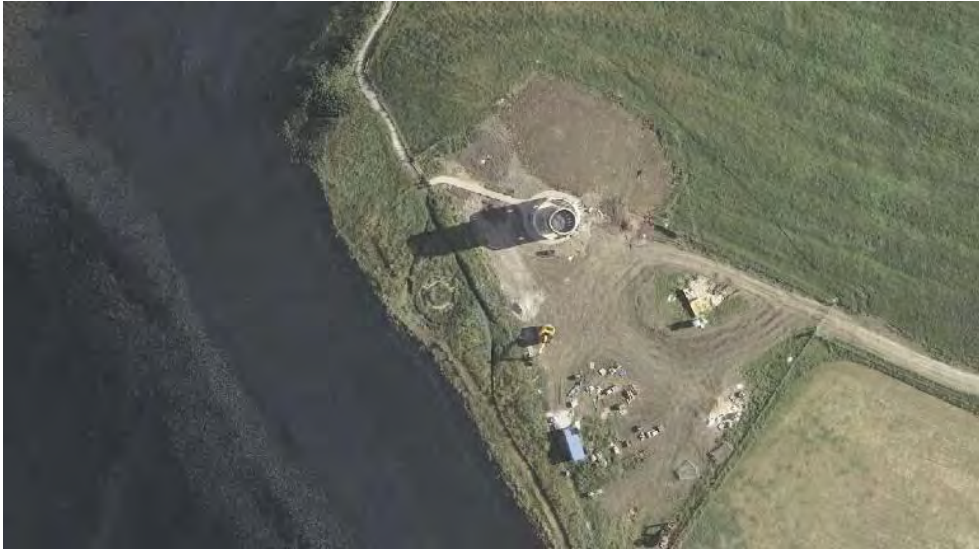
**Figure 4.6:** Clavell Tower following its set-back. The former site can be seen on the sea cliff.

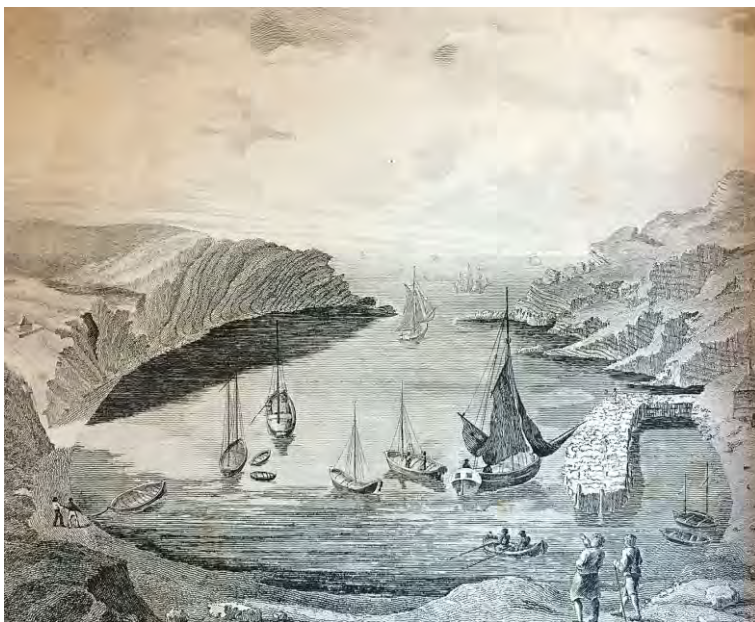
**Figure 5.1 (left):** A late eighteenth century copperplate engraving of Lulworth Cove shows a stone harbour arm on the western side.

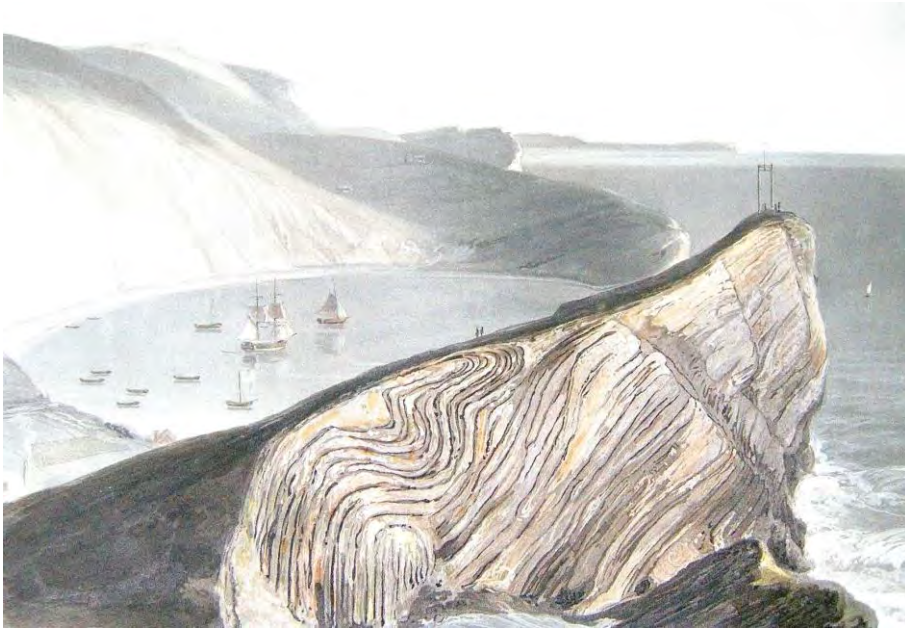
**Figure 5.3:** William Daniell RA produced this view of Lulworth Cove on his '*Voyage Round Great Britain*' in 1823. It shows signalling masts on the western headland for the first time.
