# **Coastal Heritage Risk – Imagery in Support of Heritage Planning and Management in South-West England**

**‘CHeRISH’**

***FINAL REPORT FOR HISTORIC ENGLAND***

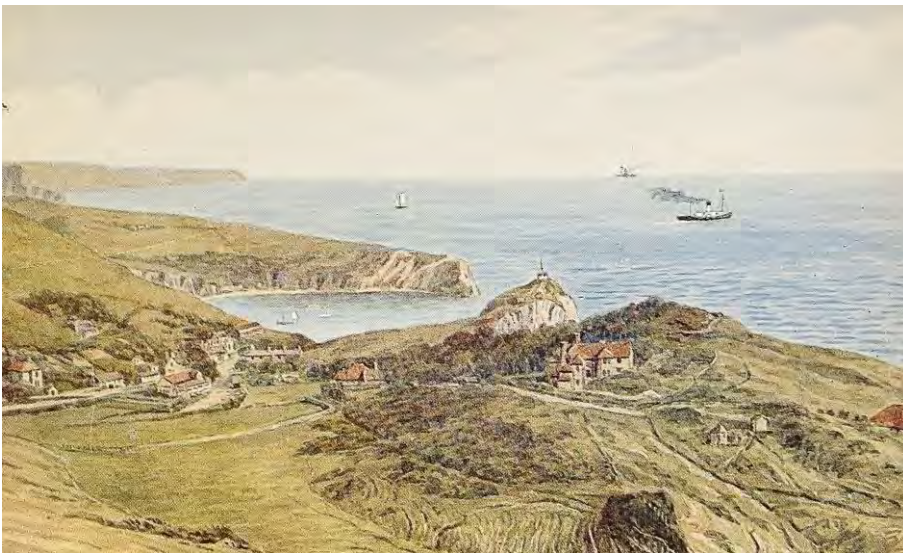
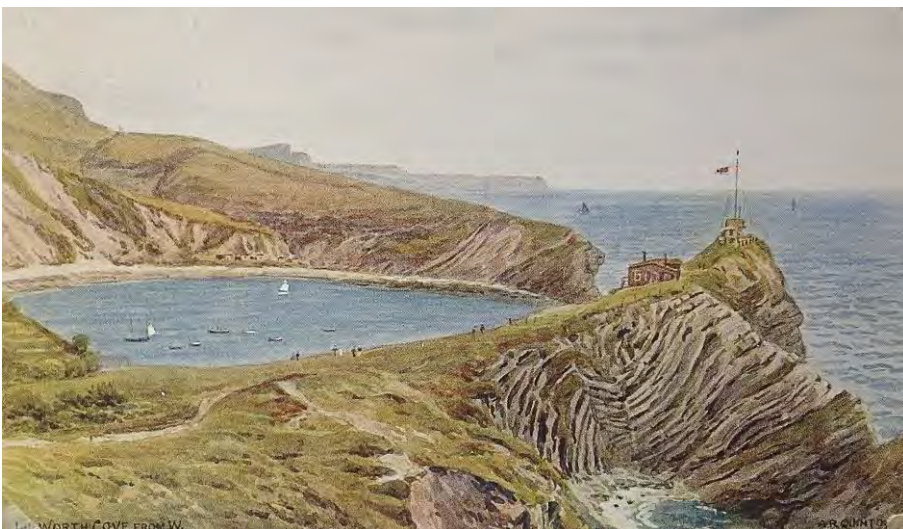
**Figures 5.4 (left) & 5.5 (below)** show the two watercolour drawings by the prolific Alfred Robert Quinton, who painted the English coast during the first three decades of the twentieth century. They show the construction of a '*Coastguard Station*' overlooking the mouth of Lulworth Cove. Although the downland behind, which contains significant buried heritage, is finely painted, heritage evidence is not immediately obvious.

The artistic images illustrated in this case study provide accurate reflections of the physical nature of the coastline. They show the geology and geomorphology particularly well and, for example, the Coastguard Station on the headland. It is difficult to interpret whether any of the faint depictions on the hillsides relate to buried heritage sites or whether they are sheep tracks or footpaths but, bearing in mind the main focus was on the coastal scenery, buried heritage was not perhaps regarded as a priority, and as such more detailed illustrations were left to antiquarians such as Sir Henry Englefield (Figures 5.6 and 5.7), who had identified Flower's Barrow, for example, on the fine map contained in his 1816 publication (Englefield, 2016<sup>2</sup>). Taking account of the excellent aerial photographs that are available for this location aerial photography offers the clearest images of heritage sites whilst artworks illustrate changes to the coastal topography over time.

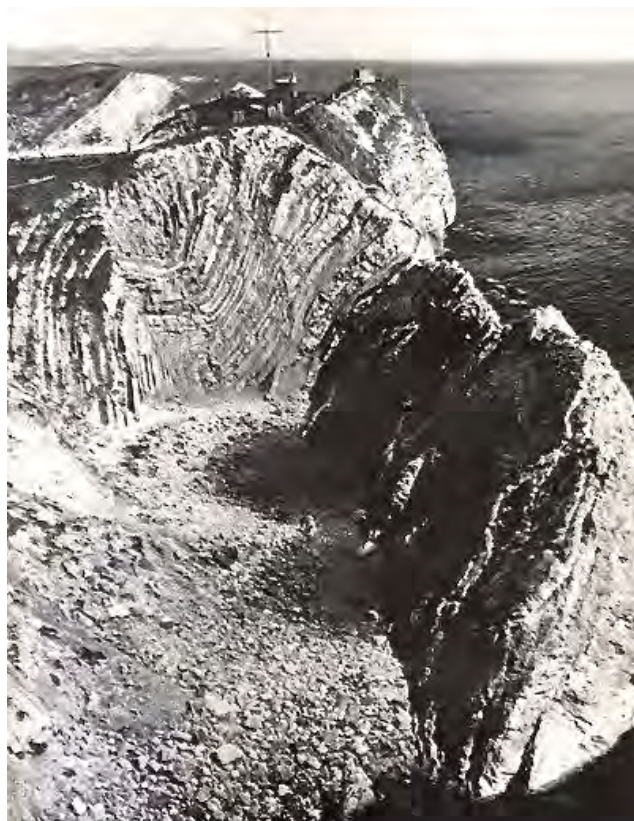
**Figure 5.8 (left):** A view from Stair Hole, c.1960s showing the Coastguard Station, which closed soon after.

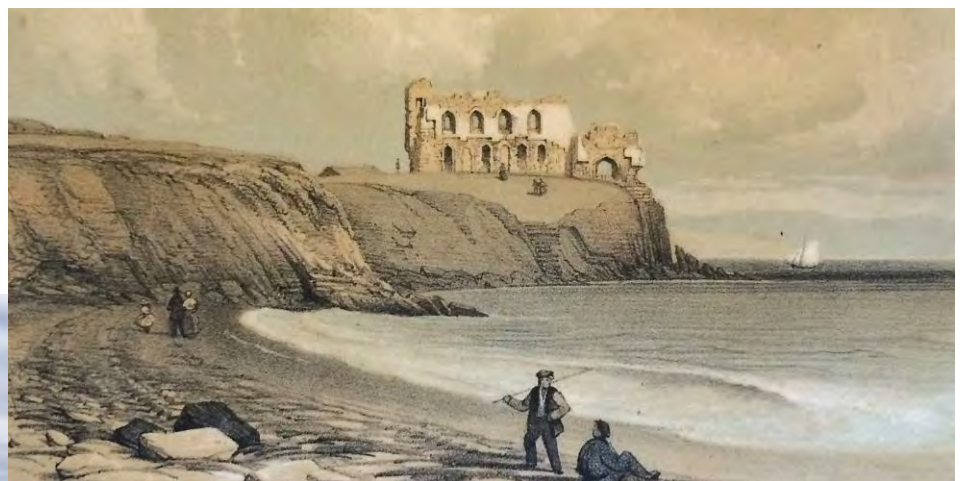
**Figure 6.1 (right):** A view of Sandsfoot Castle, Weymouth, in the 1840s. Lithograph. The seaward face of the Castle can be seen collapsing into the sea as a result of coastal erosion.

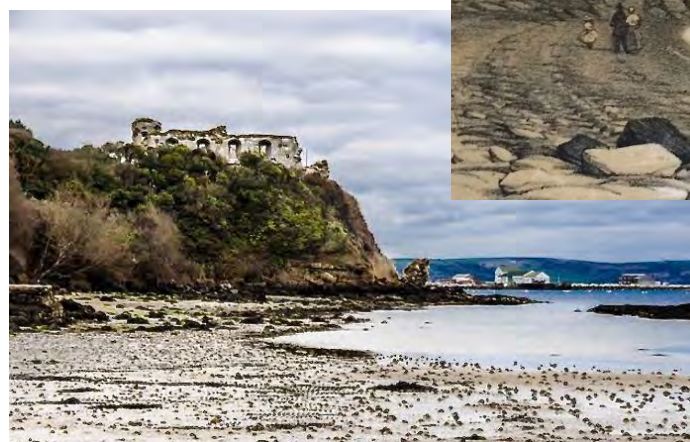
**Figure 6.2 (left):** Sandsfoot Castle today. The site has been safeguarded following works by the Council and acquisition of the grounds as an amenity.

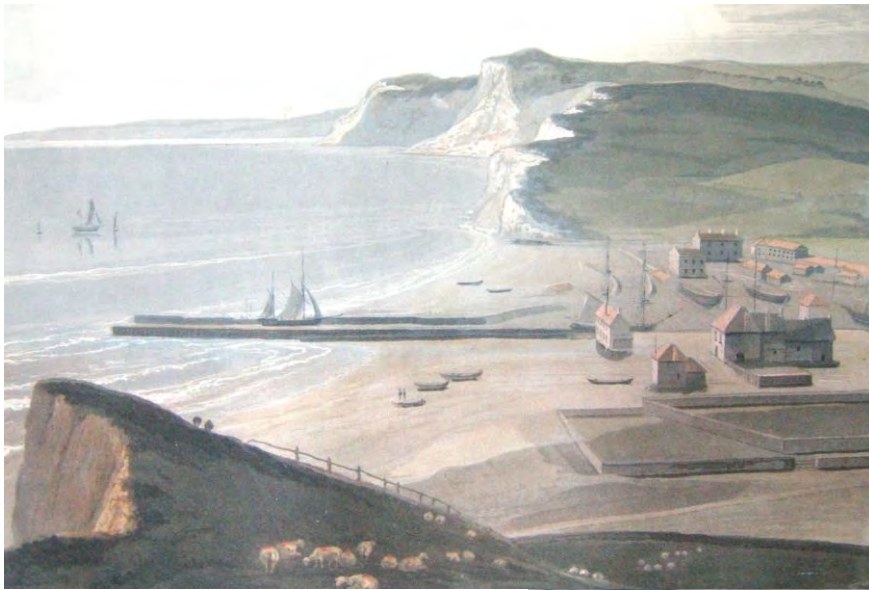
**Figure 7.1 (left):** *'Bridport Harbour' or West Bay* by William Daniell RA. 1825. The aquatint engraving shows how the historic harbour arms cross the wide beach interrupting the west to east sediment transport along the coast.

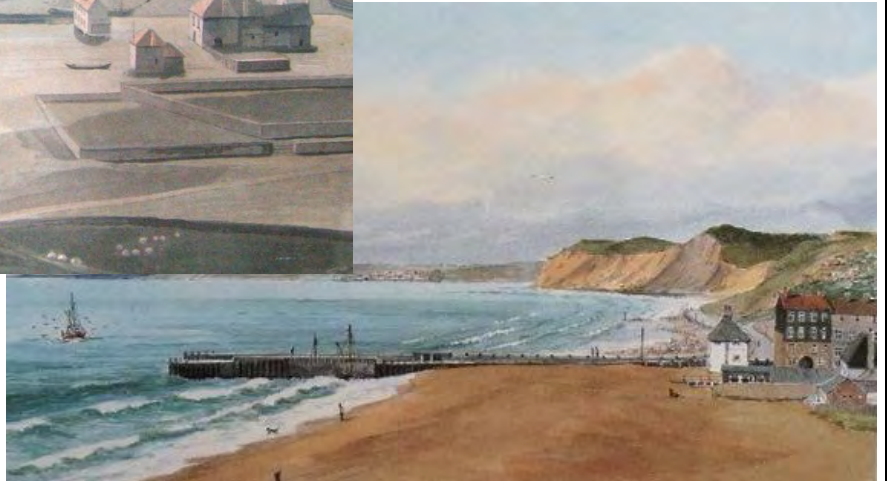
**Figure 7.2 (right):** This view of the same scene (but from a lower vantage point) was painted in watercolour by David Addey in 1990. The harbour and flood defences were improved ten years ago.

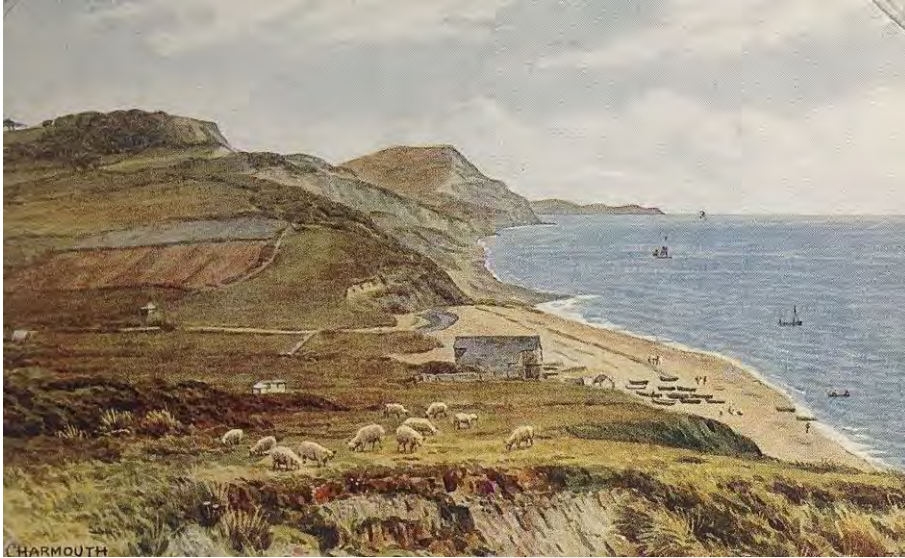
**Figures 7.5 (left) and 7.6 (below):** An extensive view along the cliff top from Charmouth looking eastwards by Alfred Robert Quinton, c.1920. The cliff tops contain numerous buried heritage sites, which are exposed through rapid coastal erosion and landsliding (e.g. Dog House Hill, Chideock MDO7655).

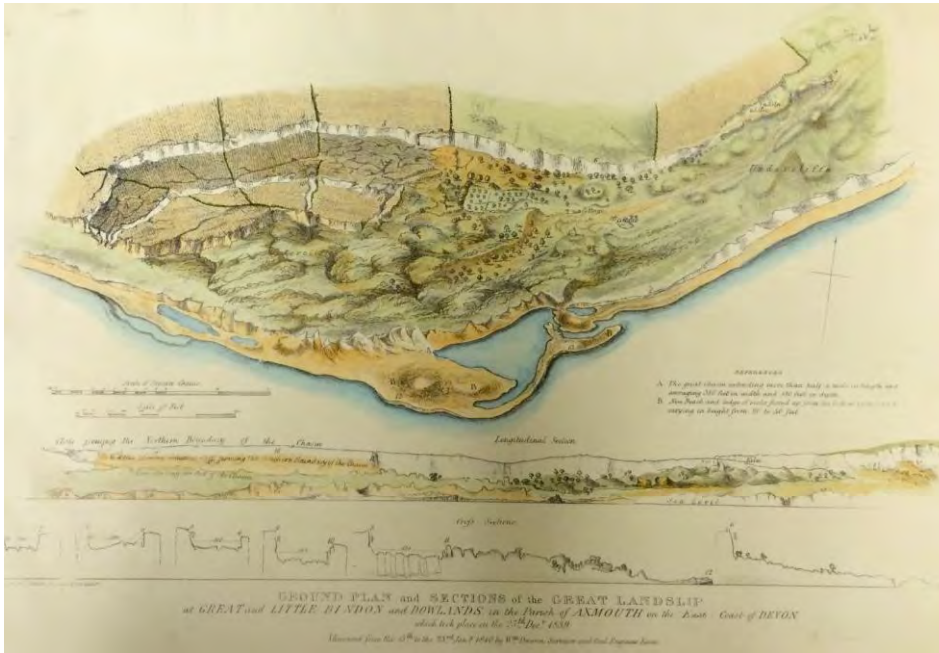
**Figure 7.8:** The coastal geology and geomorphology was mapped and described by the Rev. W. Conybeare and William Dawson in 1840. They provided detailed maps of the landslips, as well as finely lithographed views of the major landslide events.

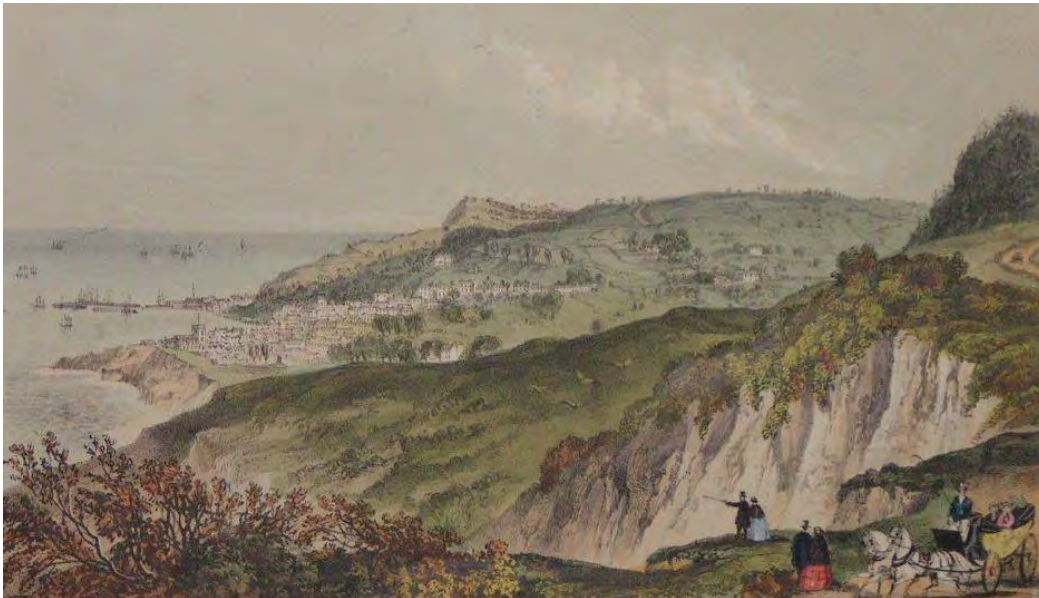
**Figure 7.12:** A mid-nineteenth century view looking over the developing town of Lyme Regis from the east side close to Black Ven. The unstable nature of the coastal cliffs can be seen in the foreground.

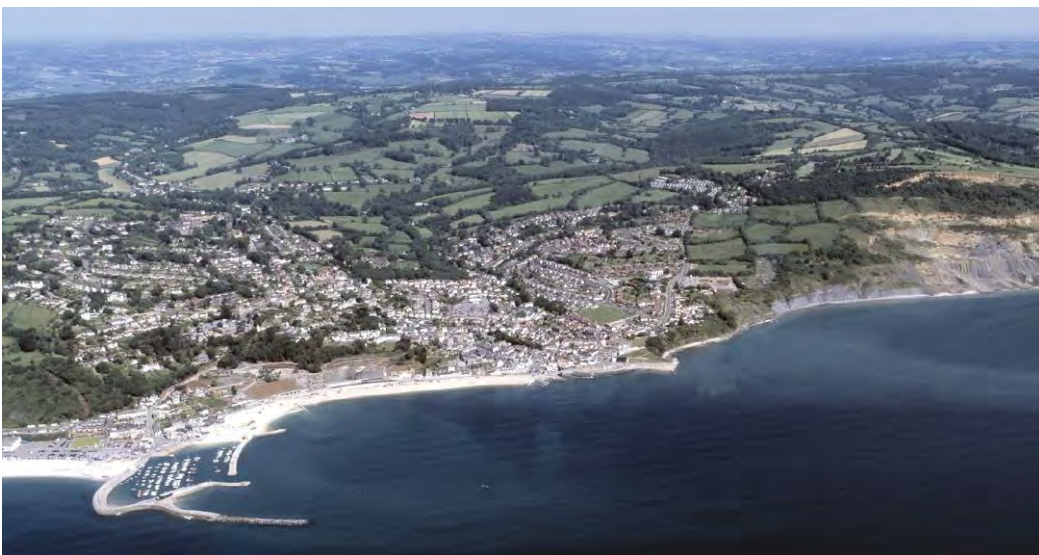
**Figure 7.13:** Lyme Regis has been protected progressively over the last twenty-five years with several phases of major coast protection and landslide stabilisation works. These have included the addition of rock armour at the end of The Cobb and, more recently, further works at the eastern end of the seafront below The Spittles.

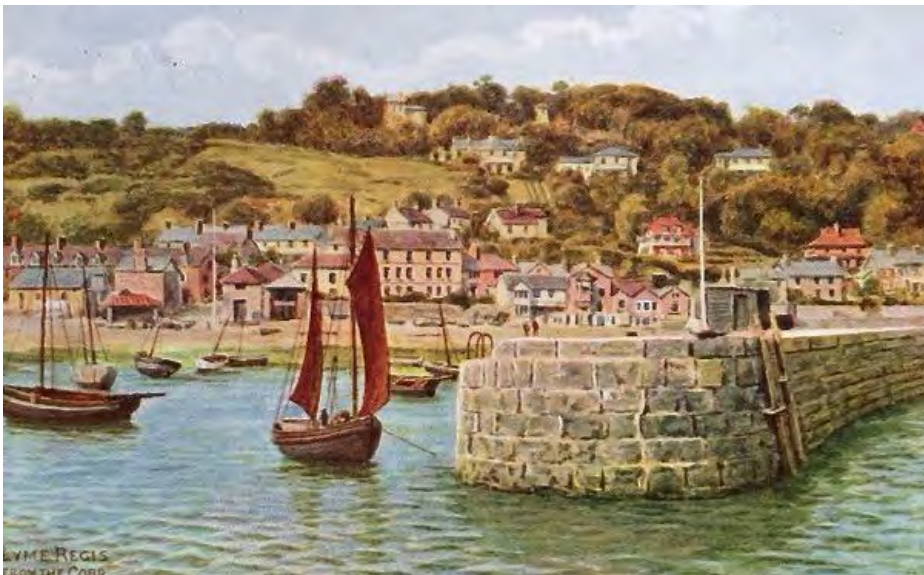
**Figure 7.15:** *'The Cobb, Lyme Regis'* by Alfred Robert Quinton, who painted numerous watercolours of the town and seafront in the 1920s. The quality and detail of Quinton's work is obvious and compares favourably with the black and white photographic postcard published at about the same time (Figure 7.16 below).

The advantages of images in colour in terms of describing the coastal architecture and the construction of The Cobb can be readily appreciated.

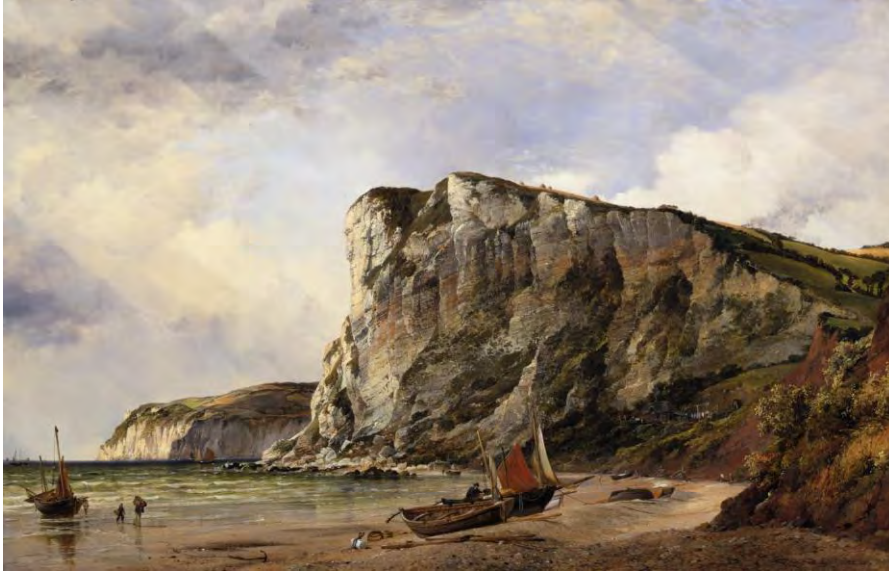
**Figure 8.3:** *'Distant View of Beer Head and White Cliff at Low Water'* by E. W. Cooke RA, 1858. This dramatic headland is captured well by Cooke and shows the end of the red sandstone cliffs, which extend eastwards towards Seaton on the right.

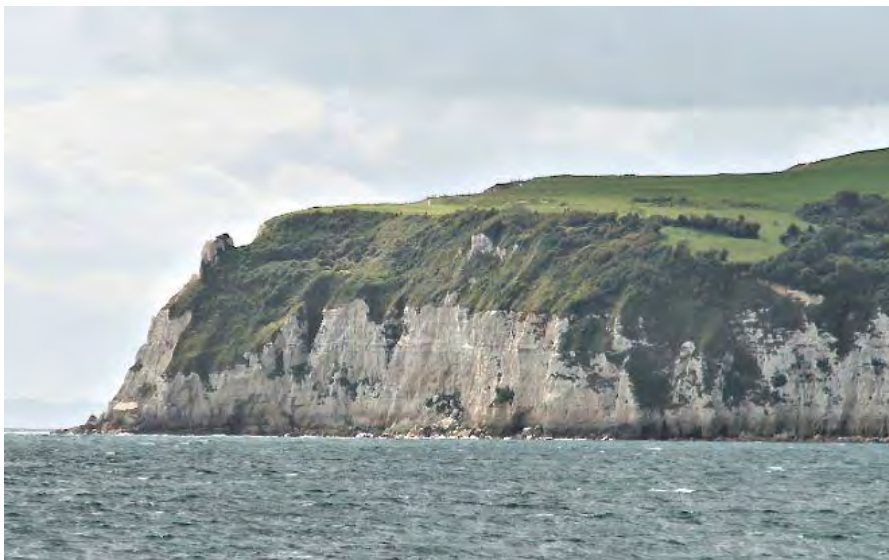
**Figure 8.4:** This photograph shows the headland on the left of Cooke's painting. The cliff tops contain heritage sites which are being lost progressively as a result of coastal erosion.

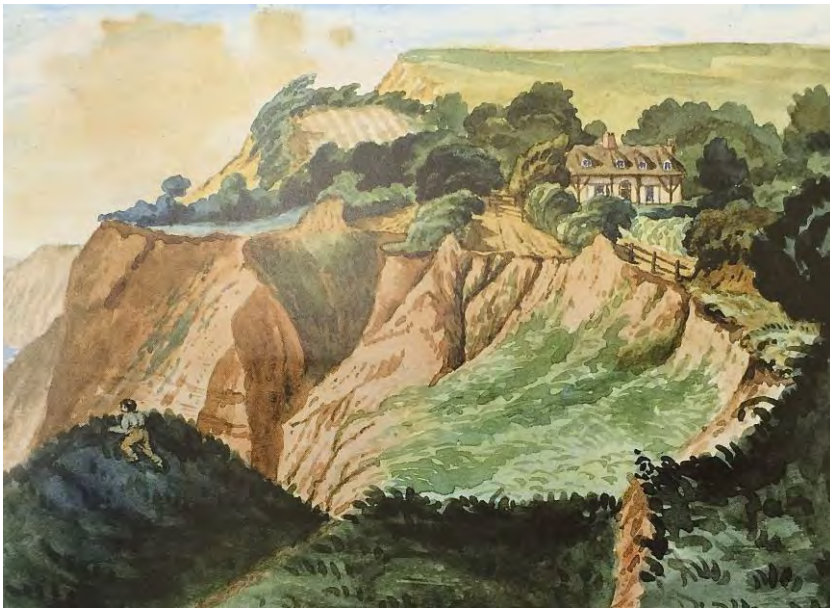
**Figure 9.8:** A failure of the cliff near Peak Cottage, Peak Hill, Sidmouth, on 31<sup>st</sup> August 1847. A watercolour painted on the spot by P. O. Hutchinson.

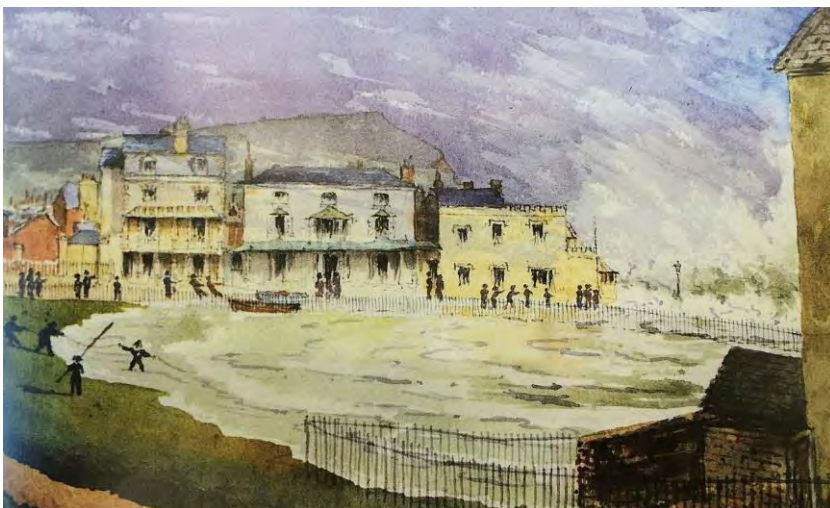
**Figure 9.9:** Serious sea flooding affected Sidmouth on 3<sup>rd</sup>/4<sup>th</sup> December 1876. The scene was captured in watercolour by P. O. Hutchinson and described in his diary.

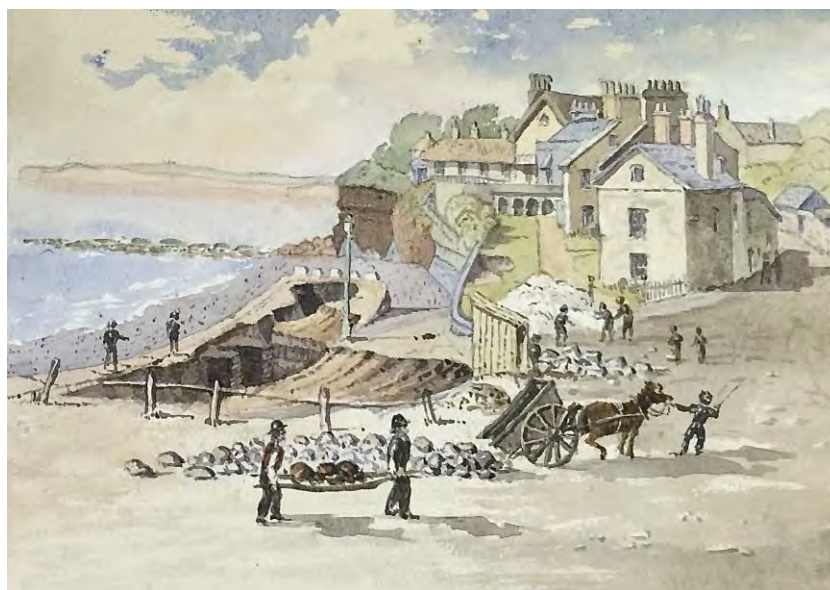
**Figure 9.10:** Sketch by P. O. Hutchinson showing repairing storm damage to the Esplanade near the bottom of Peak Hill, Sidmouth, in January 1873.

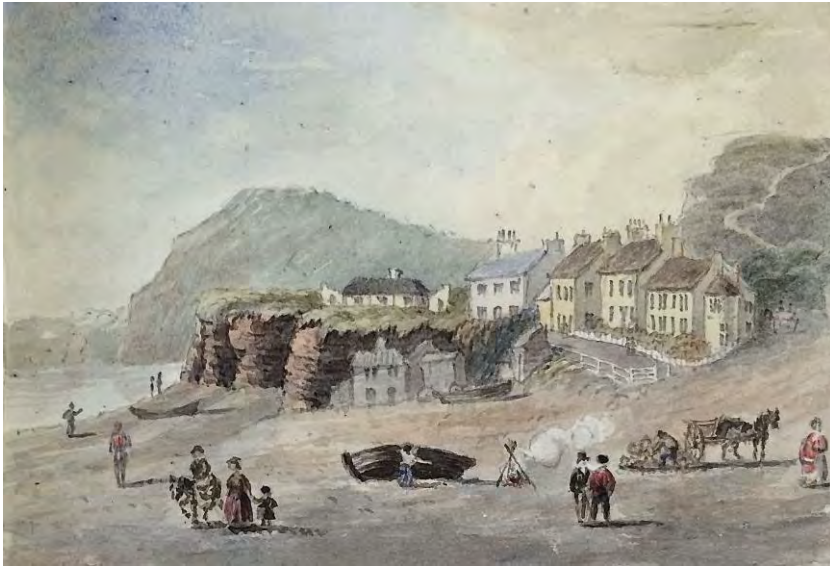
**Figure 9.11:** The west end of Sidmouth beach from an old print dated 1816. Painted in watercolour by P. O. Hutchinson, the view shows the row of fishermen's cottages that were washed away in the Great Storm of 23<sup>rd</sup> November 1824.

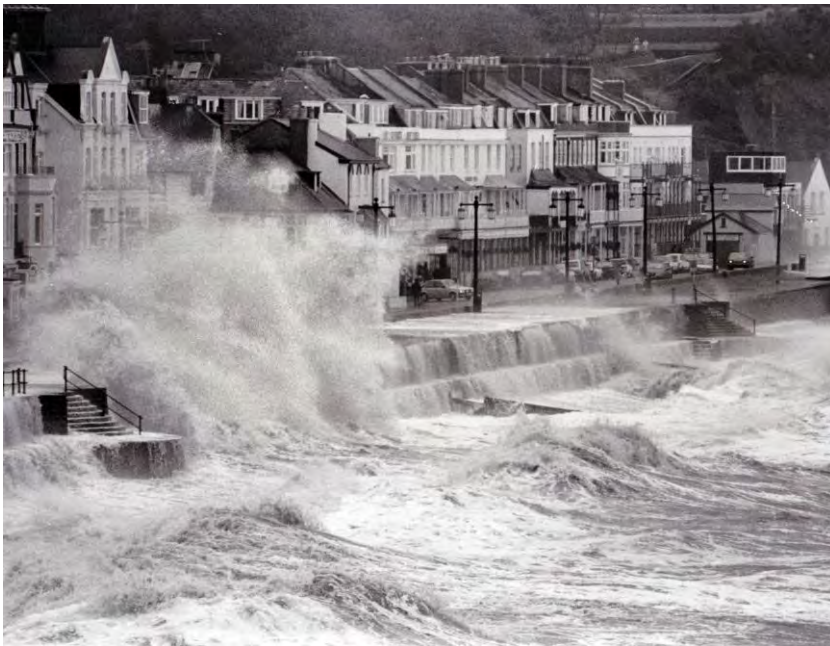
**Figure 9.12:** The exposed position of Sidmouth, facing the Atlantic's south-westerly storm waves, has led to frequent flooding events. Coastal defences have been improved since the 1990s and further upgrading is under consideration.

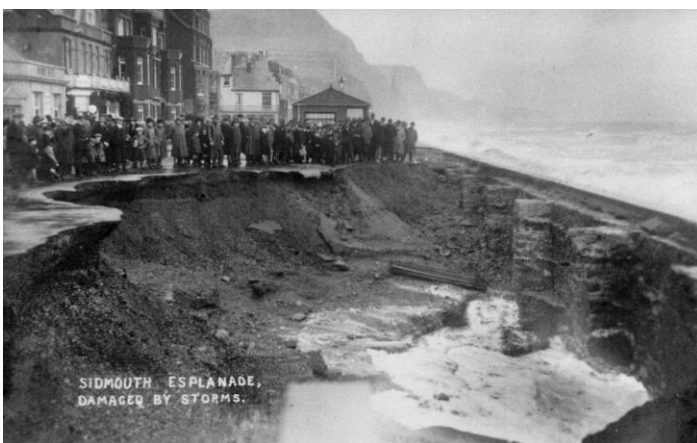
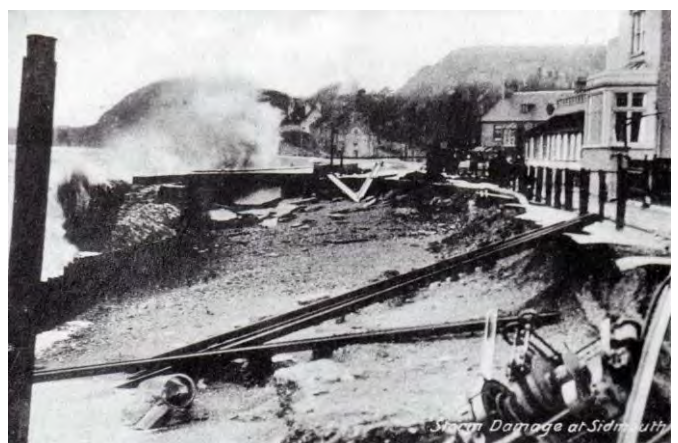
**Figures 9.13 and 9.14 (below):** show the devastation to the Esplanade after a severe storm.

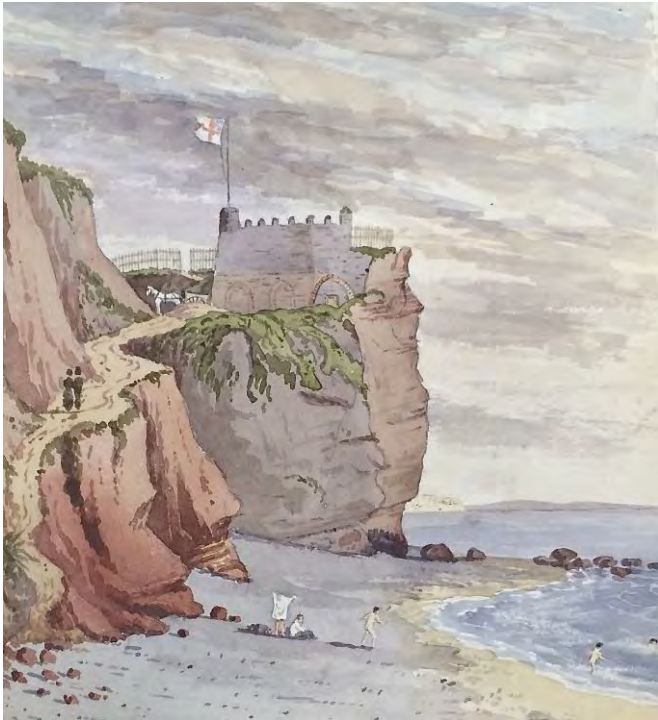
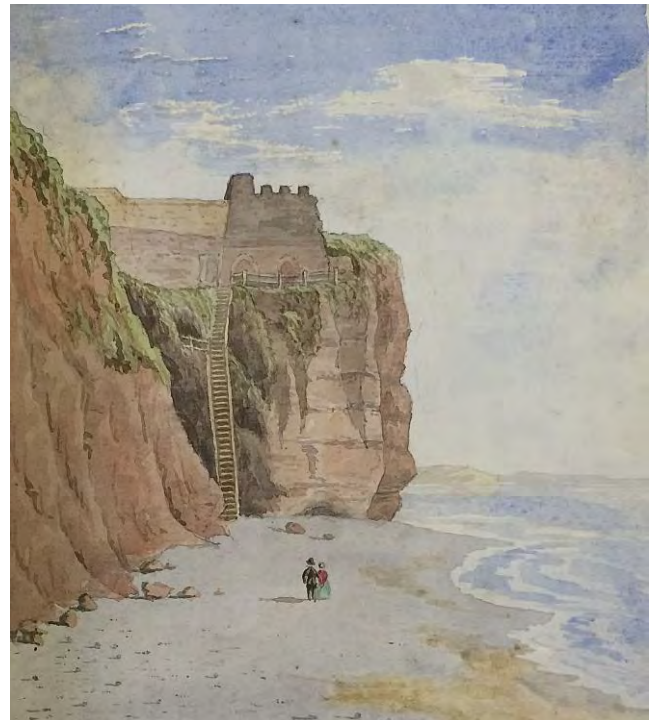
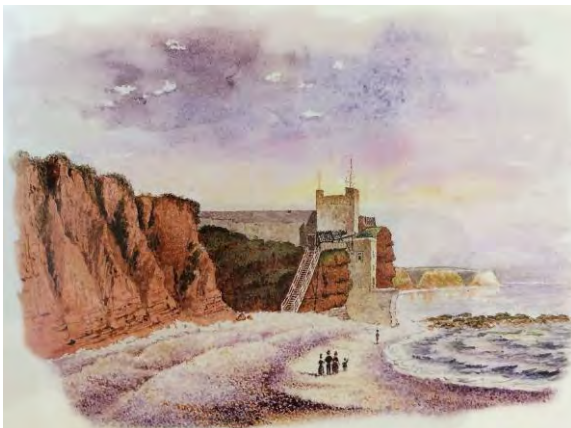
**Figures 9.15, 9.16 and 9.17:** These three views by Hutchinson depict the remains of the old lime kilns near the Chit Rocks at Sidmouth. The earliest view (top left) was painted on 4<sup>th</sup> December 1871 with a ladder providing access to the shore (top right). The view (left) was painted in May 1888 and, by now, the base of the cliff has been protected.

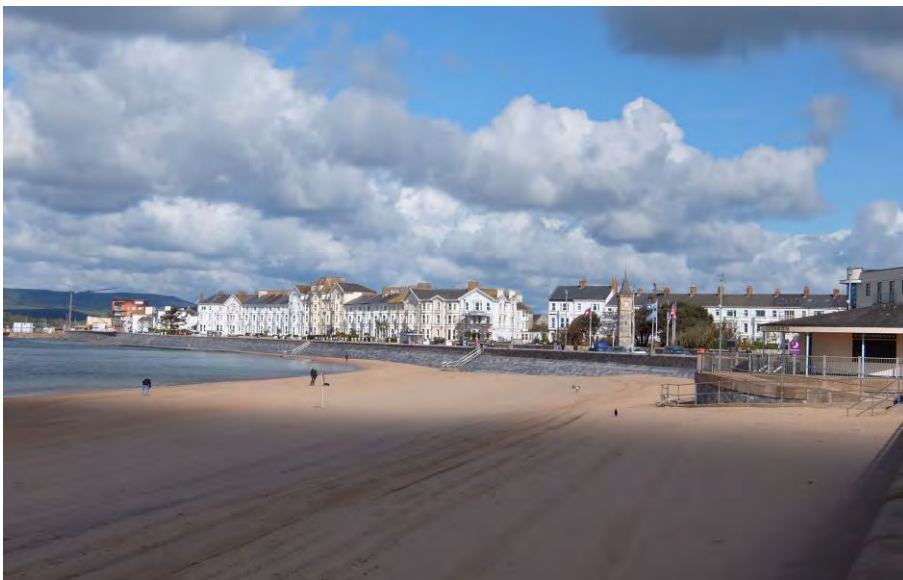
Coastal and flood defences help to protect the town frontage from erosion and flooding (**Figure 10.7 left**). However, the requirements are being reassessed through an erosion and flood risk management strategy. Damage caused during the severe storms of December 2013/January 2014 have highlighted the need for possible further improvements.

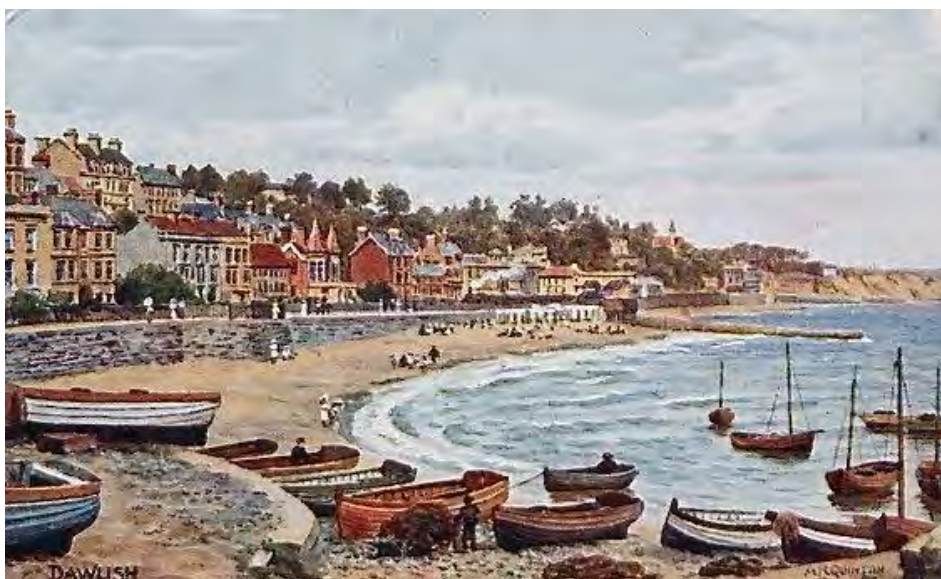
**Figure 11.9:** The seafront at Dawlish by A. R. Quinton painted in about 1920. By this time the railway line and the coastal properties are protected by a stone-faced seawall.

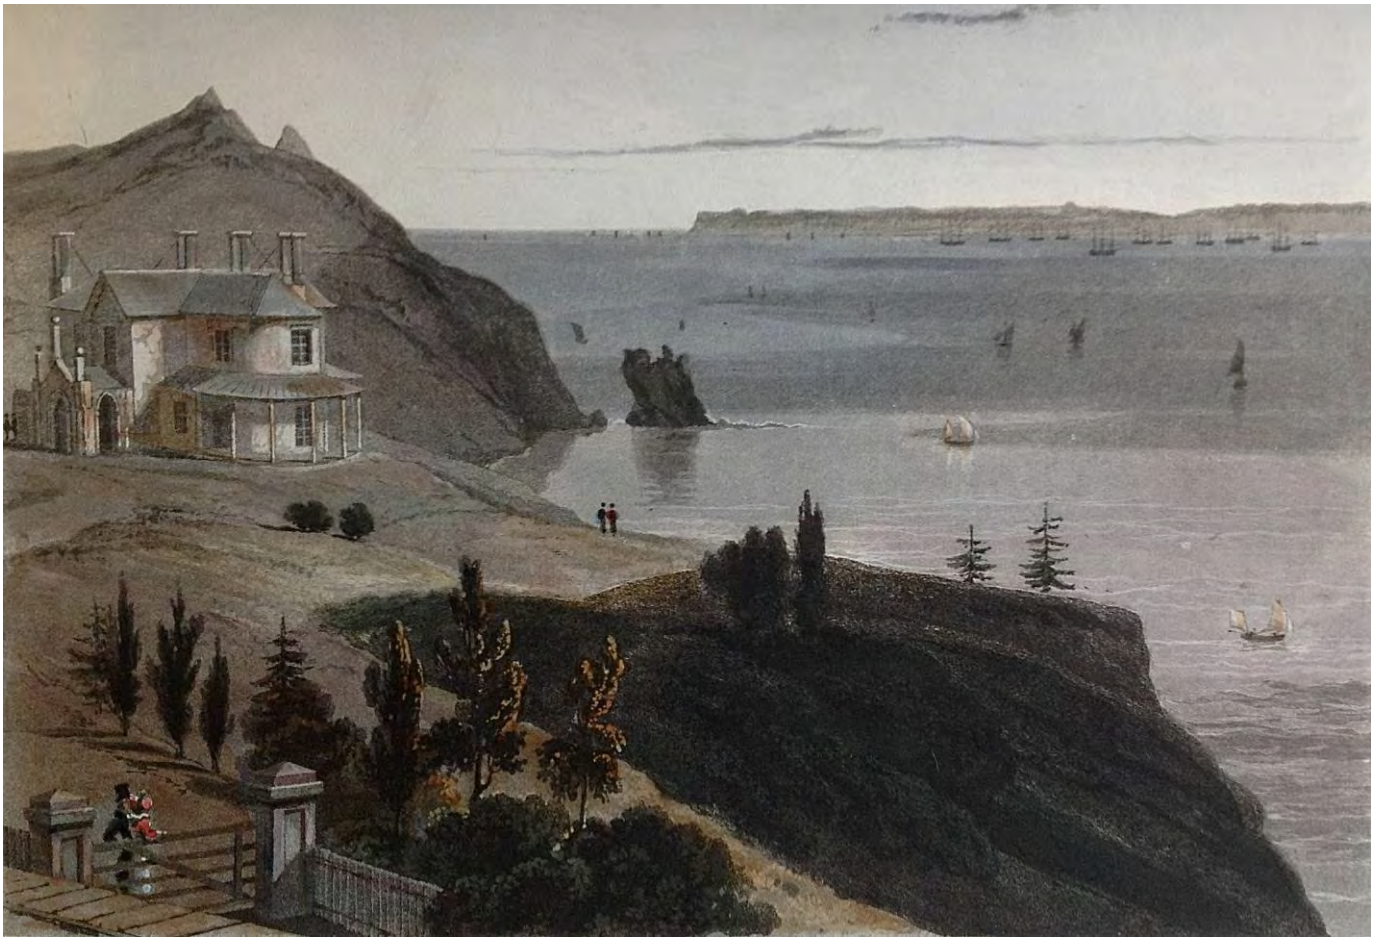
**Figure 12.1:** *'Torquay'* by William Daniell RA. Aquatint. Engraving. 1825.

This attractive house was Marine Villa, which is present on John Wood's Plan of *'Torquay and Environs'* of 1841, and was then occupied by a Dr Parkin. In 1853 it appears on the *'Plan of the Town of Torquay, from the Ordnance Survey, Being a Companion to the Torquay Directory'*. Edward Cockrem's directory records the house was occupied by Sir Henry Bold Hoghton, Bart (Cockrem, 1851<sup>1</sup>).

This view demonstrates Daniell's skill and accuracy as both a topographical and architectural artist and shows a scene that has changed dramatically over the last 200 years.

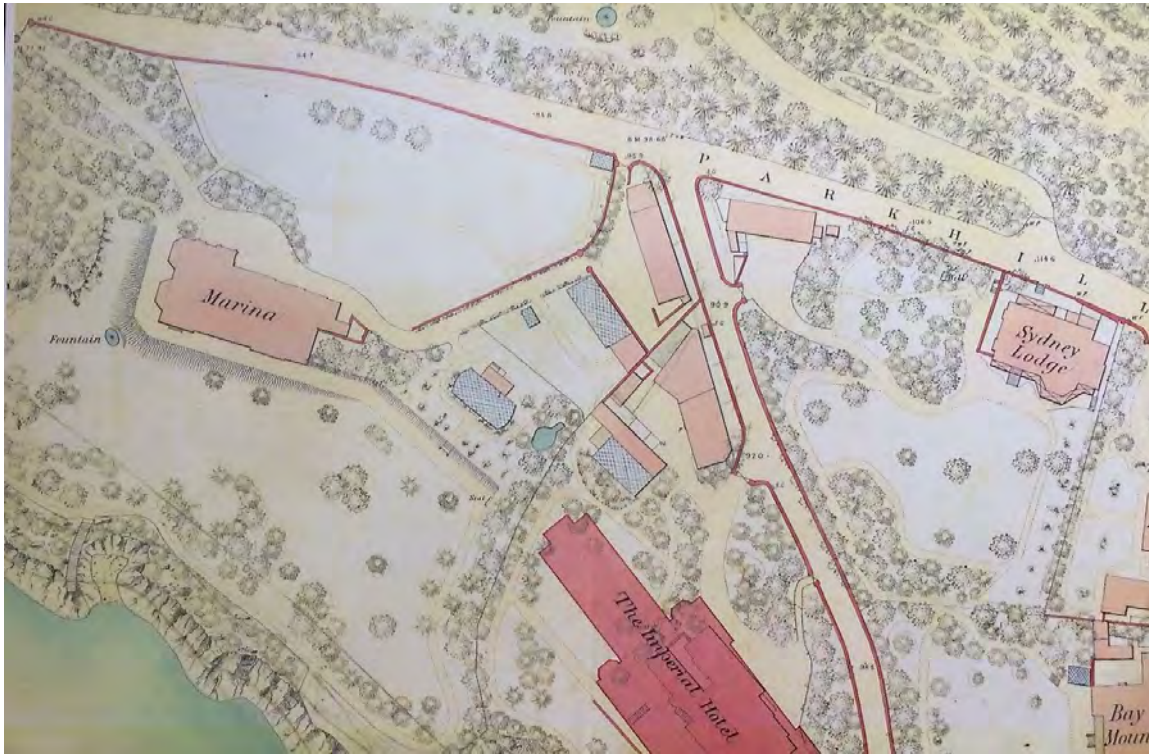
**Figure 12.2 (above):** The Ordnance Survey Map (1860-61) shows the expansion of the Imperial Hotel adjacent to 'The Marine Villa' or 'Marina' which is shown in Daniell's view (Figure 12.1).

On the First Edition Ordnance Survey Country Series, surveyed in 1861, (see Figure 12.2) it appears as Marina, which survived with extensions independently for a time, for it appears on the Second Edition County Series surveyed in 1904. It was finally subsumed into the ever-growing Imperial Hotel (which had opened in 1866 after the Marine Villa's neighbour *'The Cove'* was demolished in 1863 to make way for it) and as shown on the Third Edition County Series surveyed 1933. Elements of the ornate façade survived at least until the Second World War.

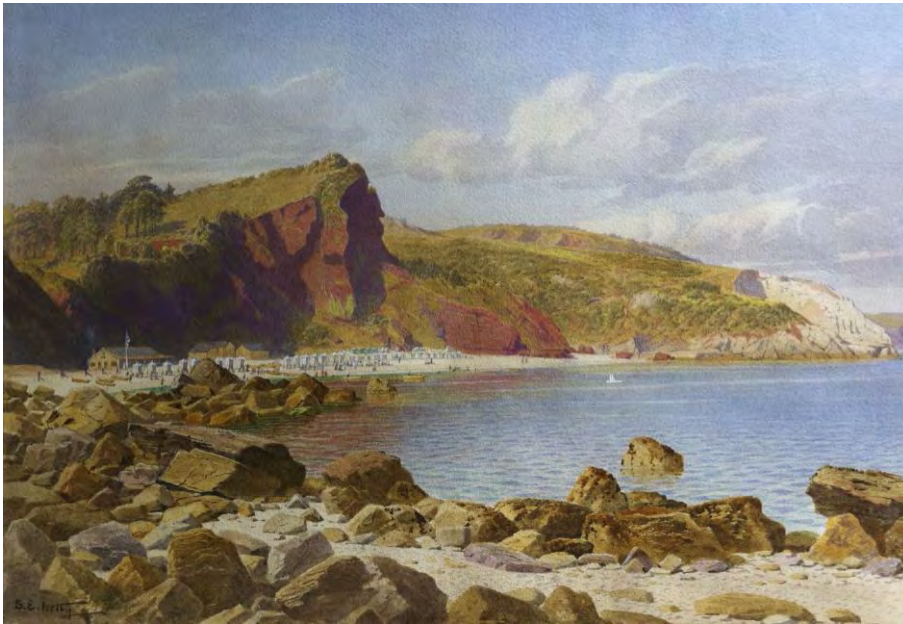
**Figure 12.18:** This detailed watercolour of 'Oddicombe Beach' by Samuel Edward Kelly, c.1910, shows development beneath the precarious red sandstone cliffs. Debris from previous cliff falls litters the shore in the foreground.

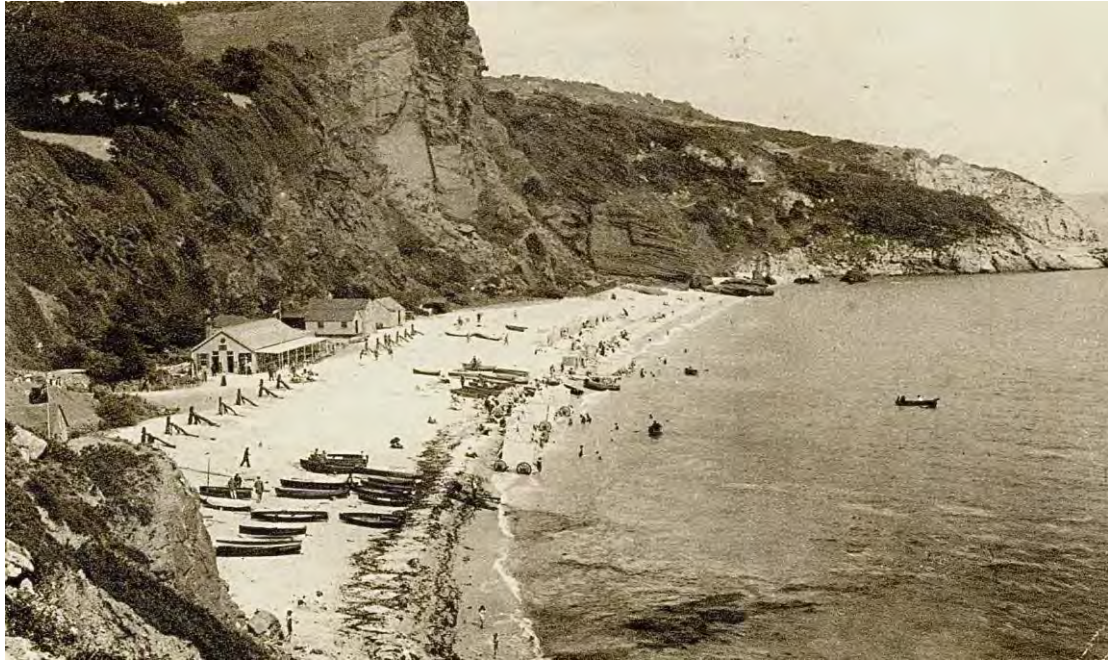
**Figure 12.21:** A photograph of Oddicombe Beach c.1900 looking eastwards. A cliff fall has occurred from the face of the bluff in the centre of the view.

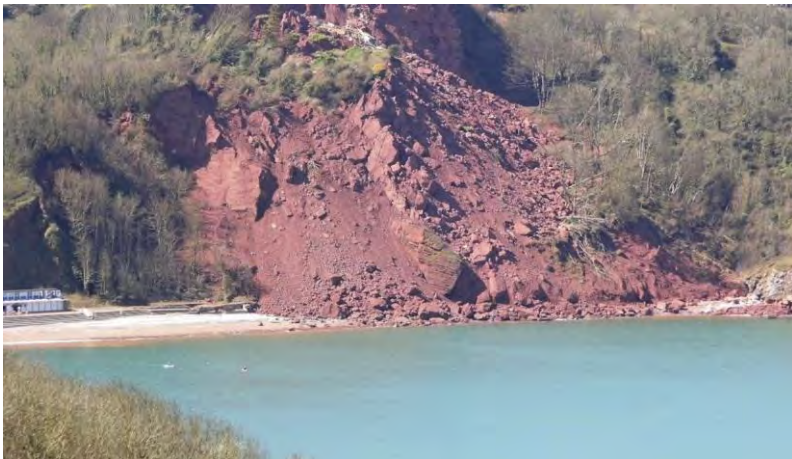
**Figure 12.22:** The massive cliff fall onto Oddicombe Beach on 3<sup>rd</sup> April 2013 at Ridgemont House.

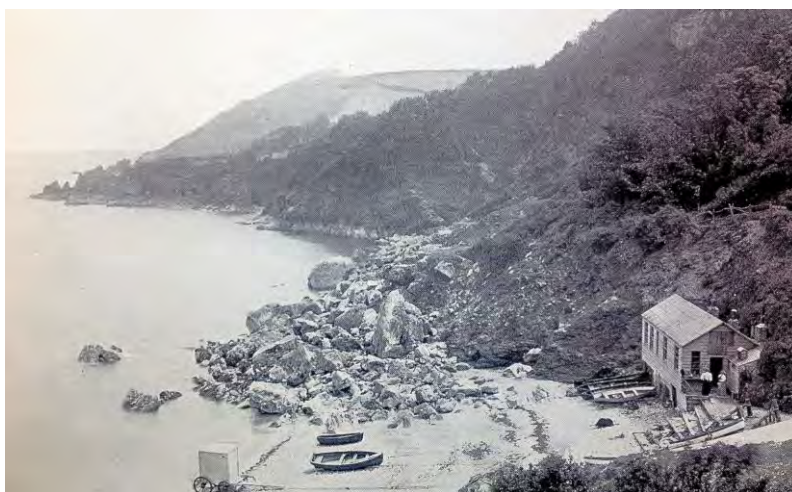
**Figure 12.23:** Another massive rockfall at nearby Anstey's Cove is recorded in this photograph c.1900.

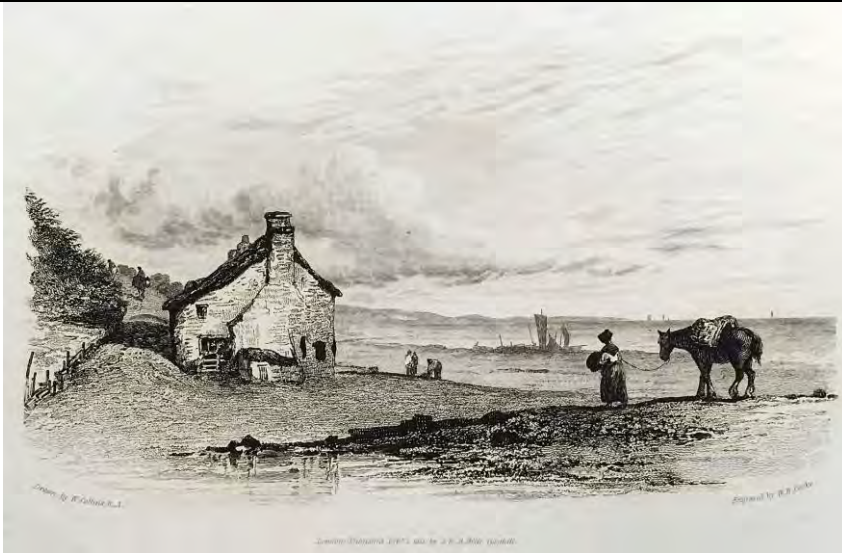
**Figure 13.1:** Lying just to the north of Start Point the fishing community of Hallsands occupied an exposed coastal location. Following dredging for aggregates too close to shore the beach lowered significantly. After a severe storm in 1917 the village was abandoned. This engraving of Hallsands is from an oil painting by William Collins (1846). No other paintings of the village have been found although there are a number of old photographs such as **Figure 13.2 (middle left)**. Where no artworks exist early photographs describe the nature of such relatively unvisited locations although the views are not in colour.

It has been explained that this part of the coastline is predominantly one of hard rock and, therefore, there is very limited coastal erosion or cliff instability. This case study highlights the effects of intervention at Hallsands for the extraction of material for expansion of the Naval Dockyard at Keyham near Plymouth. It illustrates the impact of such nearshore activity on development. Only one art image was found of Hallsands, which was subsequently engraved and is illustrated as figure 13.1. A number of photographs exist of the Hallsands community and a picture of life there can be gained from the photograph shown as figure 13.2.

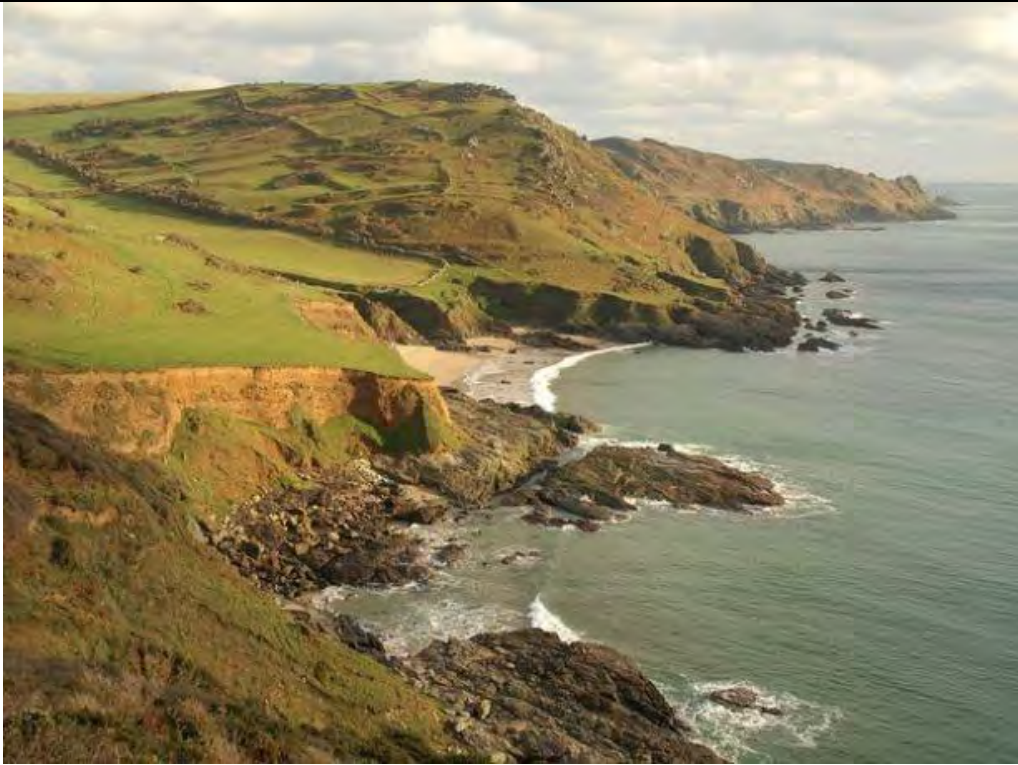
**Figure 13.4:** This recent photograph shows Deckler's Cliff with the ancient field system clearly visible. Although undefended the coastline has changed only slightly since the earlier Frith photograph.

With regard to Deckler's Cliff, despite extensive searches, no paintings, watercolours or prints were found of this specific coastline, and certainly none which showed the field systems. A photograph by Francis Frith (see figure 13.3) does show the field system, which is better illustrated in the recent photograph shown as figure 13.4.

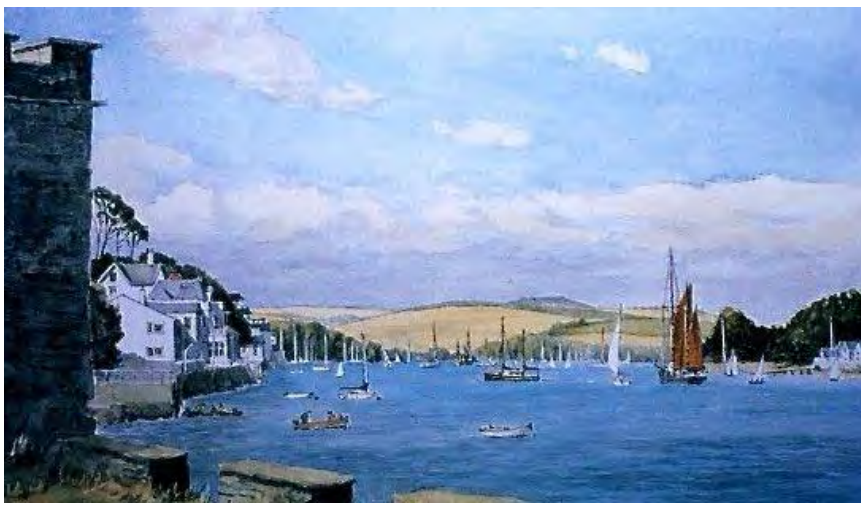
**Figure 13.7:** The architect and watercolour artist, David Addey, retraced Daniell's journey around the British coast in the late 1980s; he reached Salcombe in 1988. Whilst the villa depicted by Daniell had gone, part of the crenelated steps up to it still existed.

William Daniell's view of Salcombe (figure 13.6) shows a marine villa '*Woodville*' perched on the side of the estuary. In David Addey's watercolour taken from the same spot in 1988, the castellated steps on the left hand side form part of those shown in Daniell's view, but the present house called '*Woodcot of Woodville*' bears no resemblance to the property depicted by Daniell. The view by Alfred Robert Quinton (figure 14.8) shows Salcombe from Sunny Cove in about 1915. The scattered villa development bordering the estuary is now more intensive.

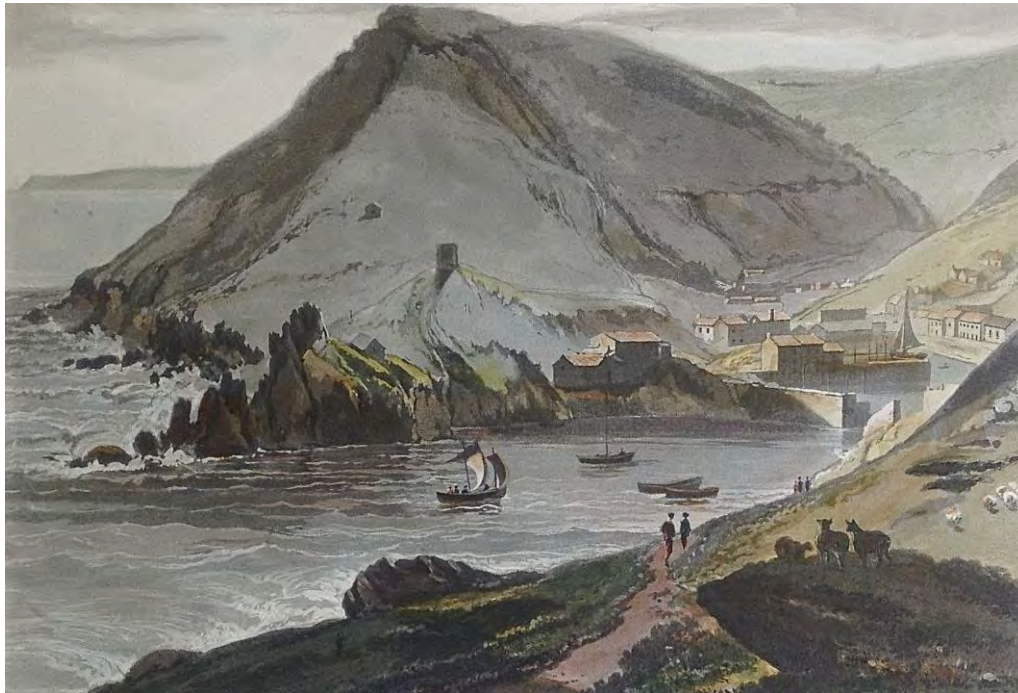
**Figure 15.1 (above):** 'Polperro' by William Daniell RA was engraved in 1825, near the end of his eleven year 'Voyage Round Great Britain'. It compares with the view by David Addey painted in 1988 (**Figure 15.2 below**). Daniell has foreshortened the western side of the entrance to the harbour, and has slightly exaggerated the height of the scenery. Daniell said of Polperro *"the town is very irregularly built; the inhabitants are mostly fishermen, and in the pilchard season, whatever inclination they may have for cleanliness, they cannot be otherwise than dirty. Of course little can be said of the beauty, and nothing of the elegance of Polperro; but the environs abound in picturesque features, though of a humble kind, such as uncouth cottages, so strangely planted amongst the rocks, that they seem to have been dropped there and left to take their chance of a settlement"*. The harbour piers at Polperro were damaged in the late eighteenth and early nineteenth centuries, and nearly destroyed in 1824. A new pier was constructed in 1824 and improved in 1897, due to the growth of the fishing industry. It is possible that Daniell's aquatint engraving was produced as the new pier was being completed. The harbour and pier is listed Grade II. Today the village has become a major tourist attraction and its development is well illustrated in the series of views by Alfred Robert Quinton (below).

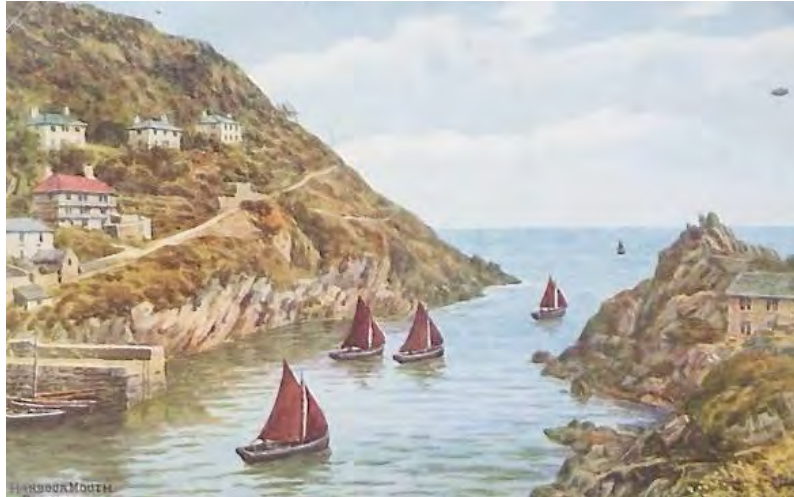
**Figures 15.3 (above) and 15.4 (middle)** show two views of the entrance to the harbour at Polperro taken from the same spot. Figure 3 is a watercolour by Alfred Robert Quinton, painted in about 1920, and, for comparison, a photographic postcard (c.1930) shows an almost identical scene to that painted by Quinton, who was quite meticulous in his detail.
