# **Coastal Heritage Risk – Imagery in Support of Heritage Planning and Management in South-West England**

**‘CHeRISH’**

***FINAL REPORT FOR HISTORIC ENGLAND***

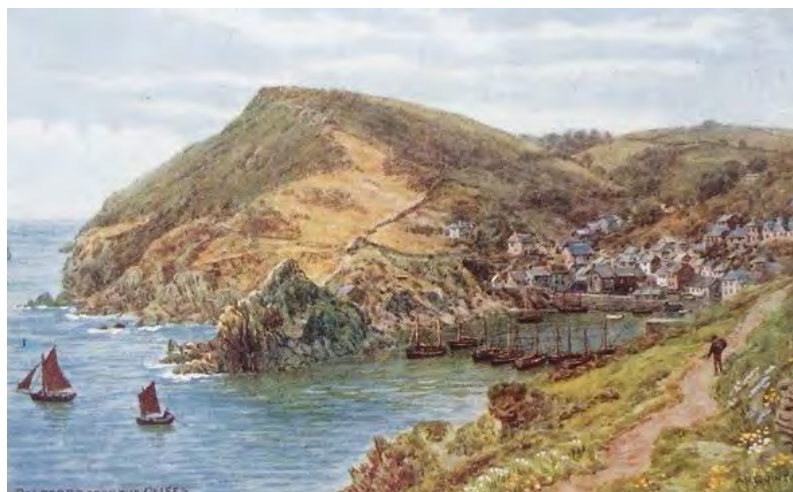
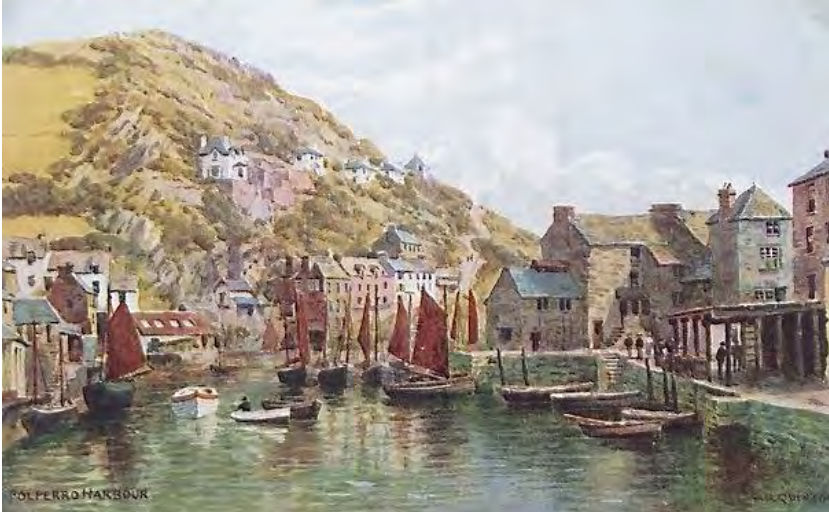
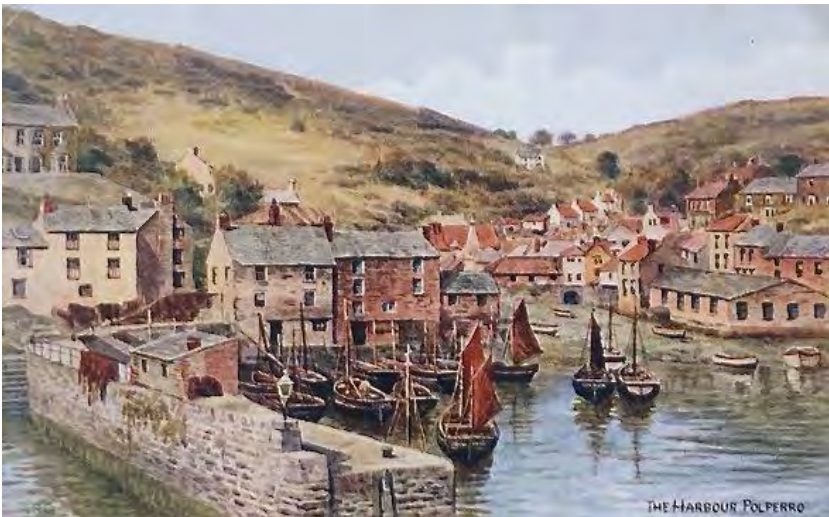
Figures 15.6-15.8 (left) are a series of views, again, by Alfred Robert Quinton, which show the interior of the harbour, together with the harbour arm, painted in about 1915.

Figure 15.8 (bottom) shows the overall setting of Polperro, looking from behind the village, out towards the sea. Quinton's work allows us to examine the nature of the harbourside buildings and the structure of the harbour wall itself. This can be compared with the works of other artists who often painted from the same location.

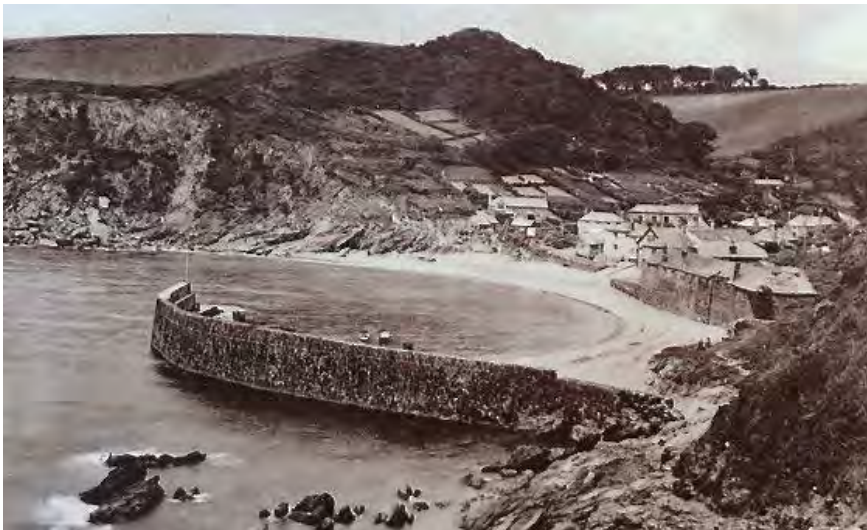
**Figure 15.10 (centre)** shows a view of Polkerris harbour in about 1920. The buildings on the right appear quite similar to those associated with the pilchard industry that are shown in Daniell's view on the edge of the shore. However, the harbour arm has deteriorated perhaps through coastal erosion at its landward end. **Figure 15.11 (bottom)** shows David Addey's view (1988) with further retreat of the cliff on the right leaving the remains of the harbour arm separated from the shore.

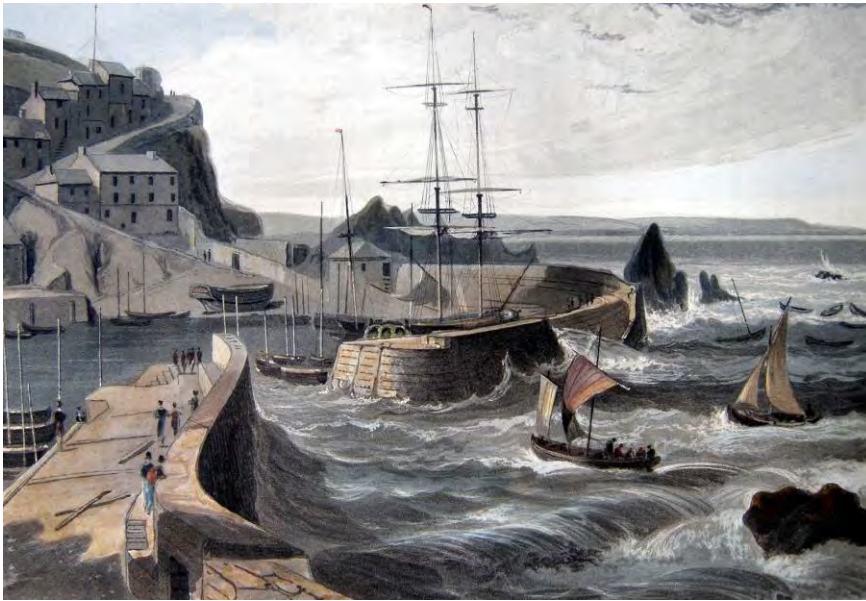
Figures 15.12 and 15.13 show two views of Mevagissey Harbour by William Daniell, engraved in 1825. The nature of the harbour construction is clearly depicted in **Figure 15.12 (top)** and the conditions of the water appear rough outside and more tranquil inside the harbour. In David Addey's 1988 view (**bottom**) he observed that the two main piers are basically unchanged, although a building of pleasing architectural design, had been added to the nearer pier on the left. The rounded end of the main harbour arm, as depicted by Daniell, has been squared off in Addey's view.

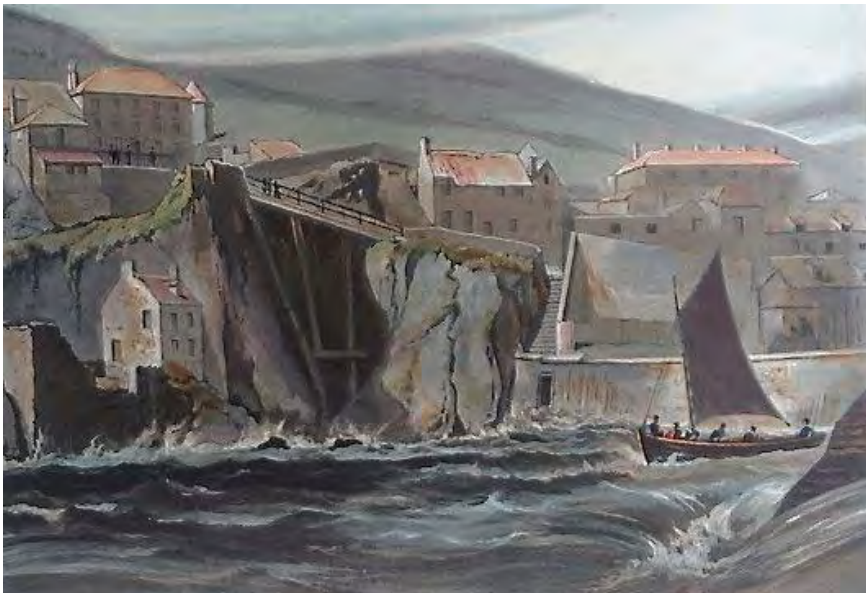
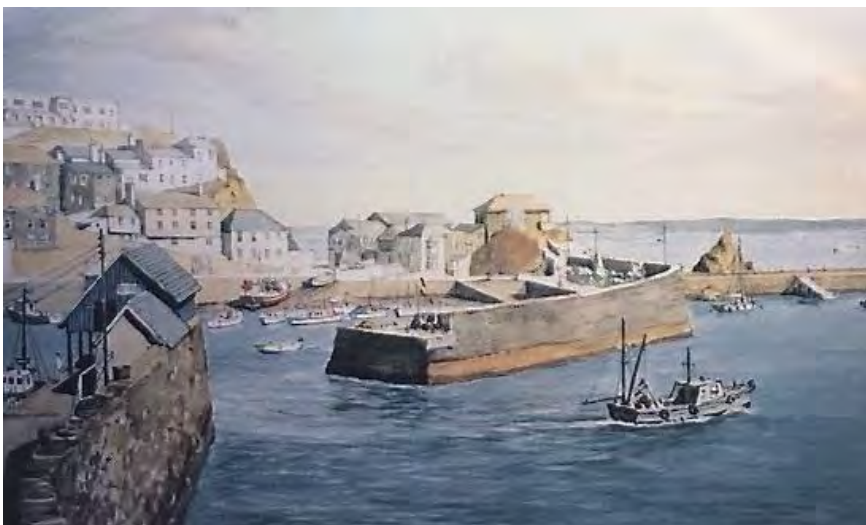
It is believed that Mevagissey Harbour dates from as early as the fifteenth century, although, in 1775, a new pier was built enclosing the present day inner harbour, and additional wharfs and jetties were constructed in the late eighteenth century.

The harbour was enlarged in the 1880s with two outer enclosing breakwaters. These were destroyed in the Great Blizzard of 1891, necessitating the harbour to be rebuilt in 1897 (HER, Cornwall County Council, 2012).

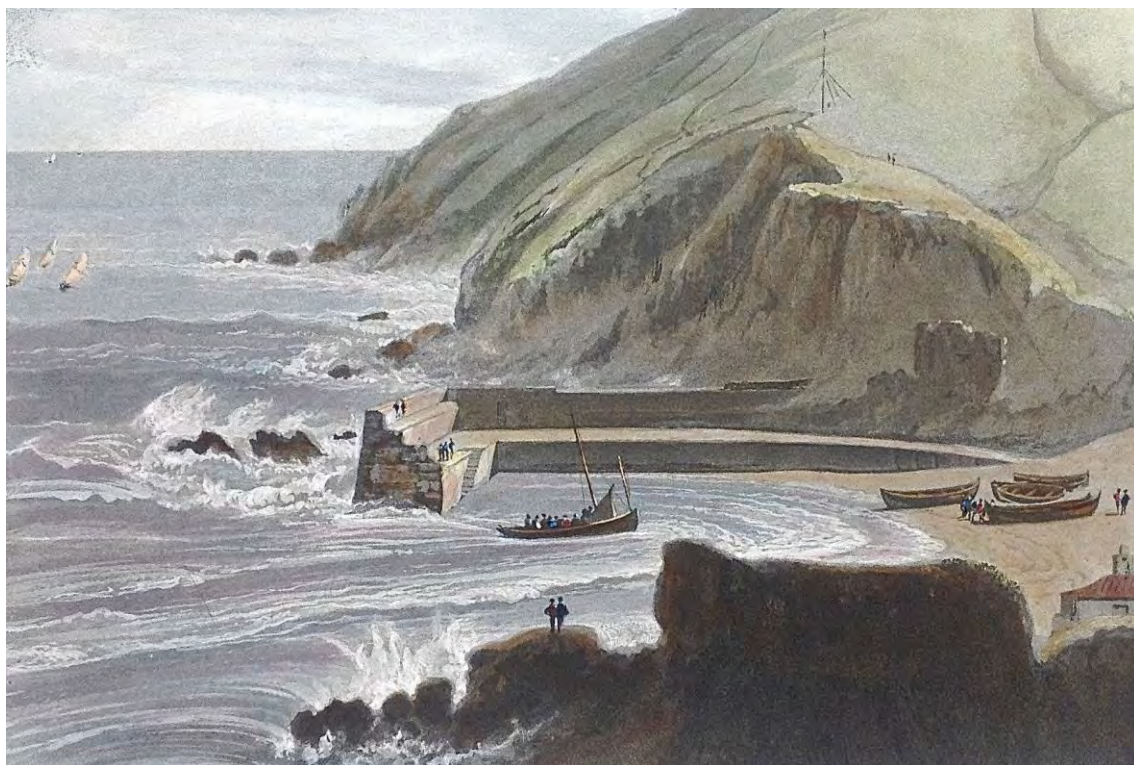
**Figure 15.15 (above)** shows Daniell's view of Gorran Haven, a quay which has existed since Medieval times. Daniell's 1825 engraving of the harbour arm appears very similar in design to that depicted by David Addey in 1988. Daniell noted "*at Gorran Haven there is a little pier for the shelter of the pilchard boats. The rocks here and in the neighbourhood are of a bold and picturesque aspect. On the high ground there is a signal post for the preventive service*". David Addey noted that, for his watercolour, "*the view has remained almost unchanged since Daniell's visit on the same day 167 years earlier*".

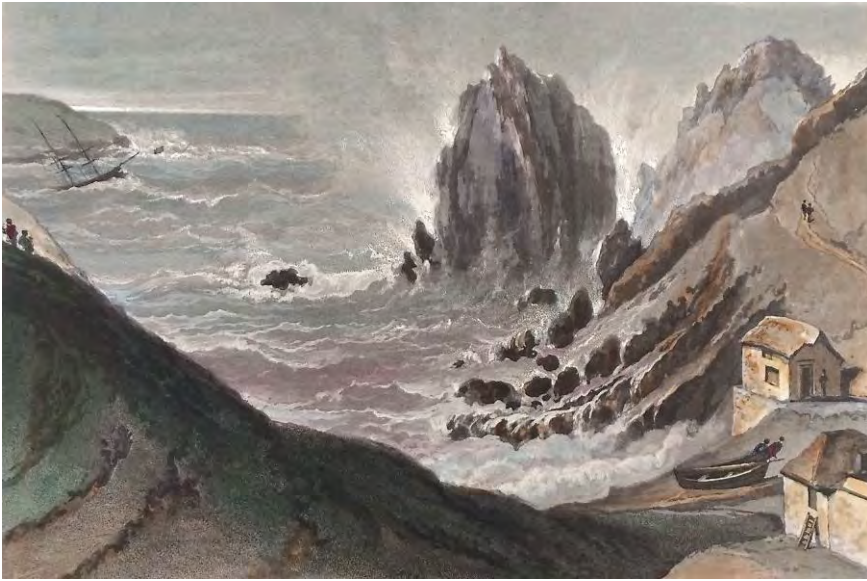
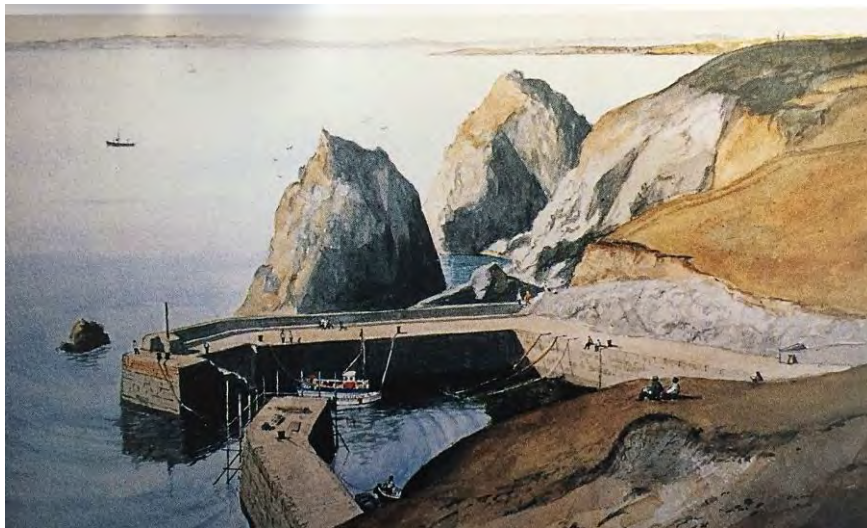
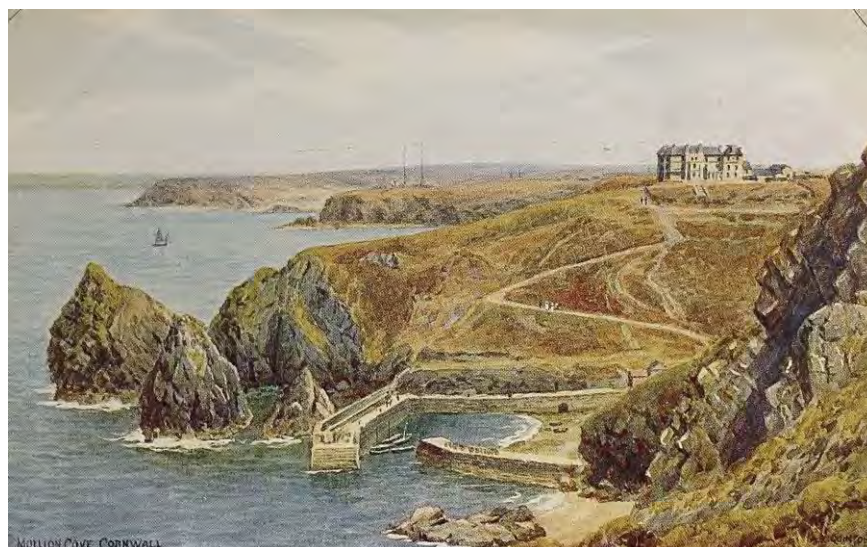
**Figures 15.17-15.19** show the dramatic physical location of Mullion Harbour. At the time Daniell visited the location a harbour did not exist, and he says *"the scenery around Mullion Harbour is rocky and as wild as possible. In heavy gales from the south-west the cave affords safe shelter for small vessels, whilst the Gull Rock protects them from the sudden and dangerous influence of the ground swell"*. **Figure 15.18 (middle)** shows a fine depiction of Mullion Harbour in 1988 by David Addey. The harbour appears to be in good condition at this time. **Figure 15.19 (bottom)** shows the harbour depicted from further uphill by Alfred Robert Quinton in about 1920. Quinton's view provides a panorama along this part of the south-west coast; in the distance the masts of Poldhu can be seen on the headland.

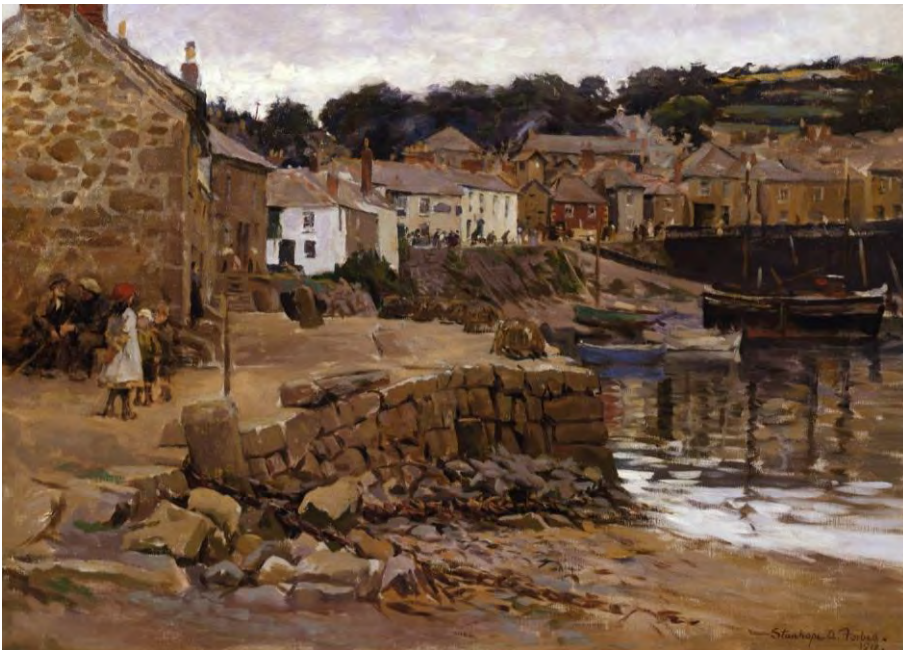
**Figures 15.23-15.25** show three further views of Mousehole. **Figure 15.23 (top)** shows a view of the interior of the harbour by Stanhope Forbes, an oil painting that he completed in 1919. He shows the nature of the cottages clustered around the edge of the harbour, and the apparent state of the interior harbour walls at that time.

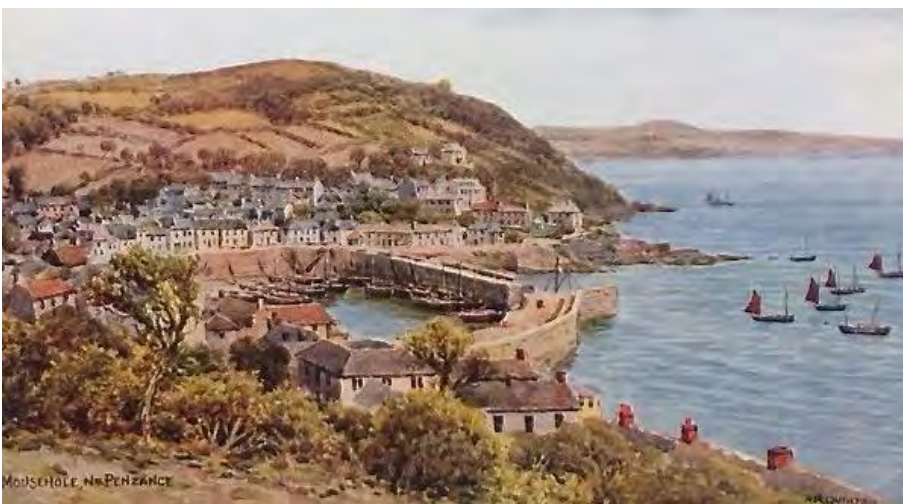
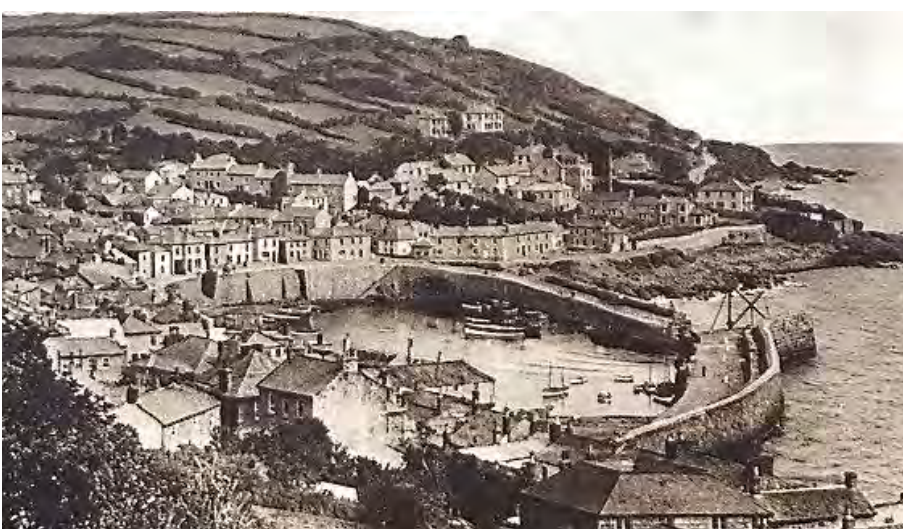
**Figure 15.24 (middle) and 15.25 (bottom)** show two views taken from almost the same spot; the first by the artist, Alfred Robert Quinton, in about 1920 and, below, a photograph also looking down into the harbour. There is a remarkable similarity between all aspects of the artwork and the photograph confirming Quinton's eye for detail.

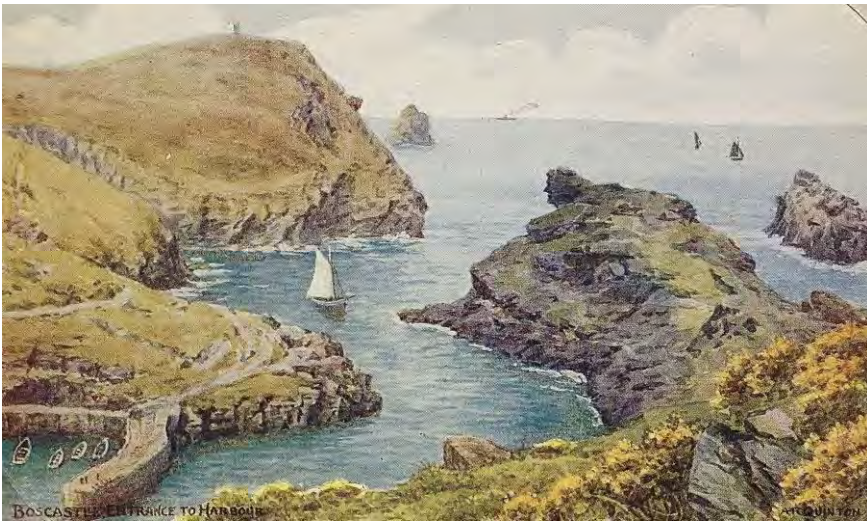
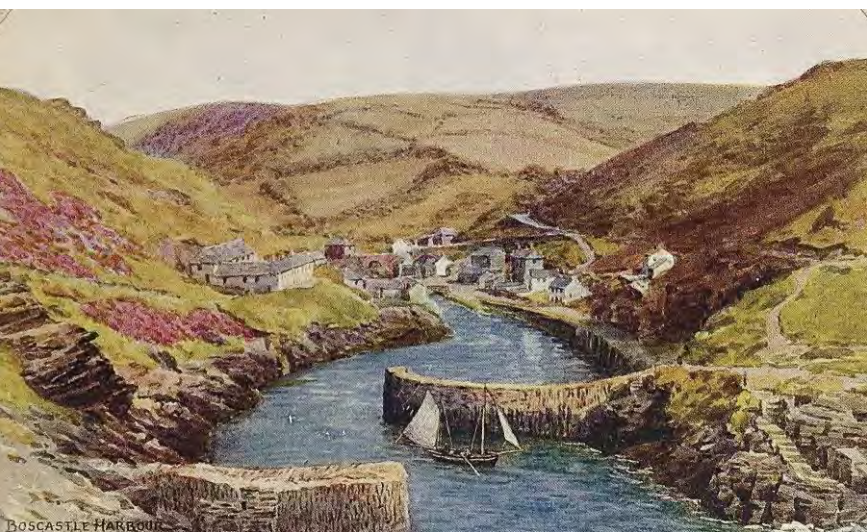
**Figures 15.29 and 15.30 (middle and below)** show two further views of Boscastle harbour by Alfred Robert Quinton. Figure 15.29 (middle) is taken from a similar angle to that of the view by Daniell looking out to sea, whilst Figure 15.30 (bottom) looks inland up through the harbour towards the village. The harbour is now in the care of the National Trust although it and appears to have changed little since Daniell's visit the flood damage in 2004 necessitated rebuilding of many properties flanking the inner end of the harbour as well as the widening and strengthening of the river's channel leading into the harbour.

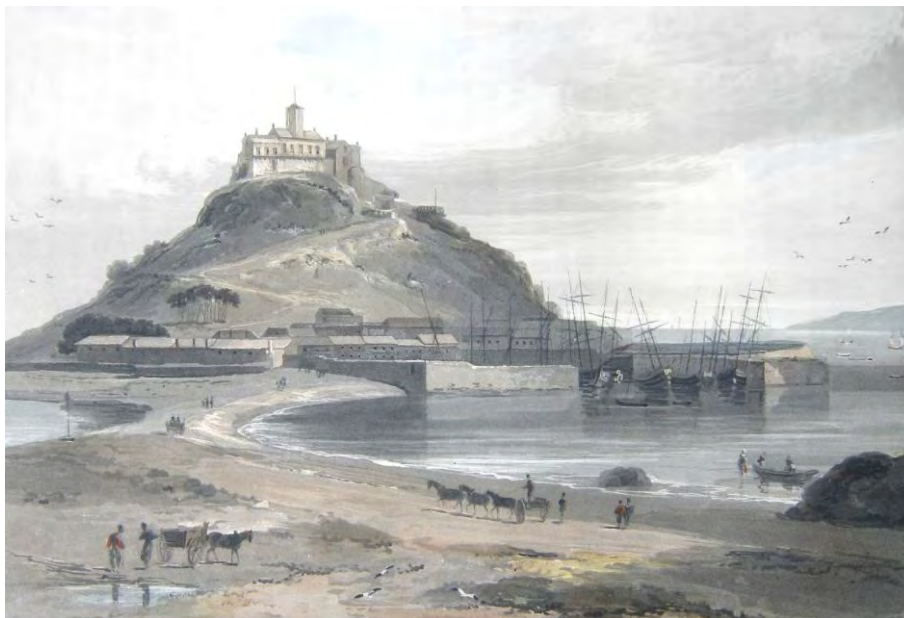
**Figure 16.2:** William Daniell RA produced this detailed aquatint in 1825 and shows the scene at Low Water. The causeway, which provides the only access, is clearly visible.

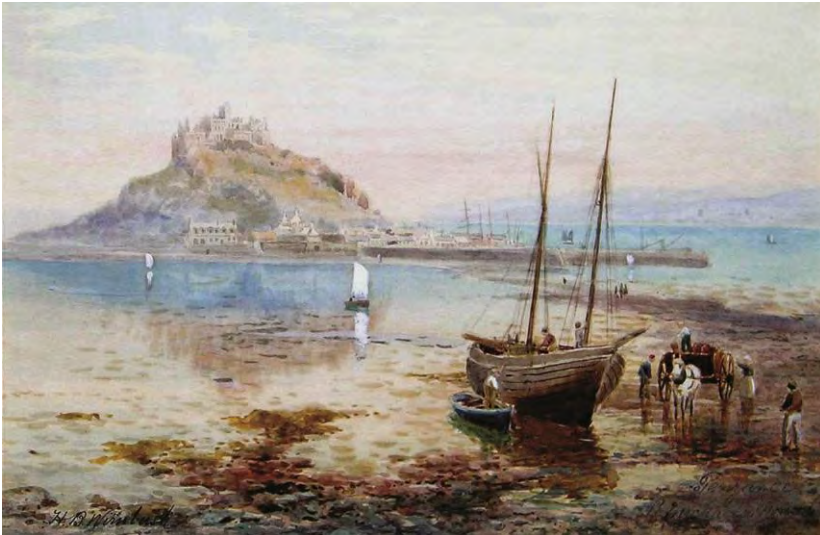
**Figure 16.4** 'St. Michael's Mount' by Henry B. Wimbush. This watercolour (c.1895) shows the scene towards Low Water as the tide recedes to expose the causeway.

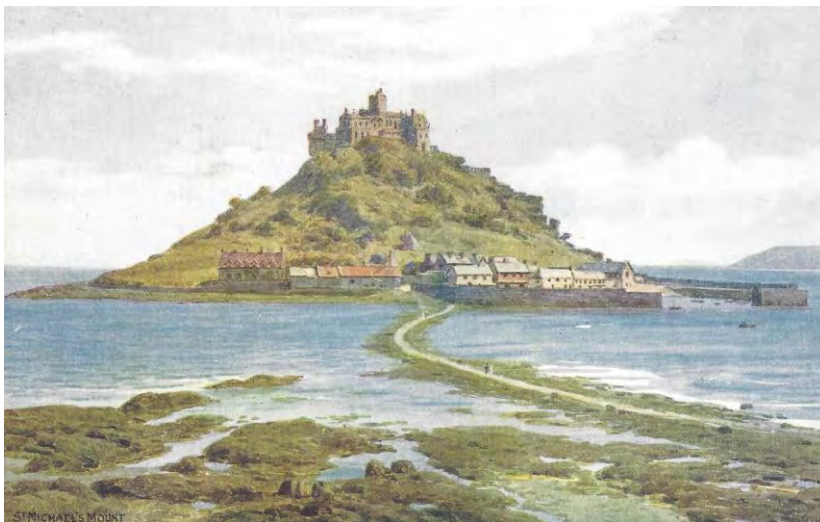
**Figure 16.5:** 'St. Michael's Mount' by Alfred Robert Quinton. Watercolour. C.1915. Quinton's view provides a detailed, almost photographic, image of the Mount showing the full extent of the causeway.

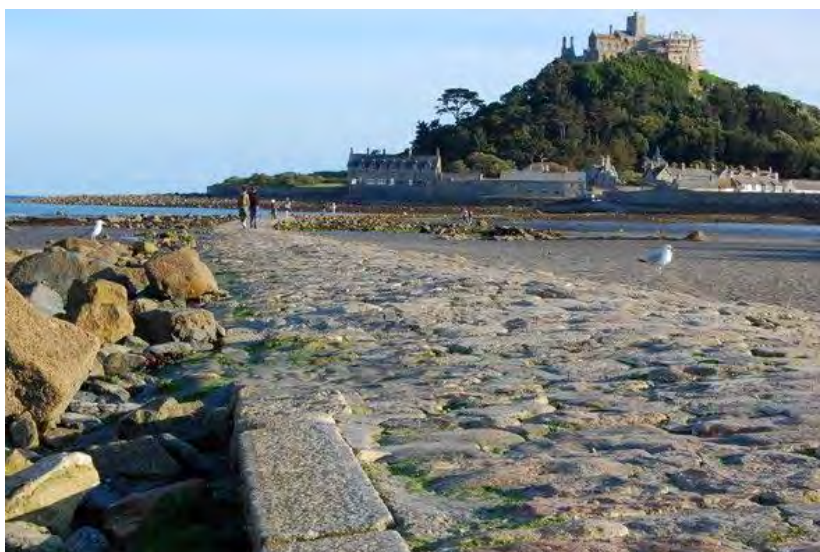
**Figure 16.6 (Above) and Figure 16.7 (Right)** show the granite setts of the causeway before and after the severe storms of 2013/14.

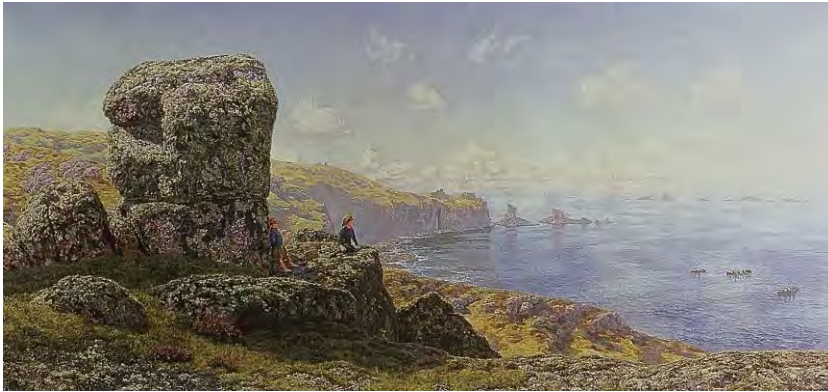
**Figure 17.9:** *'Golden Prospects, St Catherine's Well, Land's End'* by John Brett. 1881. Oil on Canvas.

In this particular case study two areas were considered. First, the accuracy with which features such as castles were depicted by artists. The fine detail achieved by some artists is clearly illustrated in figures 17.1 and 17.3 in the case of St Mawes Castle. Both John Chessel Buckler (figure 17.1) and Charles Napier Hemy (figure 17.4) were masters in terms of artistic accuracy. Buckler was an architectural draughtsman by training, whilst Hemy was a follower of the Pre-Raphaelite ideal of capturing the landscape in very precise detail. These two examples (a watercolour and an oil painting) show the quality and detail that was achieved by some artists in the nineteenth century. Equally, exceptional detail has been provided by artists such as John Brett (figure 17.6) in his painting of the headland of Treryn Dinas, which was painted from a point high up on Treen Cliff overlooking Porthcurno Bay. Brett again was a significant figure in the Pre-Raphaelite movement and his coastal scenes are perhaps some of the most accurate to be found. In Figure 17.7 a view of Penwith Cliffs (also entitled '*Towards Land End*') by Charles Naper (c.1940) is a masterful depiction of the Cornish coast. A further magnificent view of the headland on which Maen Castle is situated, is provided by Brett in figure 17.9.

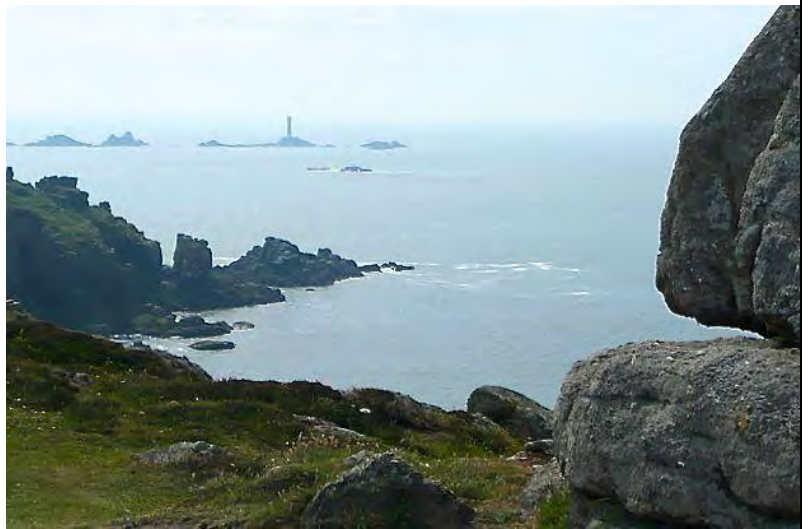
**Figure 17.10 (below):** *'View from Maen Castle'* near Sennen.

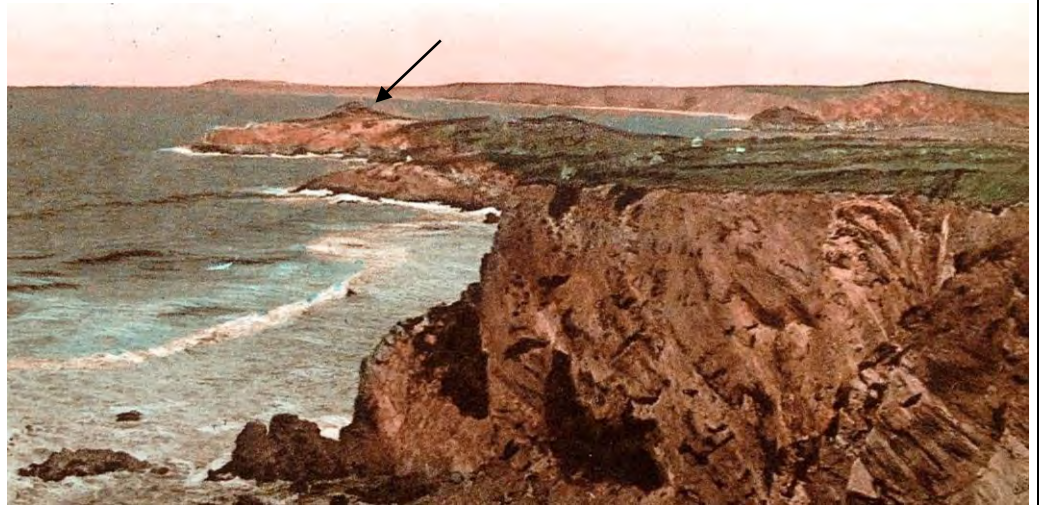
**Figure 17.15 (left):** *'Tintagel Castle, Cornwall'* by William Trost Richards. c.1890. Watercolour.

The names of some key artists have been mentioned, and many others can contribute to our understanding of the changing south-west coast. Some of these worthy of note include Myles Birket Foster RWS, who was the leading watercolourist of the mid and late Victorian period, painting watercolours in a highly detailed and precise manner. Charles Robertson, who was also influenced by Pre-Raphaelite thinking, produced detailed views of Lyme Regis and Clovelly, whilst Samuel Edward Kelly, who worked in the Edwardian period, painted fine watercolours such as Babbacombe Bay, Devon (see case study 12). Other artists depicted coastal heritage sites from the sea, and foremost amongst these was Charles Napier Hemy RA RWS (1841-1917). As well as being a master of sea painting, he was a fine architectural draughtsman, as demonstrated in his oil painting *'Lining for Mackerel off St Mawes Castle'* (see figure 17.4). William Trost Richards painted a fine watercolour of Tintagel Castle, Cornwall, viewed from the sea (see figure 17.15).

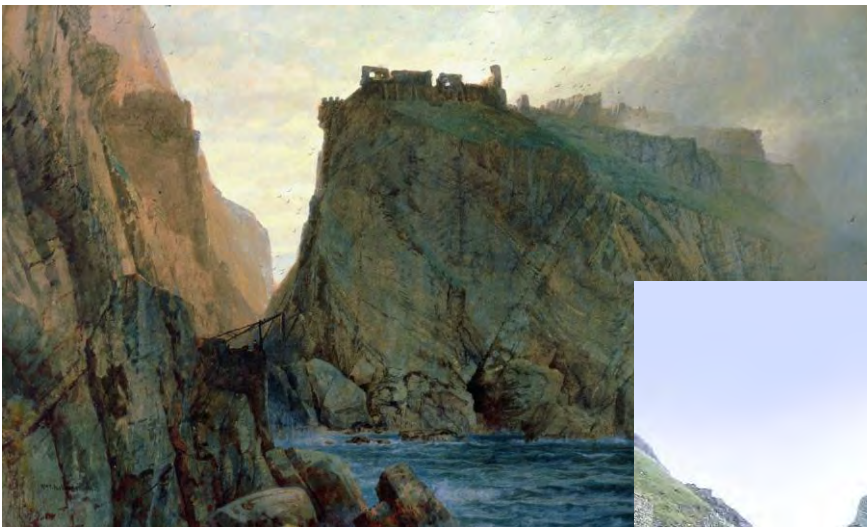
**Figure 17.16 (right):** *'Tintagel Castle'*.

The enormous value of old photographs and photographic postcards has also been stressed in this report and these images, alongside art, help to provide a more complete illustrated record of coastal change and its impacts on heritage sites in the south-west of England. Sites such as Tintagel Castle in Cornwall (Figures 6.4.6-6.4.8, and Figures 17.15 and 17.16) might appear to be resilient but photographic evidence clearly shows the loss of cliff material over time as a result of weathering and coastal erosion and demonstrates the value of this medium.

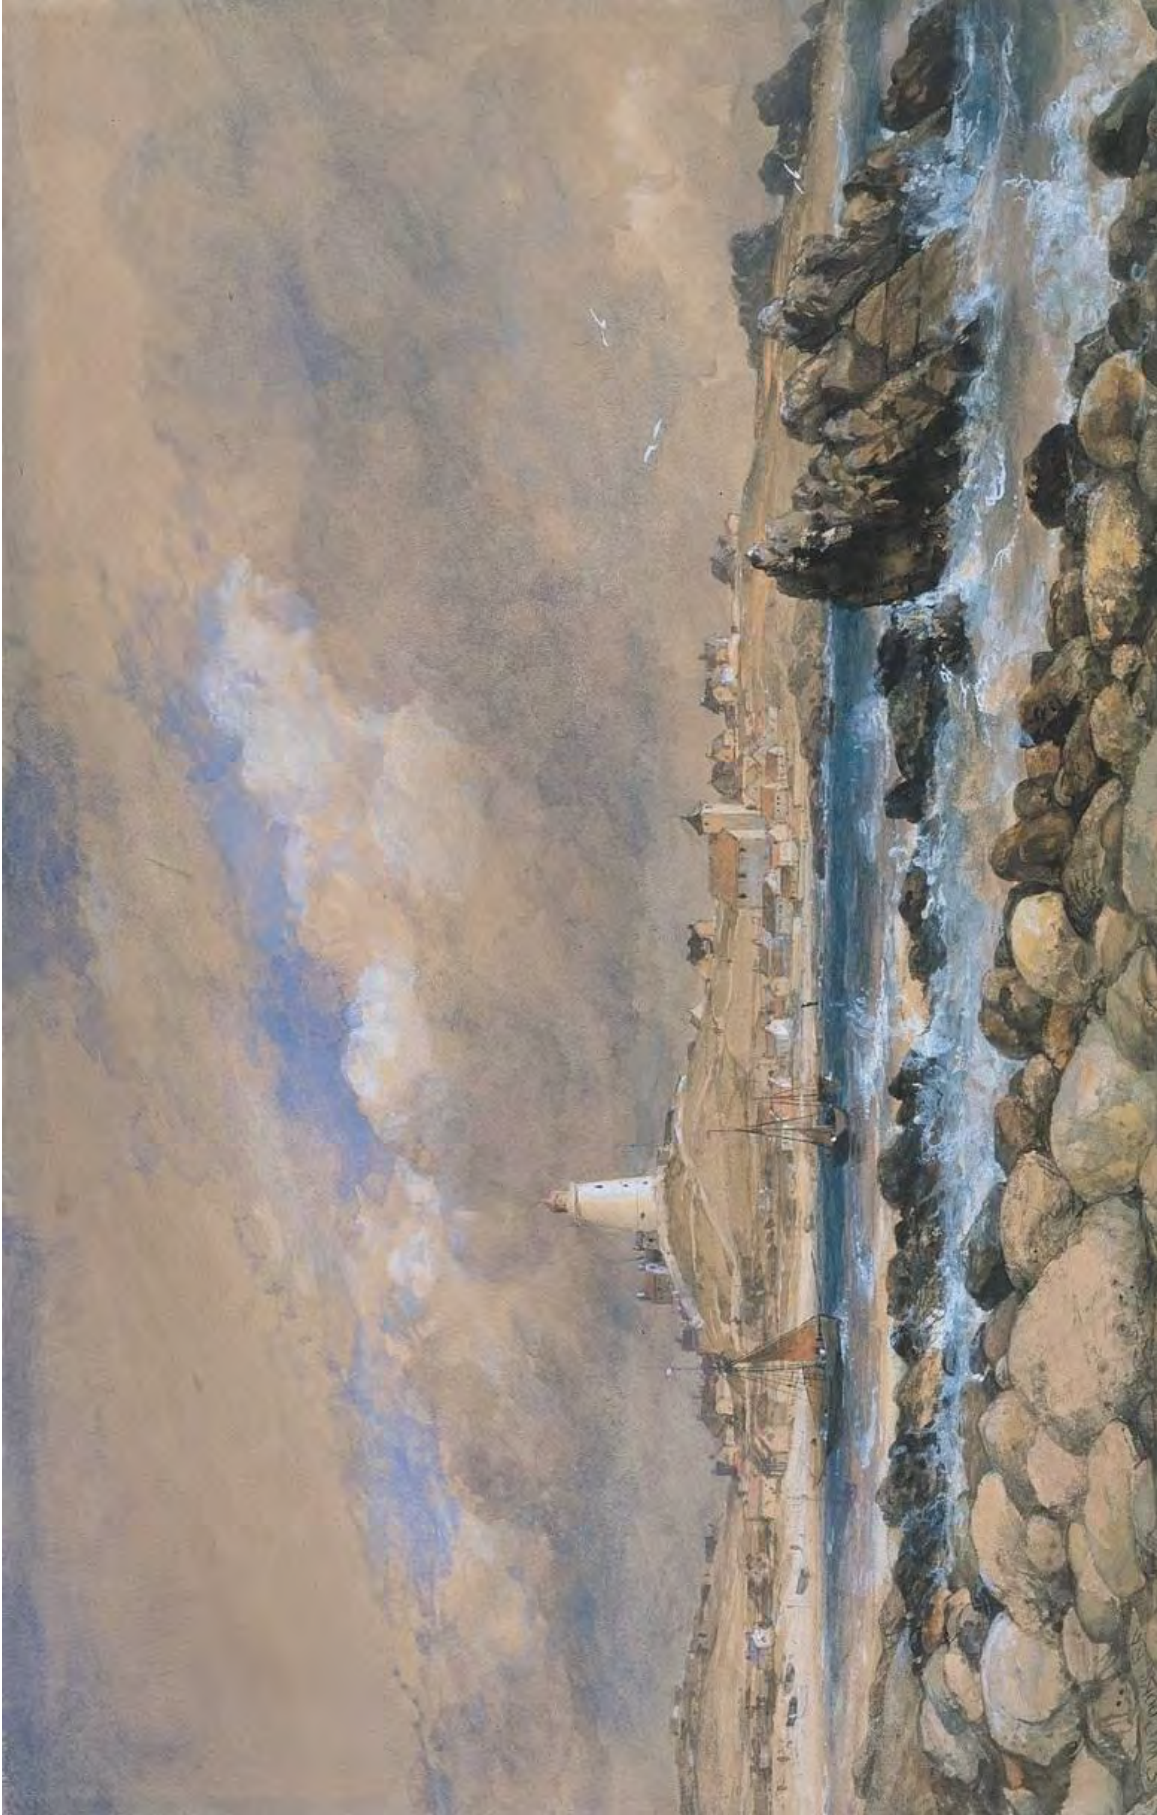
**Figure 18.6:** 'St Agnes' Point, Isles of Scilly' by Edward William Cooke RA. A fine watercolour by the leading marine and coastal artist. Cooke was one of relatively few artists to visit Scilly. 1848.

In terms of artworks, relatively few artists ventured across the sea from Cornwall to the Isles of Scilly, although the celebrated marine and coastal artist, Edward William Cooke RA, did paint a fine watercolour of '*St Agnes Point, Scilly Isles*' in 1848 (see Figure 18.6). A comprehensive illustrated description of the Islands was provided by William Borlase in 1756 (Borlase, 1756<sup>4</sup>). His book contains maps, topographical views from the sea and some fine copperplate illustrations, which show the patterns of development in the Islands at that time. During the mid-to-late nineteenth century the artists, Fanny le Marchant and Sophia Tower, produced delicate watercolour views of '*Old Grimsby on Tresco*', '*St Mary's from Carn Morval*', and '*Off St Mary's Pier*' (Llewellyn, 2005<sup>5</sup>).

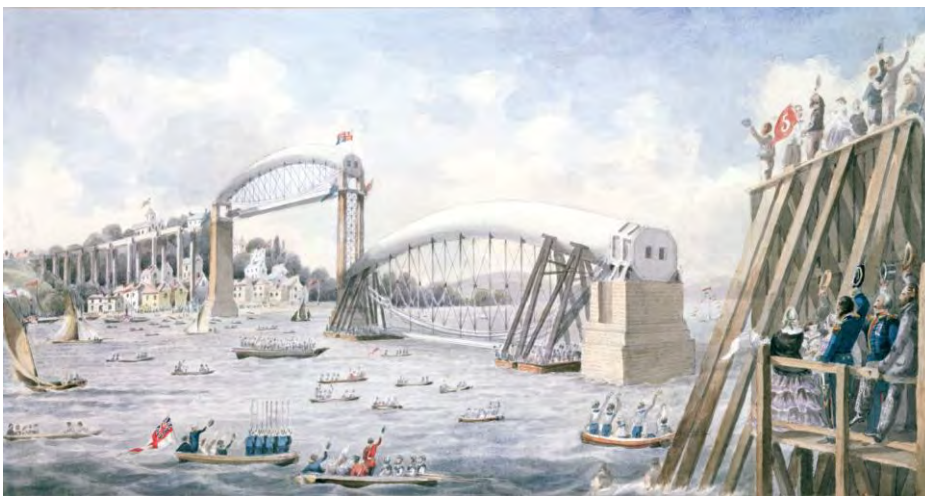
**Figure 19.2:** 'The Floating of the last spar of the Royal Albert Bridge, Saltash'. English School Watercolour. 1859. Another oil painting by T. V Robins depicts the opening of the bridge by Prince Albert on 2nd May 1859.

The very detailed images provided in this case study illustrate methods of civil engineering construction, for example at Plymouth breakwater and Brunel's Royal Albert Bridge, at Saltash, together with the construction of the pier at Bournemouth. The images also show us the condition of these various structures at the time the views were painted. A watercolour by Alfred Robert Quinton shows the original condition of the elaborate Plymouth pier which was destroyed by enemy action in World War Two, and also the ornate Listed Burgh Island Hotel at Bigbury-on-Sea in about 1920. In compiling a Historic Environment Record for such sites, the addition of images of the structures over time could form a useful addition. Alternatively, a link can be provided to the source of the individual images alongside photographic records.

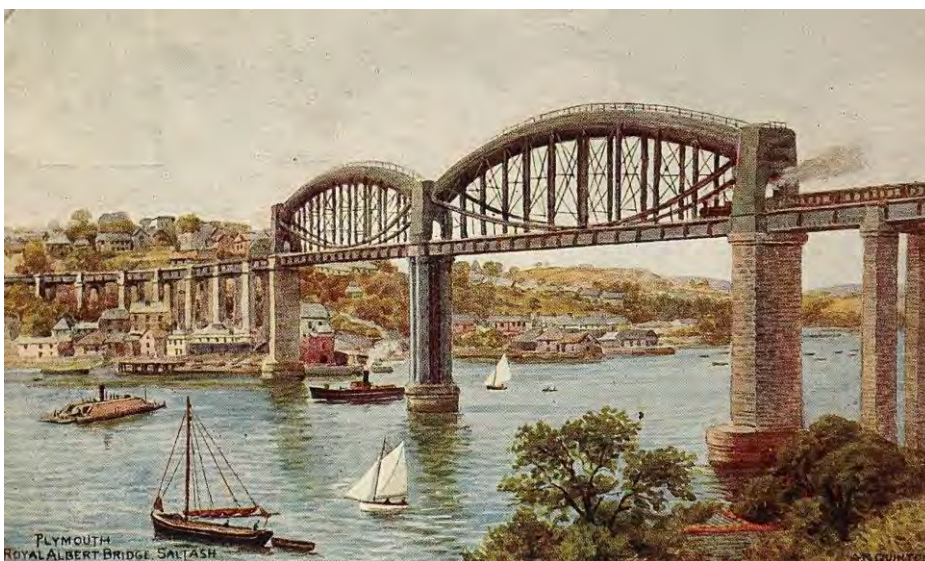
**Figure 19.3:** 'The Royal Albert Bridge, Saltash', c.1920 by Alfred Robert Quinton. His detailed watercolours produced between 1904-1934 provide a wealth of coastal heritage (including architectural) information. Over this time period he produced over two hundred watercolours of South-West England.

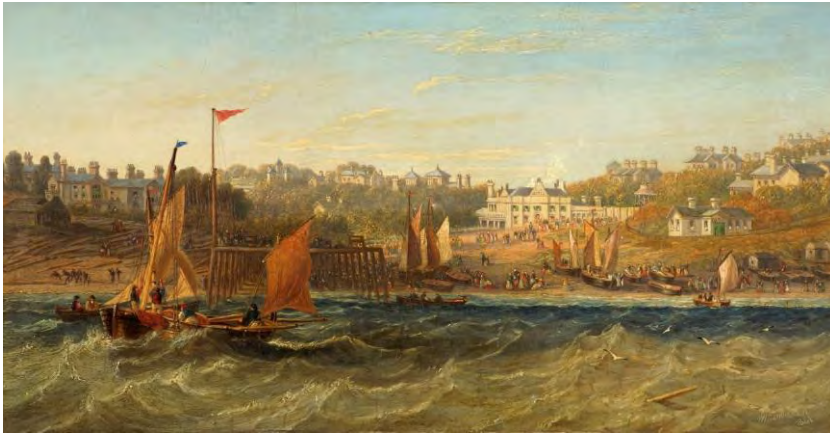
**Figure 19.4:** During the mid-to-late nineteenth century nearly every seaside town saw the construction of a pier or jetty. This oil painting by John Wilson Carmichael painted in 1861 showing construction work in progress on Bournemouth Pier. The 1,000 foot new pier replaced an earlier 100 foot jetty that was built in 1856. The T-shaped pierhead was swept away in a gale in 1867. A further iron pier replaced this structure in 1880.

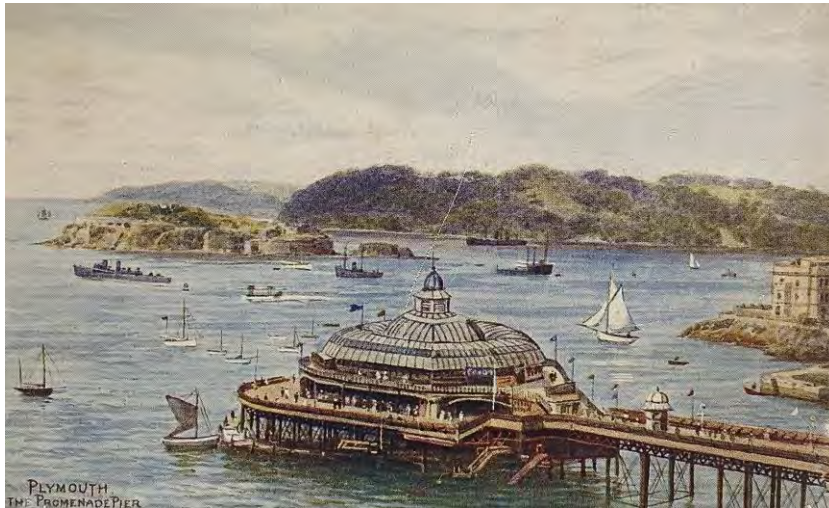
**Figure 19.5:** A watercolour by A. R. Quinton, c.1925 showing the ornate Plymouth Pier, which was destroyed in a bombing raid in the Second World War. Such architectural watercolours provide a valuable record of lost heritage.

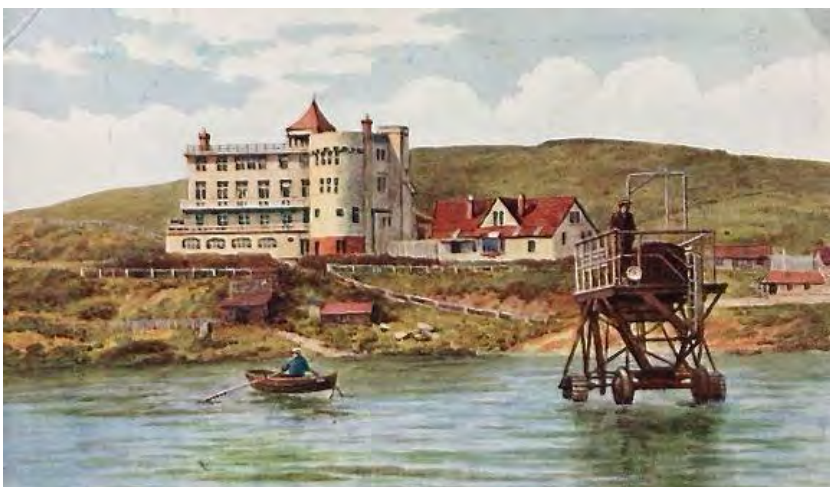
**Figure 19.6:** 'The Burgh Island Hotel' at Bigbury-on-Sea' by Alfred Robert Quinton, c.1930. This Grade II Listed Building was built in 1929 of reinforced concrete in the Art Deco style. It is one of numerous iconic seaside hotels that were built in outstanding natural locations around the coastline of South-West England between c.1890-1930.

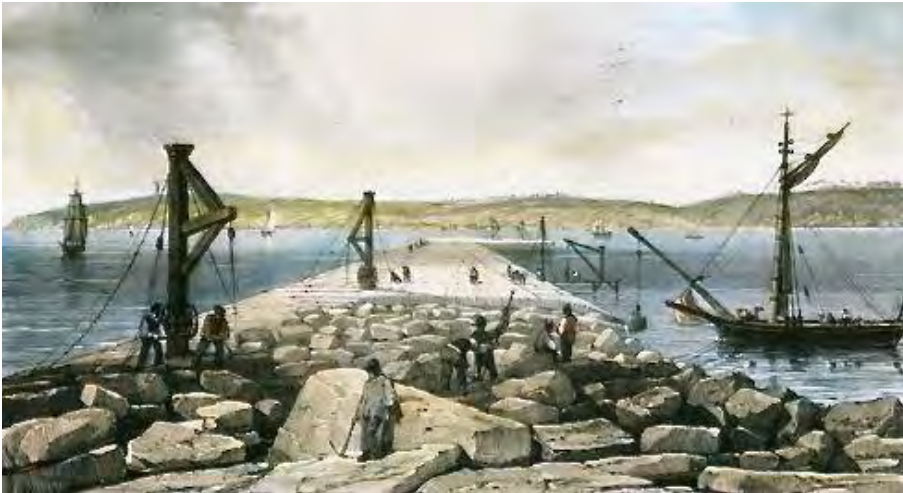
**Figures 19.7 and 19.8:** The distinguished artist Philip Mitchell RI produced a series of views of the Plymouth coast, which were lithographed by W. Speat c.1850. The view (left) shows the construction of the breakwater in progress.

The Plymouth Breakwater was built by John Rennie and Joseph Waidbeye from 1812 at a cost of £1.5 million, which was funded by the Navy. The Breakwater protects Plymouth, Plymouth Sound and their anchorages. The Breakwater is 40 feet wide at the top and 200 feet at its base, 3,000,000 tons of rock were used for its construction. The structure was completed in 1841.

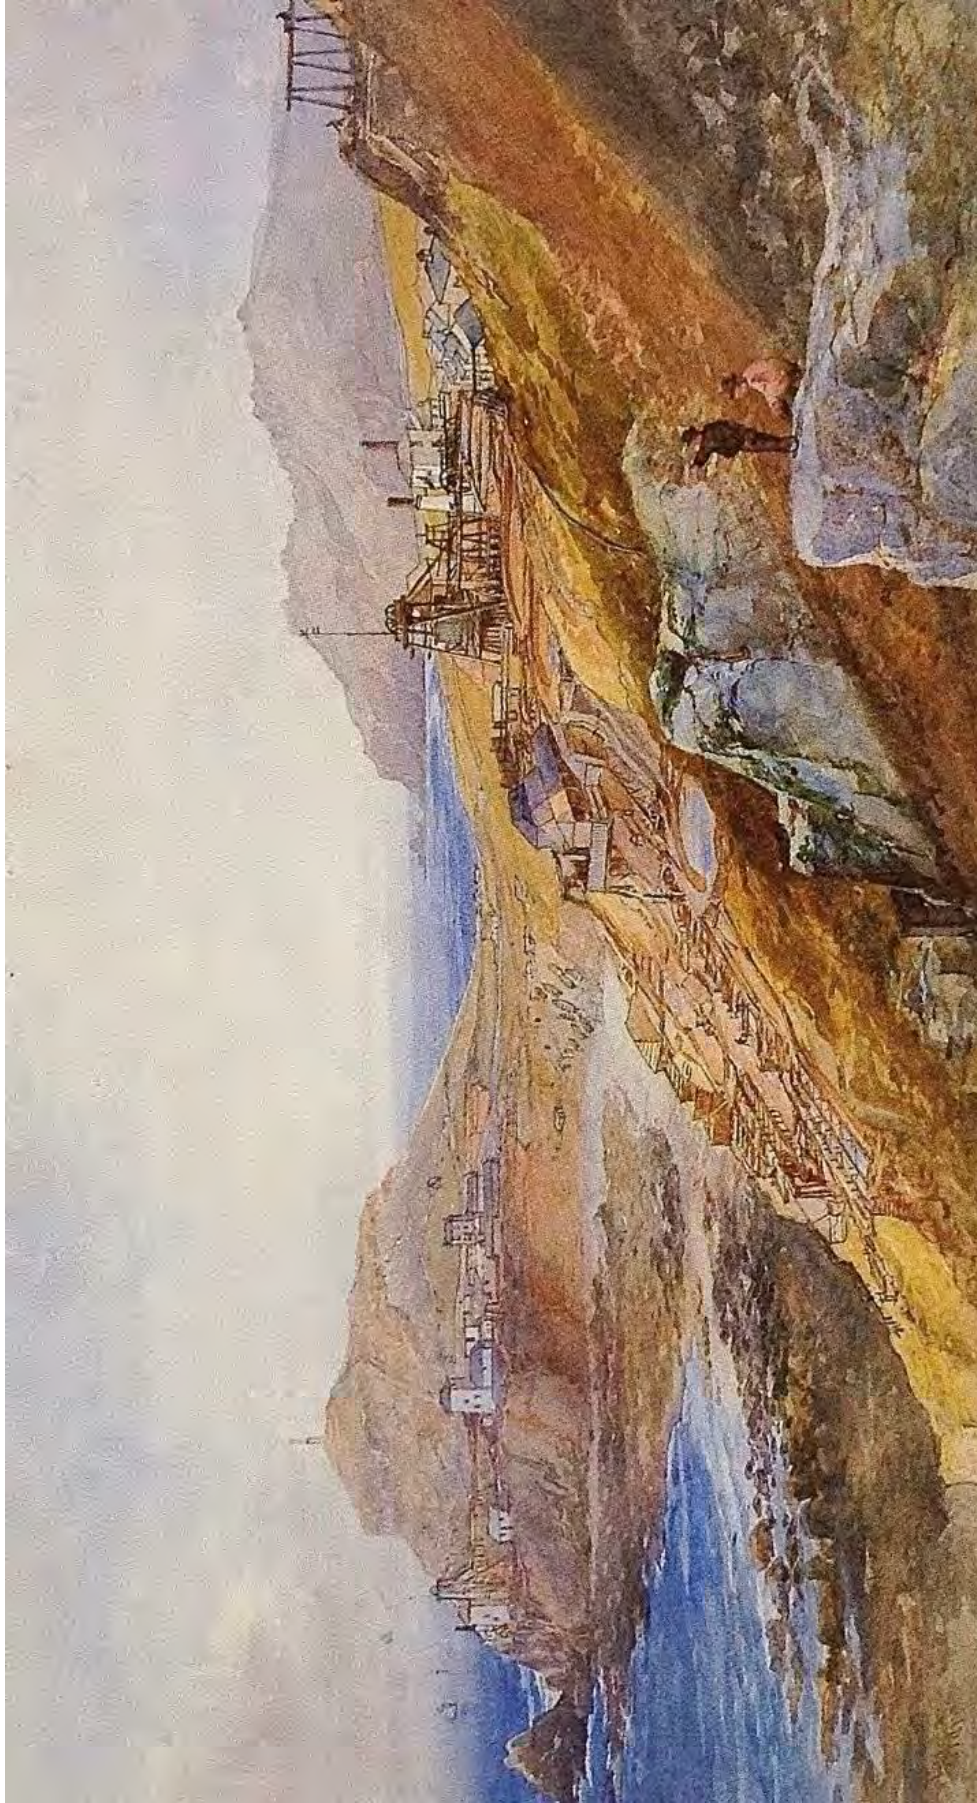
**Figure 19.9:** 'St Just United Mines' by Thomas Hart. The widespread surface remains of the mine are located on the cliffs north of St Just. The first references to the mine date back to the 1670s although the mine didn't appear on maps until 1748. The mine has been championed as one of Cornwall's top ten mines due to its rich copper yields until the mines' closure in 1930.

In terms of mining, three examples are provided showing open cast and deep mining locations. Because of the scale of activity in Cornwall, these subjects were of great interest to tourists, and were, therefore, included in nineteenth century guidebooks. It has been noted that in a number of guides to the Cornish mining industry, artwork illustrations have not been included alongside many black and white photographs.

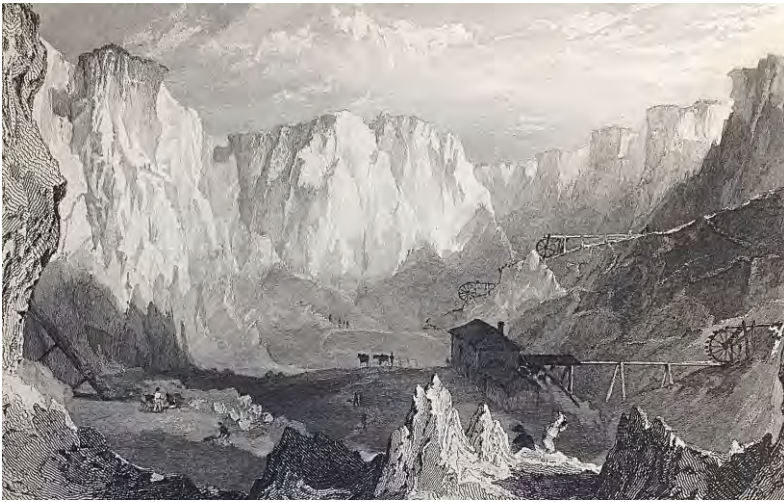
**Figure 19.10:** 'The Dolcoath Mine' by Thomas Allom (1832) is the most notable of the Camborne Copper mine series, containing the most complex arrangement of machinery in the country. Passages were up to one mile long with multiple shafts in each; it maintained the accolade of being the deepest mine in Cornwall with a shaft 3,000ft deep. It is first included in historic records in 1738 and was a prolific copper producer during the eighteenth century before switching to tin production in the late nineteenth, and finally closing in 1921. It was the fifth largest copper producer, and highest producer of Black Tin in Cornwall. After several failed re-openings, it was bought by South Crofty Mine in 1936 and became an integral part of Cornwall's last tin mine of the twentieth century.
