# **Coastal Heritage Risk – Imagery in Support of Heritage Planning and Management in South-West England**

**‘CHeRISH’**

***FINAL REPORT FOR HISTORIC ENGLAND***

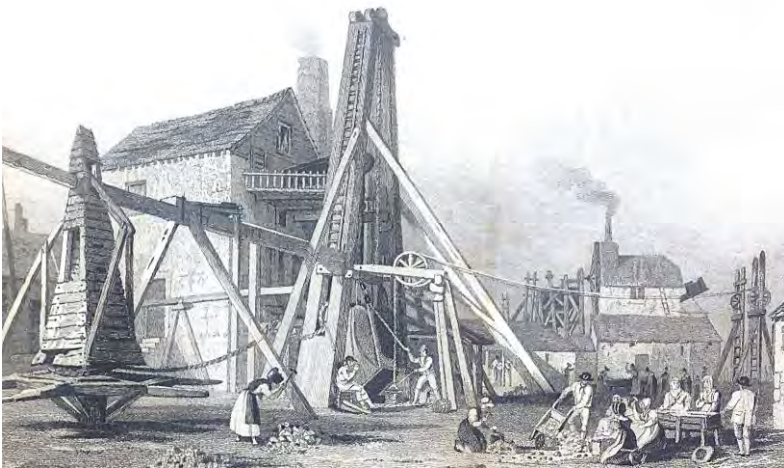
**Figure 19.11:** 'The Carclase Mine' by Thomas Allom (1832). The name translates to 'Grey Rock', in reference to the decomposed granite that contains the deep, rich veins of tin. The site is situated two miles north of St Austell, Cornwall and historic records suggest it has operated for 400 years. Operations changed through time. Tin used to be taken out of the mine on boats via a tunnel in the side of the cliff, but this practice was abandoned after the tunnel collapsed with boats inside it. After this, waste was drained down-slope whilst the ore was pulverised and refined on site.

In terms of mining, three examples are provided showing open cast and deep mining locations. Because of the scale of activity in Cornwall, these subjects were of great interest to tourists, and were, therefore, included in nineteenth century guidebooks. It has been noted that in a number of guides to the Cornish mining industry, artwork illustrations have not been included alongside many black and white photographs.

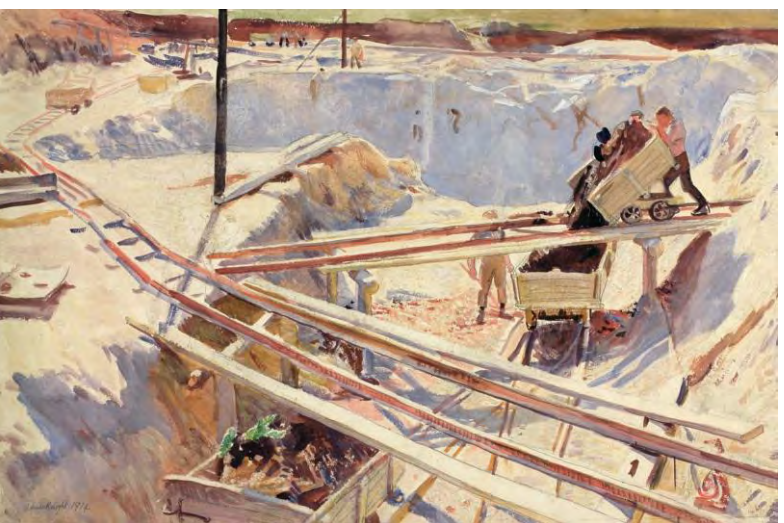
**Figure 19.12:** 'The Chine Clay Pit' by Laura Knight. 1914. St Austell deposits of 'China Clay' were the first discovered in 1755. It rapidly became popular in British pottery and for other uses in manufacturing processes including cosmetic products and medicine. The Kaolin found in St Austell is of the highest quality and purity, giving its bright white colouring. The clay is extracted by spraying with high pressure water jets; the waste is separated from the clay and then dried to remove surplus water and impurities. Trains then took the clay to Fowey and Charlestown ports where it was exported abroad (75%) or elsewhere in the UK. In 1910 Cornwall was producing 50% of the world's China Clay, and St Austell's pits alone, operating for over 300 years, contributed 120 million tonnes.

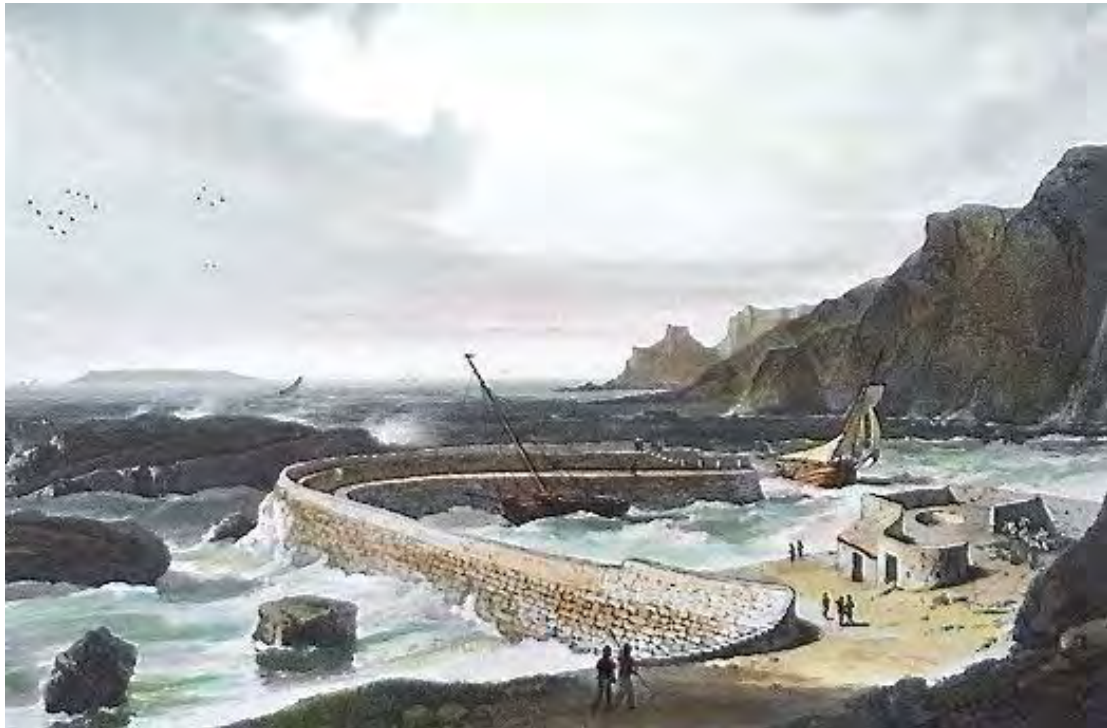
**Figure 20.1:** 'Hartland Pier' by William Daniell RA. Aquatint Engraving. 1814. This view was produced by Daniell at the start of his eleven year '*Voyage Round Great Britain*' (1814-25) and shows the stone arm/pier in sound condition. The rocky, hazardous coastline and exposure of the location to Atlantic storm waves are obvious in Daniell's view.

Hartland Quay was probably at its most prosperous during the eighteenth and nineteenth centuries. In 1841, after the damage to its pier head during gales, its owner, Louis William Buck, was confident enough of the quay’s future to raise funds for its repair. The second half of the nineteenth century saw the fortunes of the quay decline, and this was augmented by the arrival of the railway at Bideford in 1855 and the climate of agricultural depression. The end of the pier was washed away in 1887 and was not rebuilt. Already business at the quay had ceased, with the last ship departing in 1893. The stump of the pier was merely refaced and most of the structure’s remains were destroyed in a storm in October 1896, bringing the demise of the trade in corn, coal and limestone by sailing sloops that had carried on for nearly 300 years.

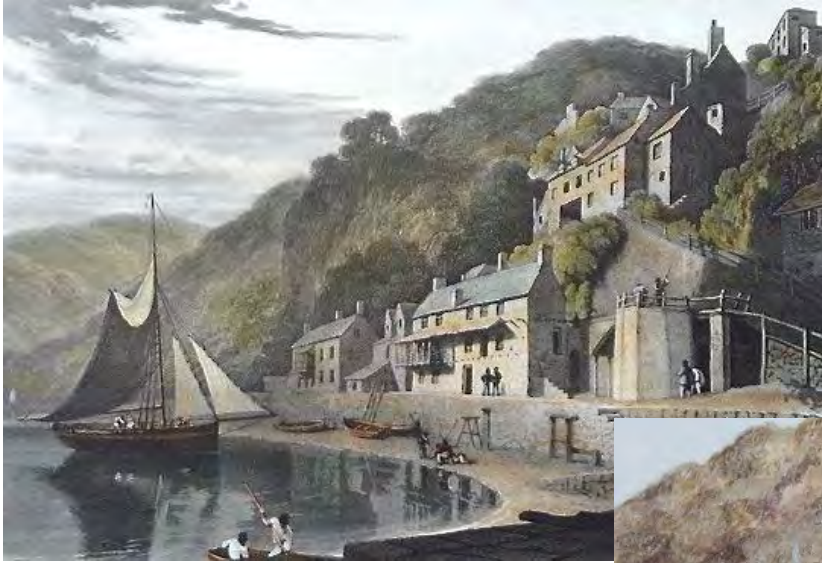
**Figure 20.3:** This early aquatint of 'Clovelly' by William Daniell RA, 1814, provides us with an accurate record of the village before its discovery by tourism. **Figure 20.4 (below)** shows the Red Lion Hotel (depicted also in Daniell's view) by the artist, David Addey, on his coastal tour in the footsteps on Daniell, in 1991.

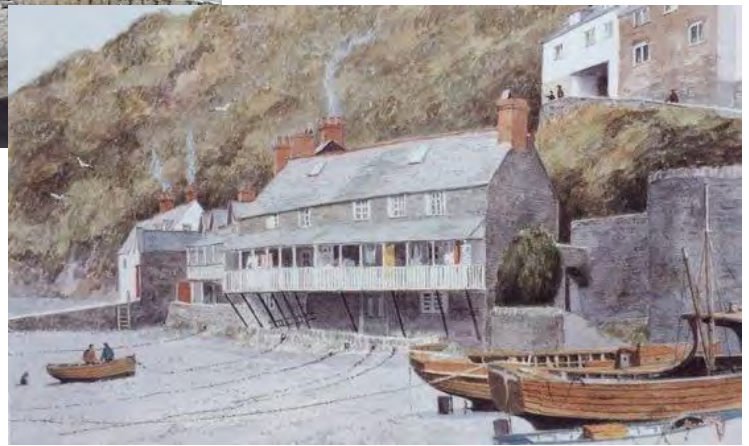
**Figure 20.5:** 'Figures on the Beach at Clovelly' by William Turner of Oxford. Watercolour. c.1840. The massive harbour wall is well illustrated in this view. The cottages in Daniell's view (above) are on the left of the harbour.

Unlike the quays at Hartland and Bucks Mills, that at Clovelly has survived the ravages of storms, and the quay is depicted by numerous artists (see figures 20.5-20.11). Within this Case Study frontage there are three Conservation Areas at Hartland, Clovelly and Bucks Mills, as well as cliff top Scheduled Monuments and numerous Listed Buildings and archaeological sites which are at risk of erosion. Clovelly and Bucks Mills may also be at risk of flooding in the future (Halcrow, 2009<sup>5</sup>).

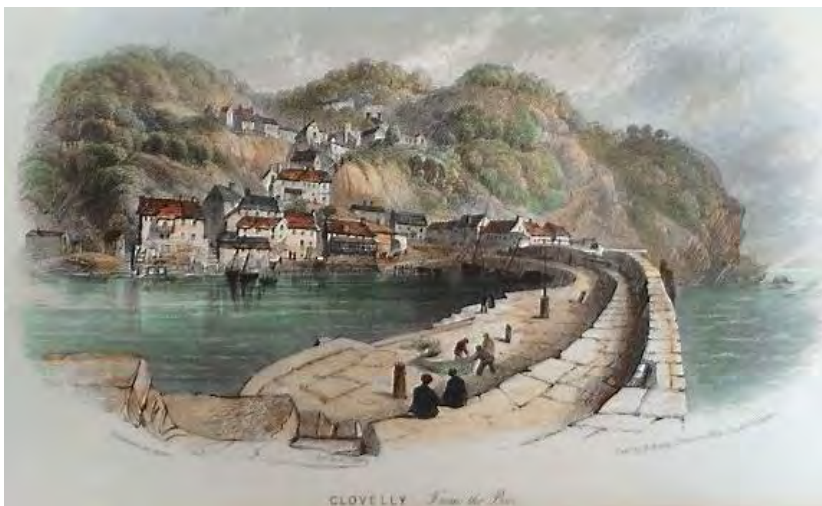
**Figure 20.6:** 'Clovelly from the Pier', a mid-nineteenth century steel engraving taken from the end of the harbour arm. The steep street leads down to the quay from above with cottages clustered round the waterfront.

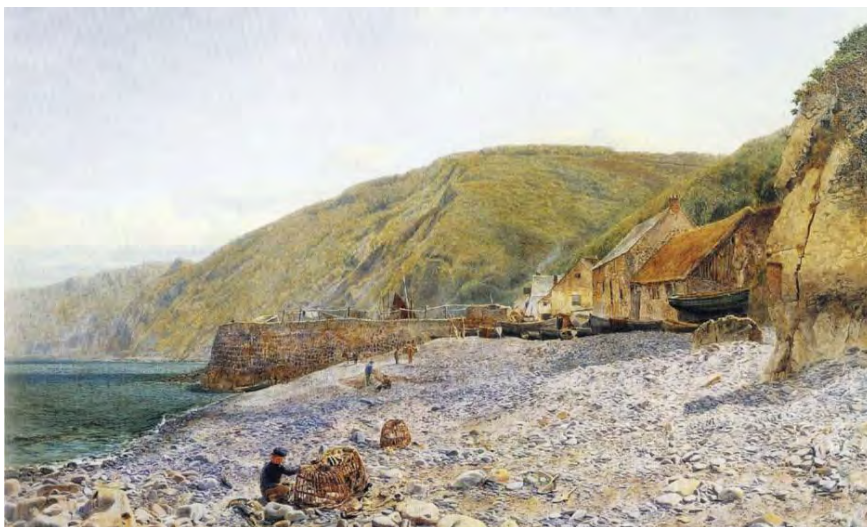
**Figure 20.9:** This watercolour entitled 'Among the Shingles, Clovelly' is by Charles Napier Henry (1864). Painted in Pre-Raphaelite photographic detail every stone on the beach can be seen together with its height and profile as well as the nature and condition of the harbour wall. Artworks of this kind equal a colour photograph of today in their detail.

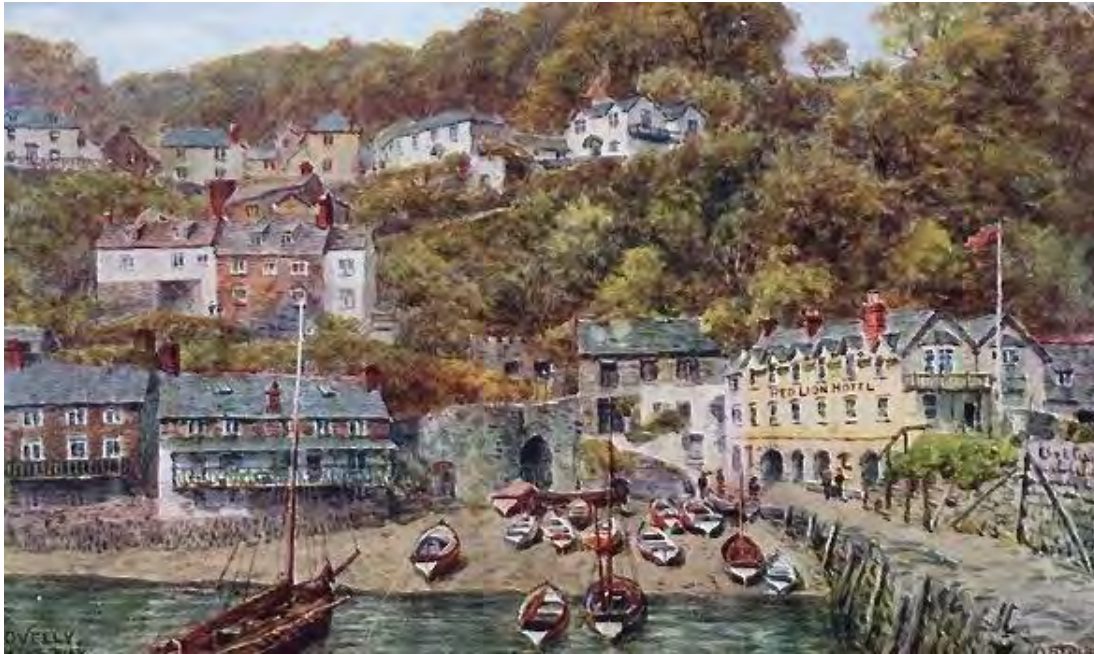
**Figure 20.10 (above):** *'Clovelly'* by Alfred Robert Quinton painted c.1920 provides a more detailed view of the interior of the harbour. The buildings on the left and behind can be seen in William Daniell's view in **Figure 20.3**.

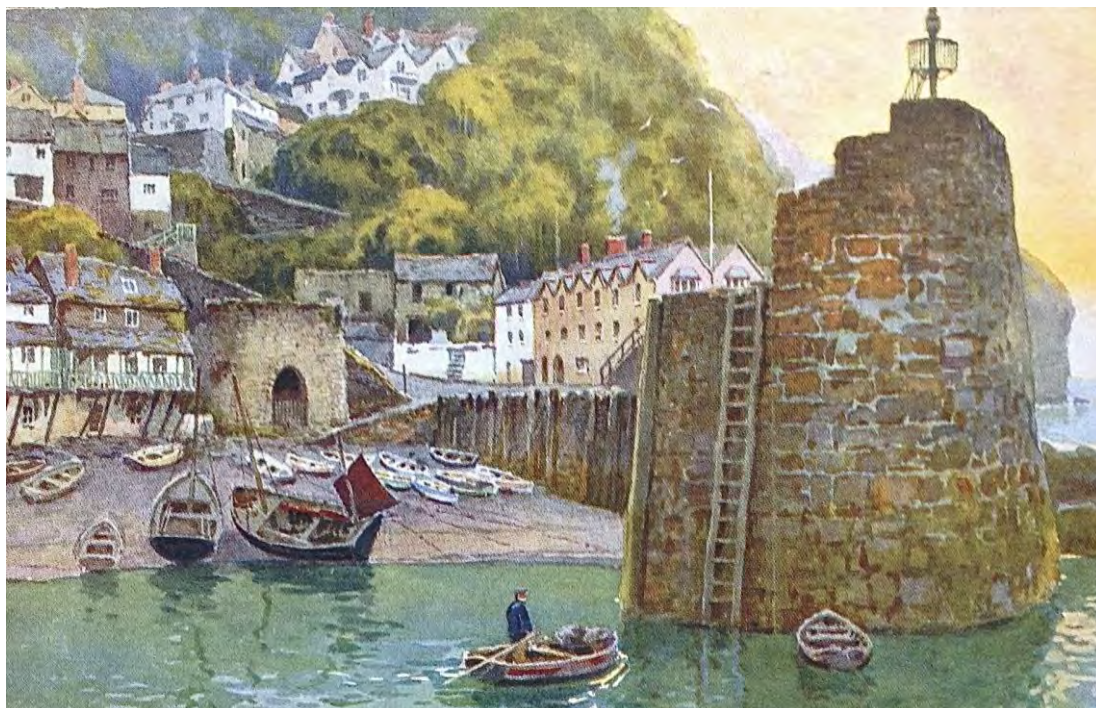
**Figure 20.11 (below):** Henry B. Wimbush, a watercolourist, shows the massive harbour well from water level in c.1895. Both Wimbush and Quinton produced watercolours for use on colour picture postcards with Wimbush working for Raphael Tuck and Quinton employed by Salmon's of Sevenoaks.

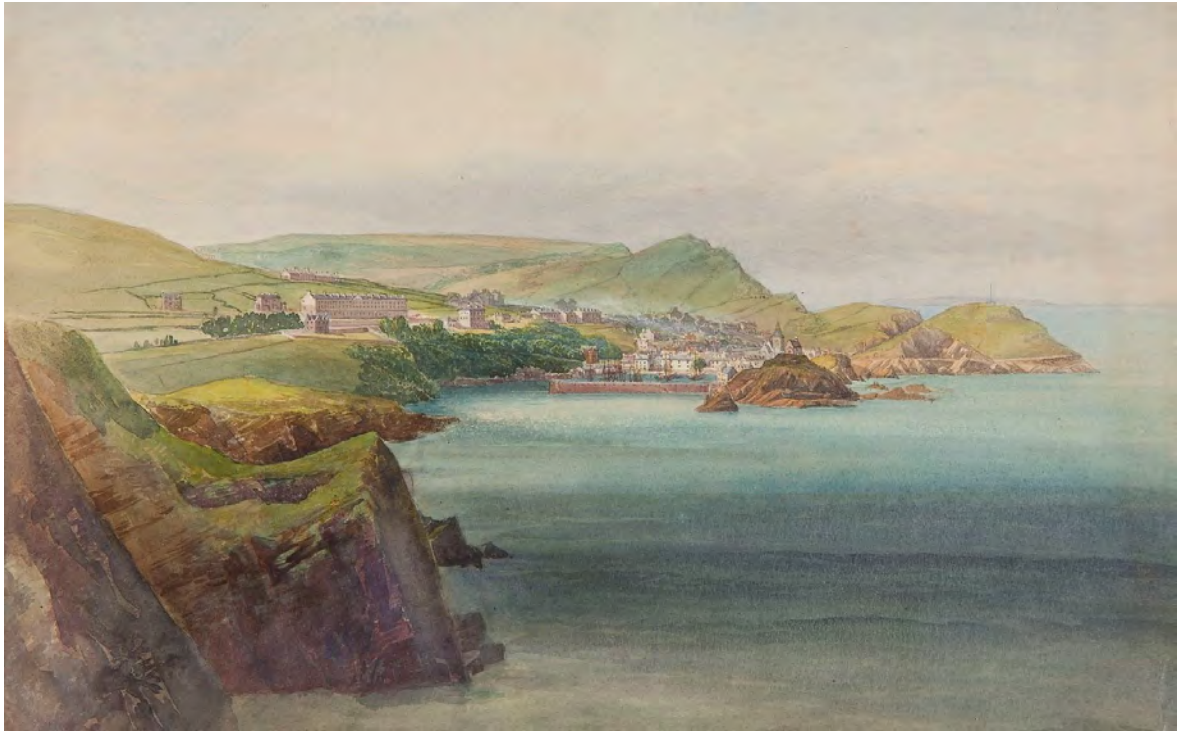
**Figure 21.1 (above):** The rugged and beautiful North Devon coastline is captured in this detailed watercolour by Frederick Jones, c.1860. The developing town with St Nicholas Chapel (Grade I) overlooking the harbour entrance was also a lighthouse and important landmark.

The images contained in the Ilfracombe case study provide a comprehensive depiction of the changes that have taken place along the town's frontage since the early nineteenth century. They provide detailed depictions of the coastal geology and landscape, as well as showing the gradual development of the town and the changes that have taken place at the harbour and along the seafront over that time. The case study also contains highly detailed watercolour drawings of the coastal landscapes and these offer direct comparisons with photographic images. Examples are provided (as was the case with the previous case study at Clovelly) of the meticulous work of Victorian artists, who provided images that, in some cases, matched the quality of present day colour photography. Bearing in mind that colour photography did not become widely used until the 1920s and 1930s, such representations provide the only colour images of the south-west coast of England right through the Victorian and Edwardian periods.

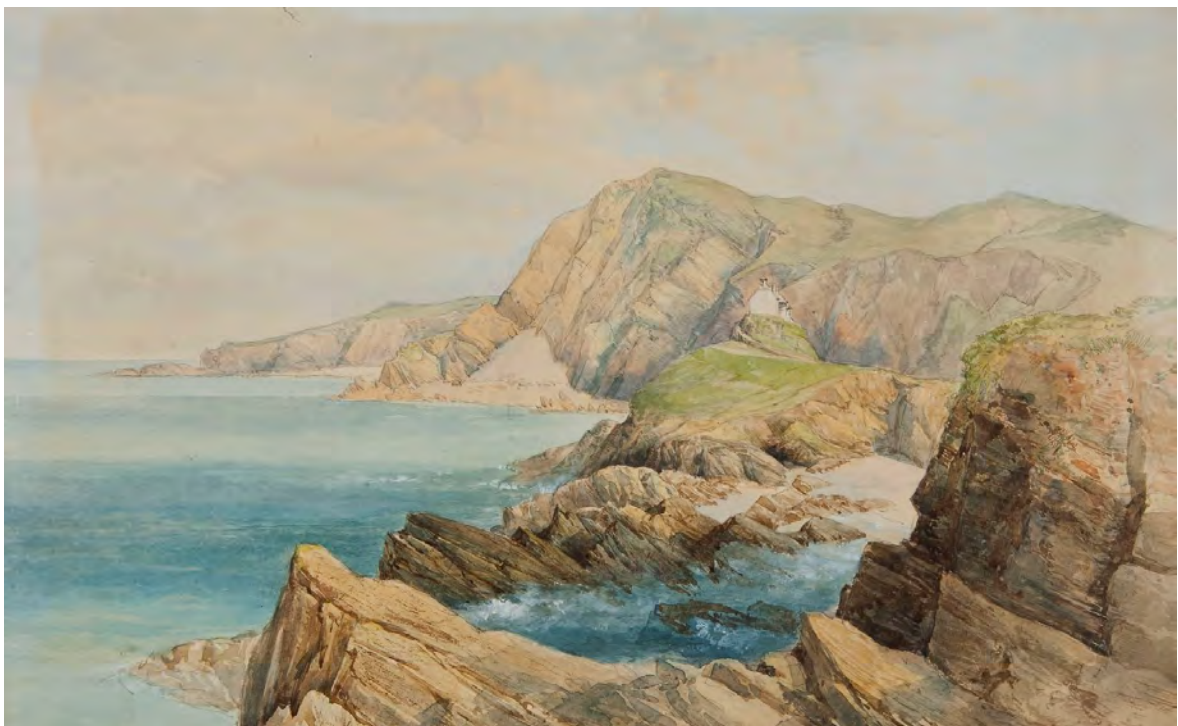
**Figure 21.3 (above):** A fine mid-nineteenth century lithograph by W. Sprent showing Ilfracombe's natural harbour, which is sheltered further by the jetty. St Nicholas Chapel dominates the skyline with Hillsborough (the hill on the right) being the site of a Promontory Fort. c. 700BC-42AD (MDV 2210).

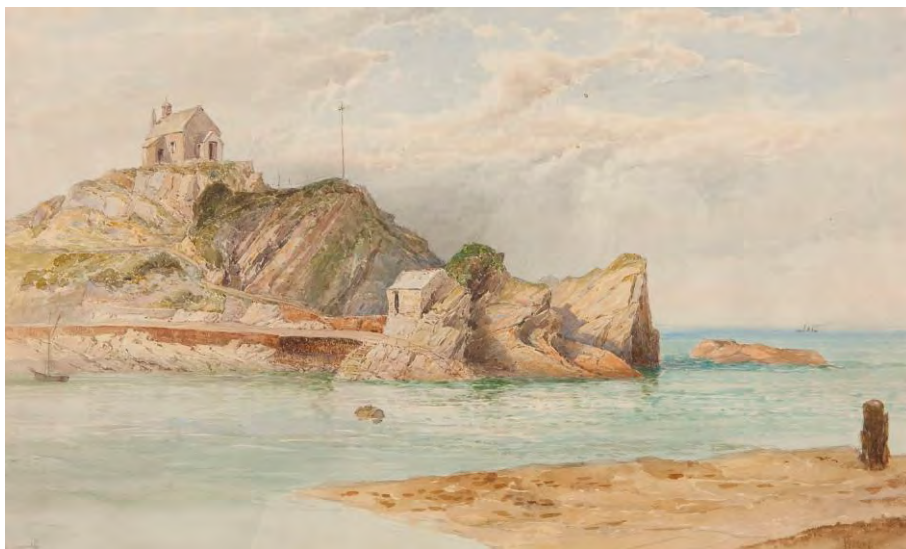
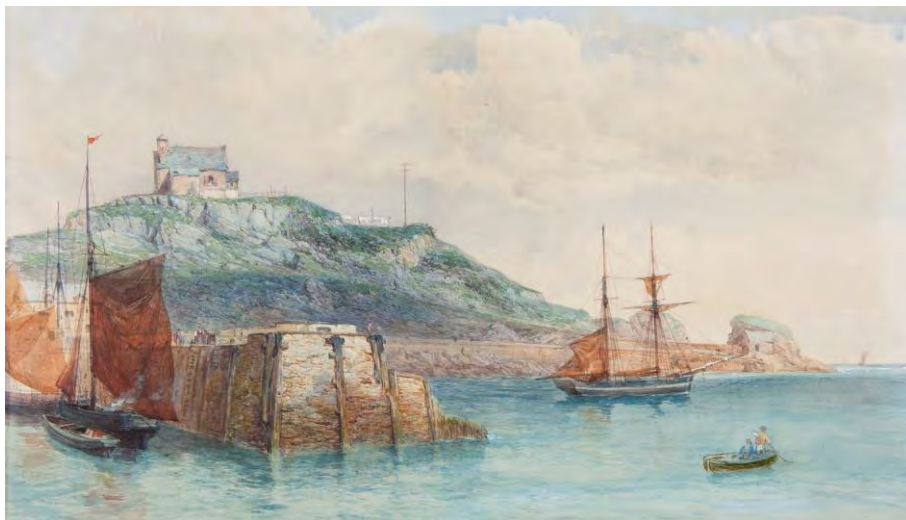
**Figures 21.6 (left) and 21.7 (middle)** provide two further highly detailed ‘geological views’ of the entrance to Ilfracombe Harbour in the 1860s (a further fine watercolour of this subject is held by Ilfracombe Museum). Frederick Jones’ views date from the mid-1860s and show exactly the nature and condition of the harbour arm and the Chapel (see also **Figures 21.1 and 21.2**). **Figure 21.8 (bottom)** shows the view today from the end of the harbour. The chapel on Lantern Hill has been a lighthouse since at least 1852 and was later used as a Summer Reading Room. **Figures 21.6 and 21.7** © British Culture (Bristol Museum & Art Gallery).

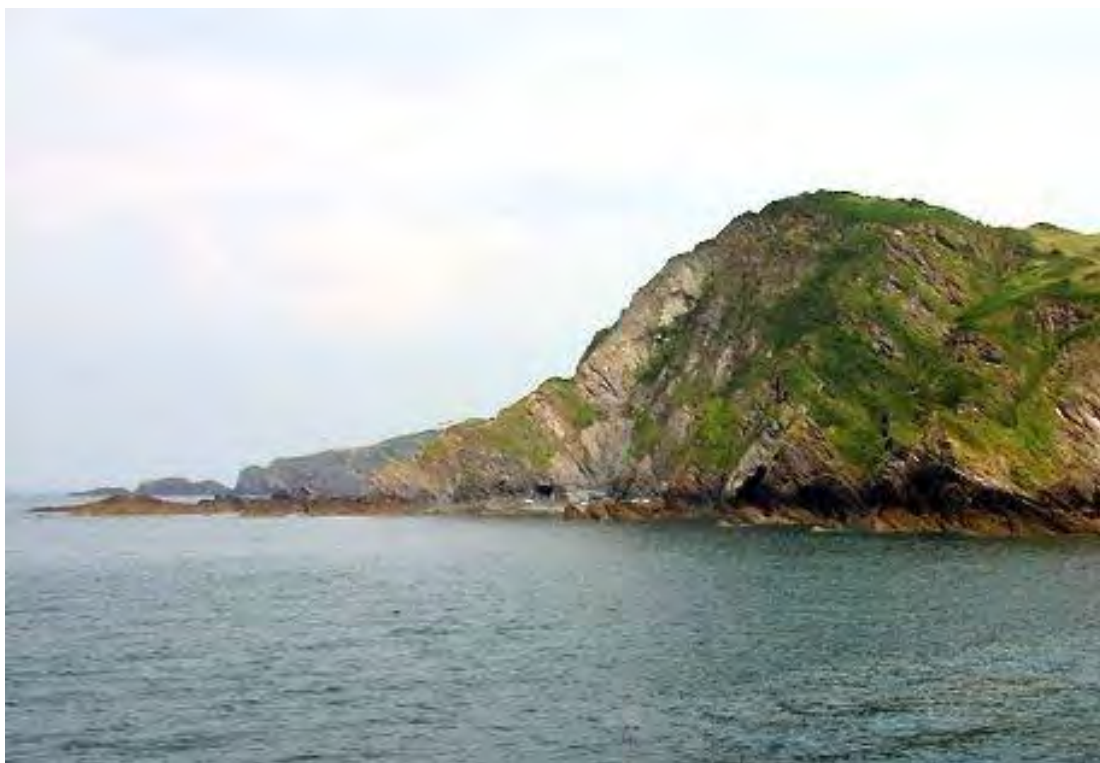
**Figure 21.15 (above):** This pair of views illustrate the photographic accuracy that could be achieved by some of the best nineteenth century artists such as Frederick Jones (Fl.1860s). Such detailed portrayals of cliff faces allow not just qualitative but also quantitative assessments to be made of cliff and coastline change. These views show Hillsborough, which includes a promontory fort on its summit (MDV2210).

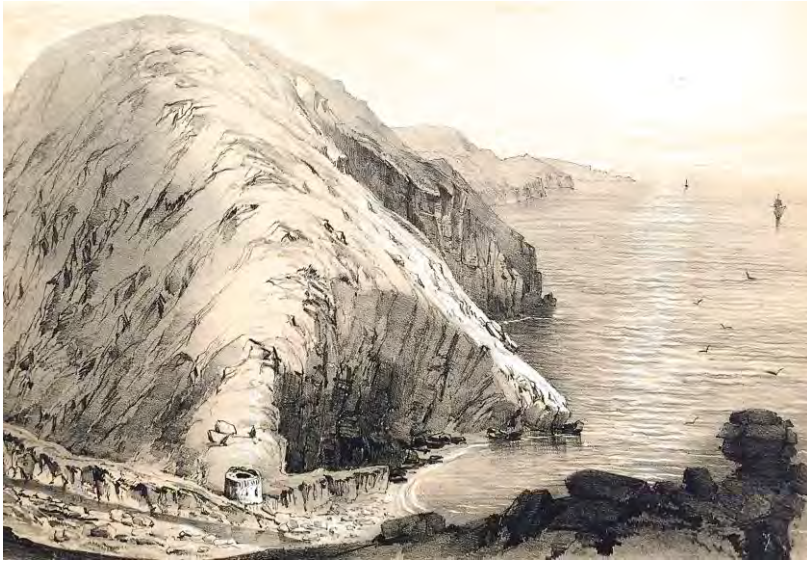
**Figure 22.1:** This lithograph produced in the 1840s shows Heddon's Mouth to the North-West of Martinhoe. The Post-Medieval lime kiln (MDE1026) is located on a ledge above the River Heddon and close to the shore. The structure was restored by the National Trust in 1982. Access steps lead to the kiln working area from the shore. In the past the kiln has suffered severe storm damage in this exposed location.

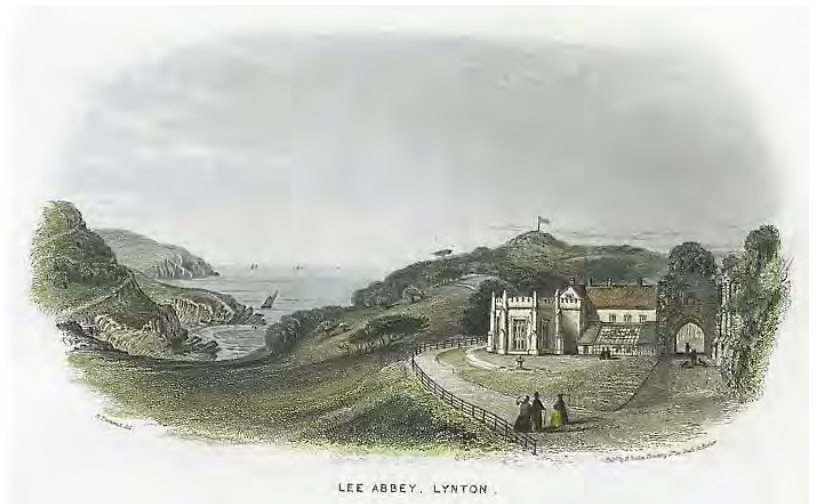
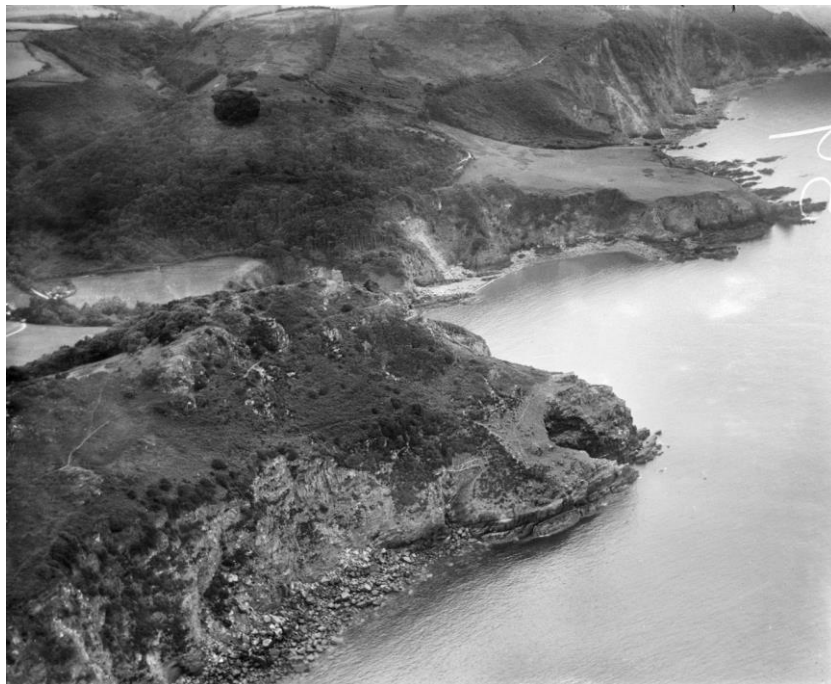
**Figure 22.2 (right) and Figure 22.3 (below)** show the location of Duty Point Tower at Lee Abbey near Lynton. This mid-nineteenth century romantic lookout tower is an important local landmark (Grade II Listed). The tower is located on the edge of high cliffs and is at risk from coastal erosion and rockfalls beneath. No artworks of the tower itself have been found although the engraving (**right**) shows the Abbey and its grounds. The aerial photograph (**below**) (c.1930) shows the Duty Point headland and Lee Bay beyond.

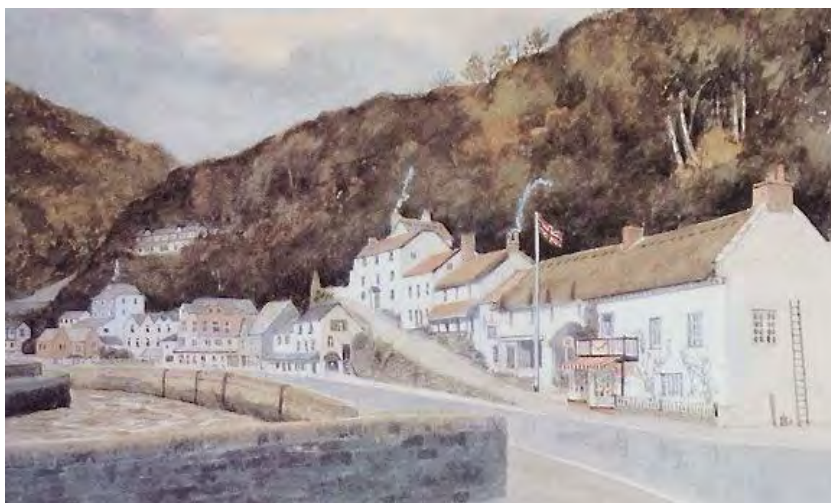
**Figure 22.5 (middle)** shows the same view in about 1920 depicted by the watercolour artist Alfred Robert Quinton. A new wall provides protection for the additional row of houses that were built after Daniell's visit.

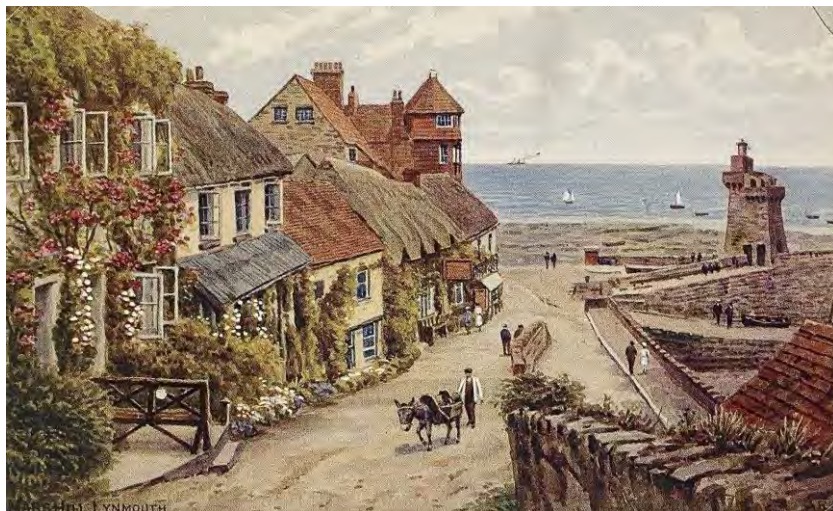
**Figure 22.10:** This detailed architectural watercolour by A. R. Quinton, c.1920 shows the view looking down Mars Hill towards the distinctive Rhenish-style tower. It was built in c.1860 to store sea water for bathing (MDE 21018). The tower was destroyed in the 1952 floods but rebuilt.

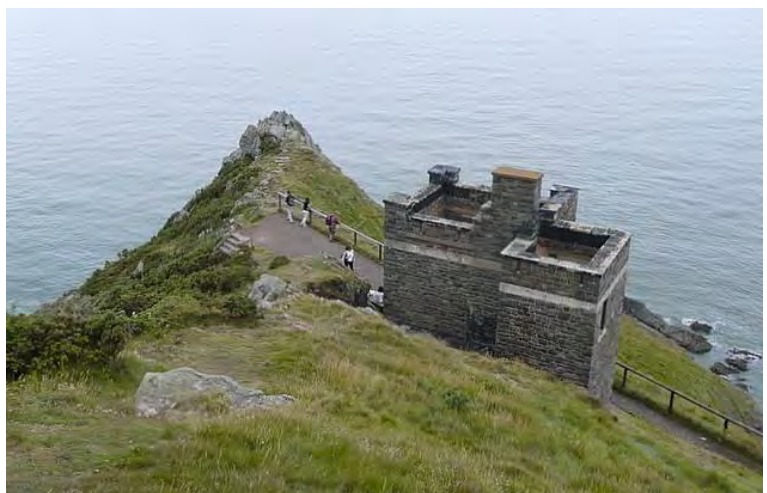
**Figure 22.16 (below right)** shows the old Coastguard Lookout Station' at Hurlstone Point near Bossington, Somerset to the east of Porlock. The two-storey building was erected c.1900 and was manned up to World War II (MSO 8110).

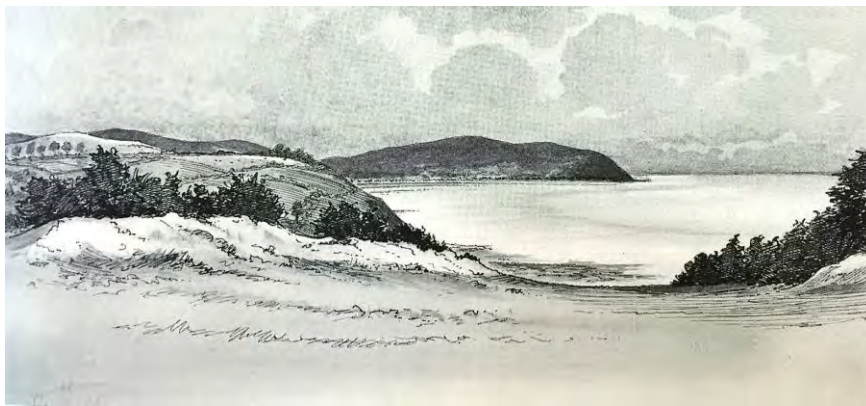
**Figure 23.5:** 'Daw's Castle near Watchet' drawn by J. Burrow, c.1924. Lying 2km west of Watchet the originally extensive camp has been dramatically reduced in size by coastal erosion.

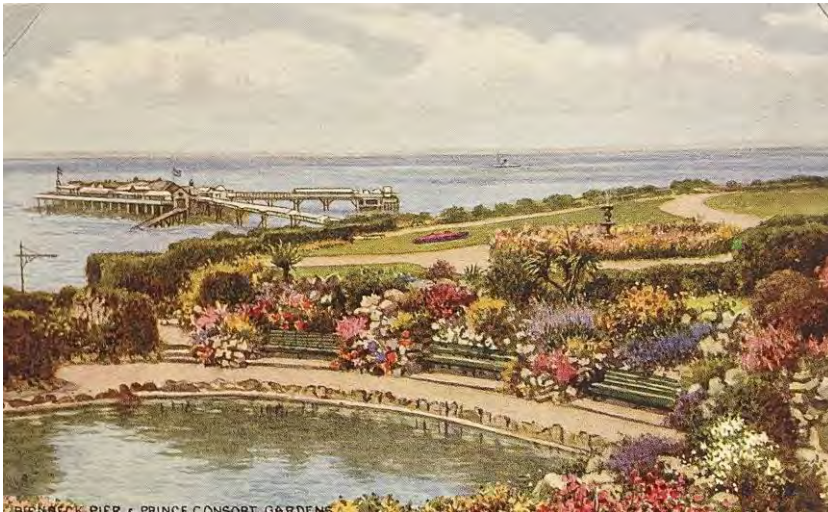
**Figure 23.11:** The Birnbeck Pier, a Listed (Grade II\*) structure, was built in 1867 and is the only pier in Britain that links the shore to an island. The pier would have been built about forty years before A. R. Quinton painted this watercolour.

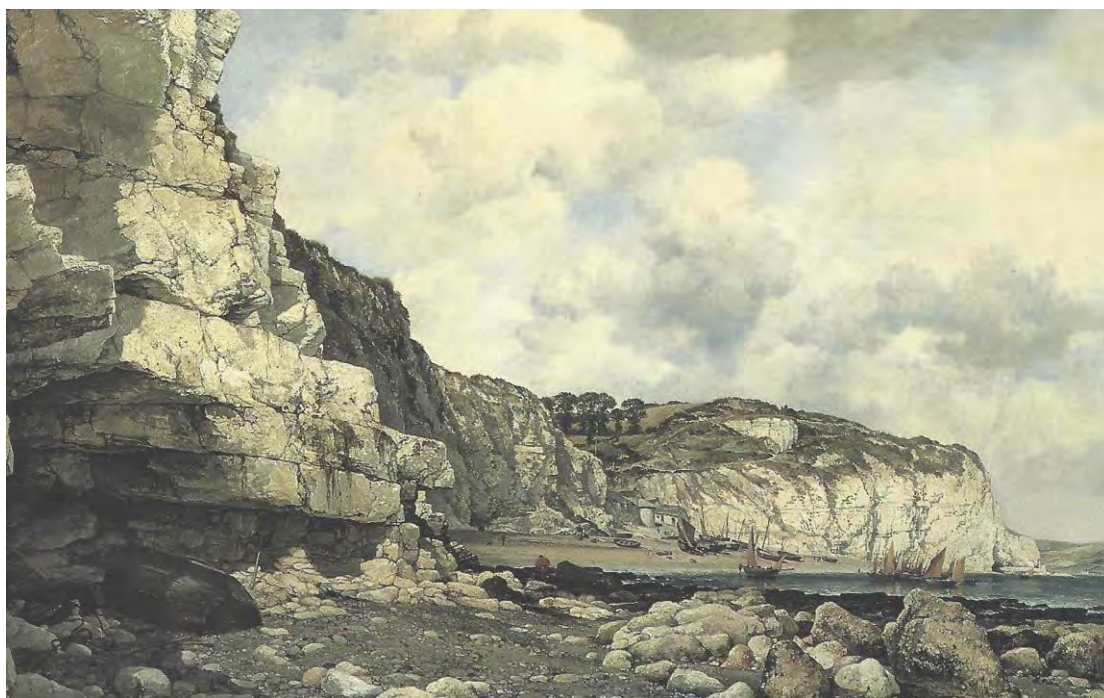
**Figure 6.4.1:** *'The Fishing Cove of Beer'* by E. W. Cooke 1858. The Upper Chalk exposure of Annis Knob also shown in **Figure 6.4.2. (right)** is clearly visible as is the extensive Middle Chalk exposure in the main cliff below. Cooke's painting also shows the nature of the landscape before the extensive tree and vegetation growth that masks the cliff top today. Photograph (right) © Ian West.

Edward William Cooke (1811-1880) was more than just a distinguished landscape painter. He was elected a Fellow of the Linnaean Society in 1857, a Fellow of the Geological Society in 1862 and his election as a Fellow of the Royal Society, an uncommon distinction for a painter, came in 1863 shortly before he was made an RA. Cooke's father, George Cooke, had engraved copper plates for Sir Henry Englefield Bt. that appeared in his *'A Description of the Principal Picturesque Beauties, Antiquities and Geological Phenomena of the Isle of Wight and adjacent Coast of Dorsetshire'* (Englefield, 1816<sup>2</sup>). Englefield had stated that *'in no instance has accuracy been sacrificed to the effect of the engraving'*. This ethos underpinned E. W. Cooke's work throughout his life with him receiving highly favourable comment from John Ruskin the great Victorian art critic (Ruskin, 1853<sup>5</sup>). On Cooke's election to the Royal Academy in 1863 the Illustrated London News said of him *'The prime characteristic of Mr Cooke's art is literal fidelity to nature. He is probably the most scientifically accurate painter we possess. His pictures provide exact reproduction of the outward aspects of the natural world satisfying the geologist, botanist, meteorologist, architects and shipbuilder'* (Illustrated London News, 1863<sup>9</sup>). Cooke's views of the south-west coast were originally intended to form a volume entitled *'The British Coast'*, however, the work was never completed for publication. Figure 6.4.1 shows Cooke's view of *'Fishing Cove of Beer'* one of several views of the location. His artwork compares almost exactly with the photographs below.

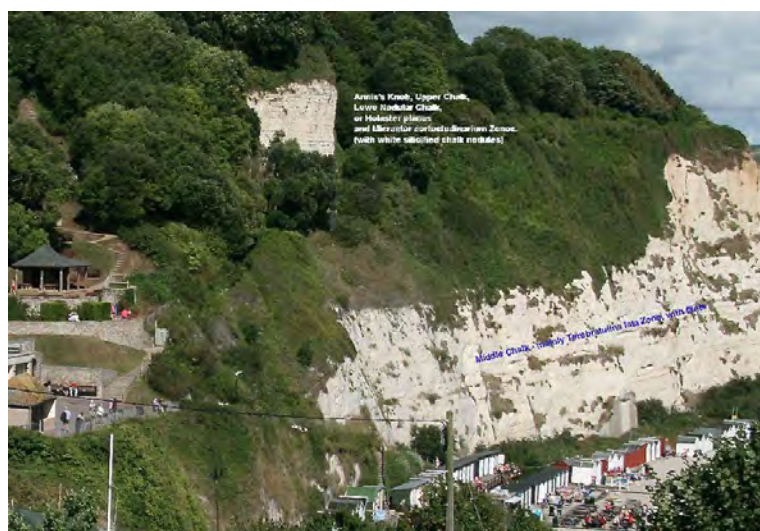
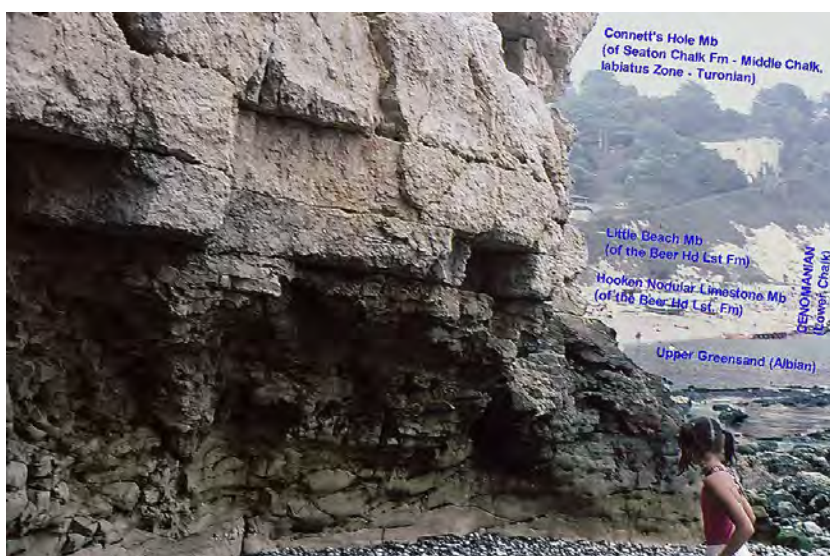
**Figure 6.4.3. (left)** shows the Upper Greensand-Lower Chalk junction on the south side of Small Point, Beer. Cooke has captured this exactly in the bottom left corner of his painting.

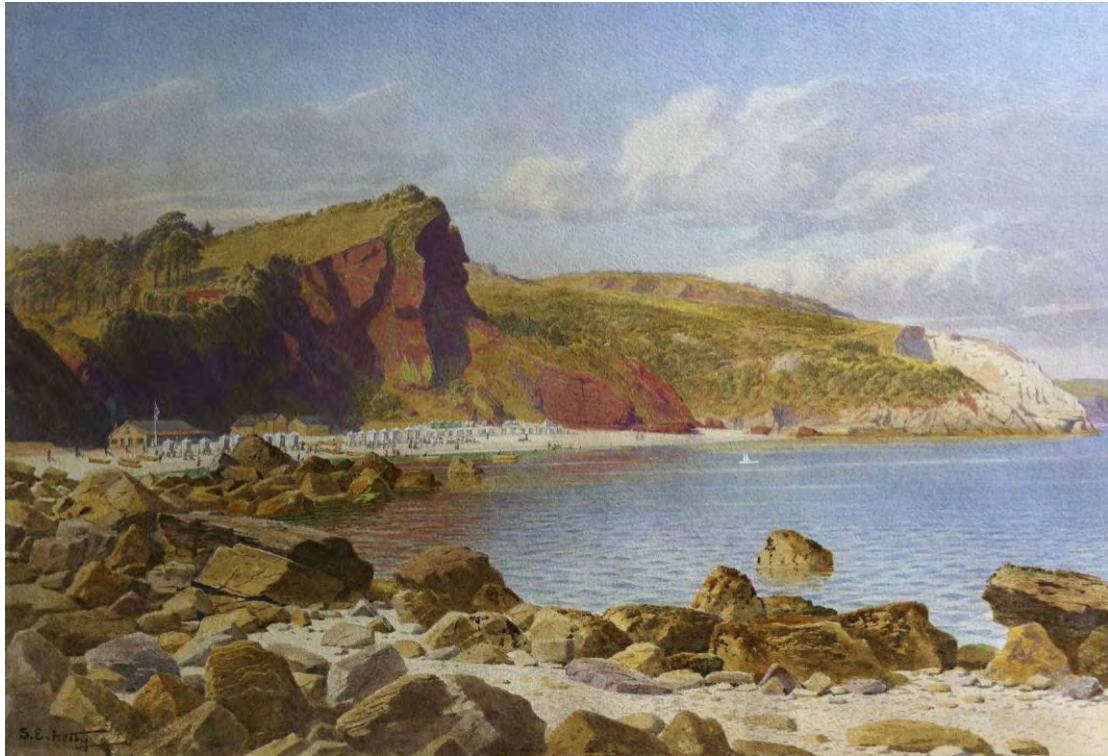
**Figure 6.4.4:** 'Oddicombe Beach' near Torquay by Samuel Edward Kelly c.1910. Views such as this remind us of the changing coastal environment both in terms of physical change, and the landscape through development and management practices. Kelly's watercolour provides evidence of coastal processes at work and risks from the unstable cliff face. It is important to bear in mind that coastal change may pose risks to buried, undiscovered heritage as well as to known heritage assets.

The watercolourist Samuel Edward Kelly (1862-1935) produced highly detailed watercolours of the south-west coast. His view of *'Oddicombe Beach'* near Torquay painted in 1910 is a fine example of his work. Kelly followed the Pre-Raphaelite ideal of capturing nature faithfully and this is evident in this scene, which shows the precarious cliffline above the beach as well as the debris from previous falls. Comparison with recent photographs confirms the level of accuracy that artists could achieve with the brush alongside photography.

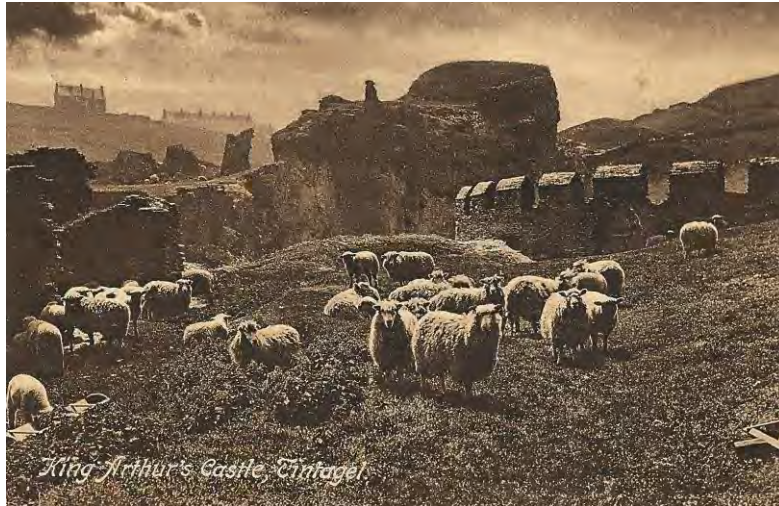
**Figure 6.4.6. (left):** 'Tintagel Castle, Cornwall'. This postcard, which was produced from a photograph taken in about 1900 shows the battlements extending towards the cliff edge. Such structures and the changes observed to them through artworks and photographs over time can provide both qualitative and quantitative evidence of the rate of coastal change.

The enormous value of old photographs and photographic postcards has also been stressed in this report and these images, alongside art, help to provide a more complete illustrated record of coastal change and its impacts on heritage sites in the south-west of England. Sites such as Tintagel Castle in Cornwall (Figures 6.4.6-6.4.8, and Figures 17.15 and 17.16) might appear to be resilient but photographic evidence clearly shows the loss of cliff material over time as a result of weathering and coastal erosion and demonstrates the value of this medium.

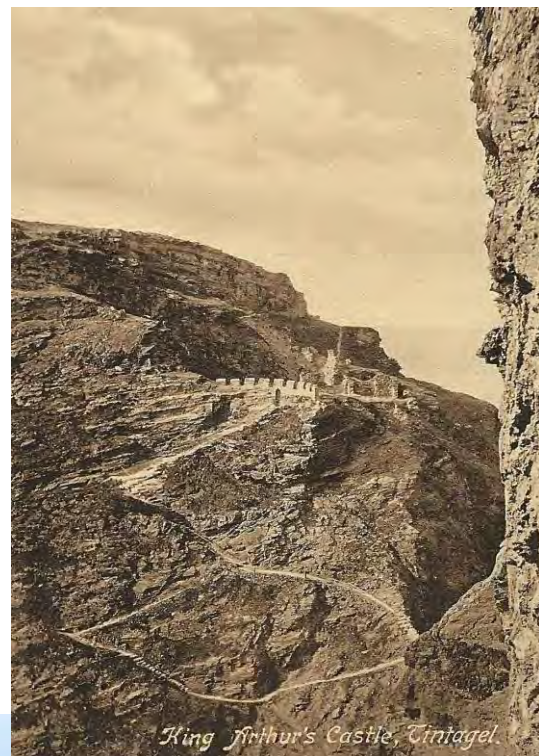
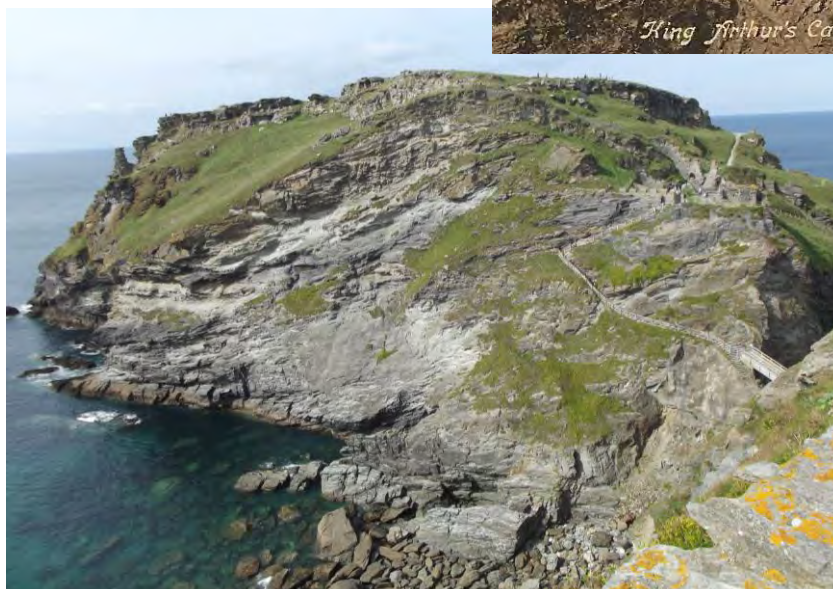
**Figure 6.4.7 (right)** shows a view of Tintagel Castle (pre-1914), which looks directly at the cliff face surmounted by the battlemented wall. This postcard shows a substantial bluff beneath that end of the wall that is now absent in the present day photograph in **Figure 6.4.8 (below)**.

The extent of loss can be seen by comparing the number of battlements to the right of the entrance arch (four) in the postcard, whilst the photograph only shows one battlement remaining.
