Sidmouth & East Beach Management Plan

Prepared for
East Devon District Council

January 2017

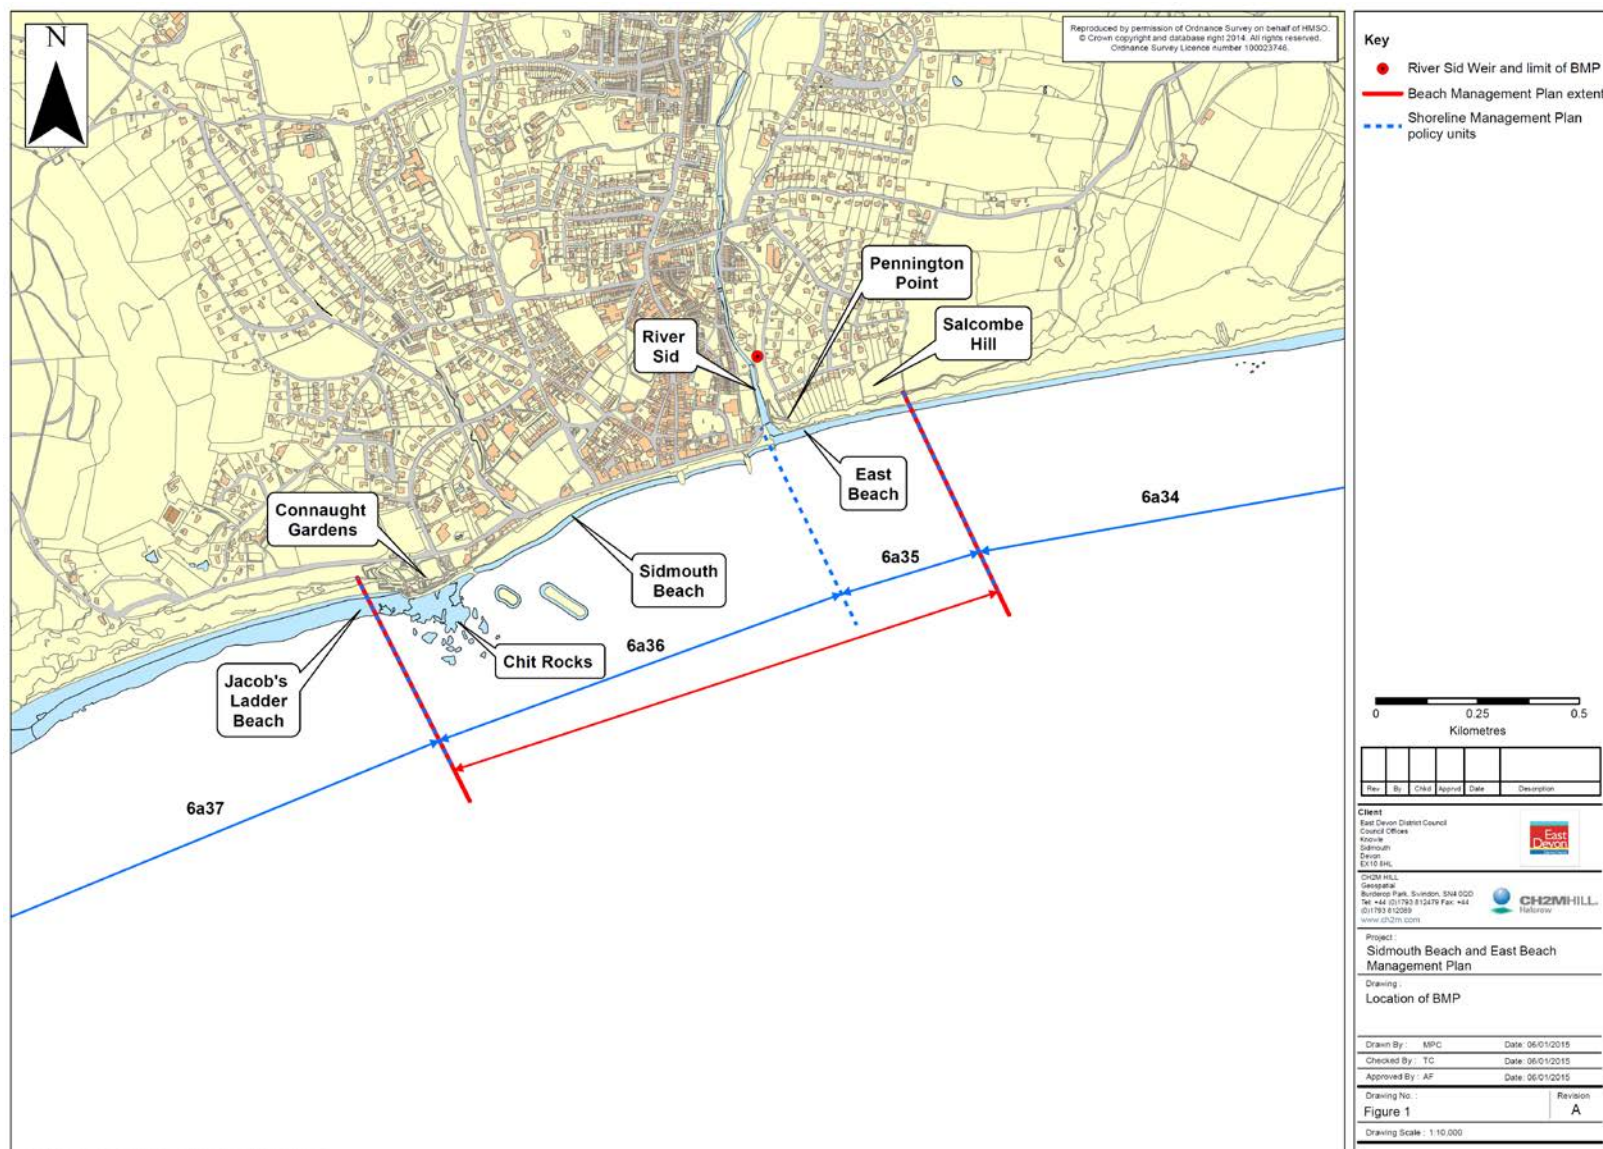
FIGURE 1-1
Sidmouth BMP extent

This Beach Management Plan (BMP) has been prepared for East Devon District Council (EDDC) and covers the coastline from Jacob's Ladder Beach, in the west, to East Beach, in the east, as well as the western bank of the River Sid up to the weir (**Figure 1-1**).

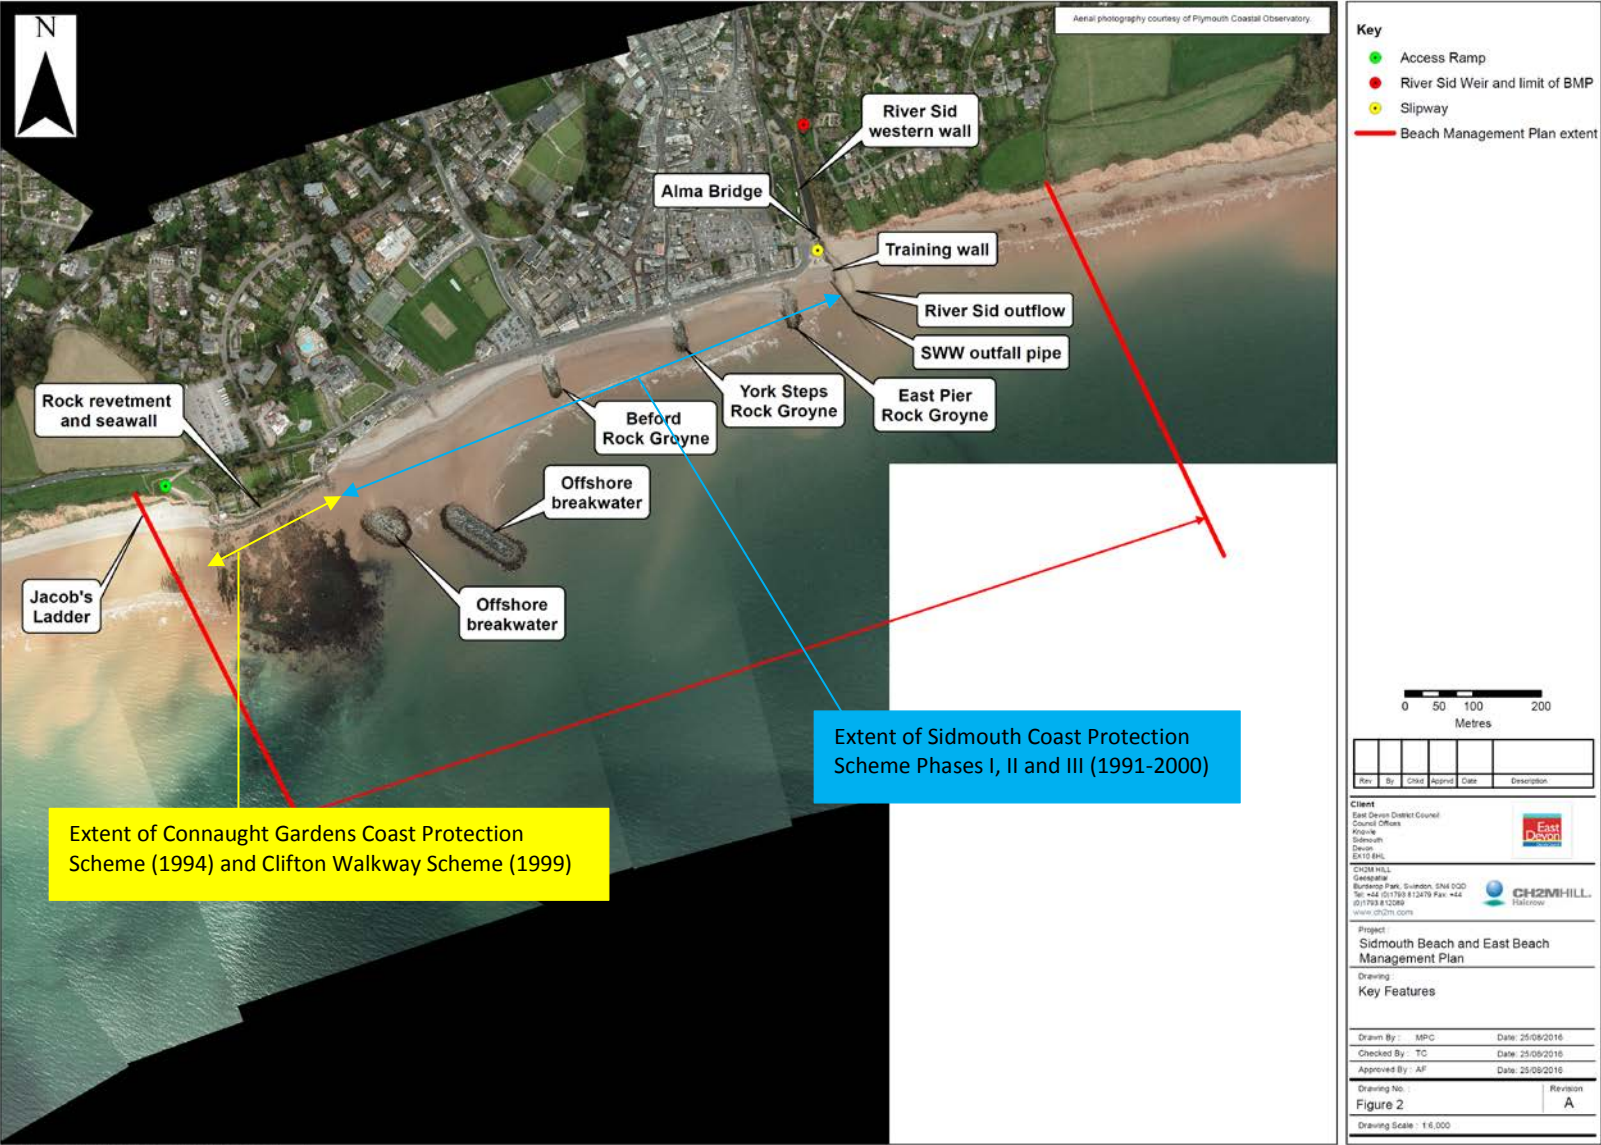
FIGURE 1-2
Key features and extent of recent schemes that have led to the current coastal defences along the BMP extent

Figure 1-2 highlights the current coastal defences and, with reference to the above list, the scheme extents that constructed them. **Section 3.1** provides further details about these current coastal defences.

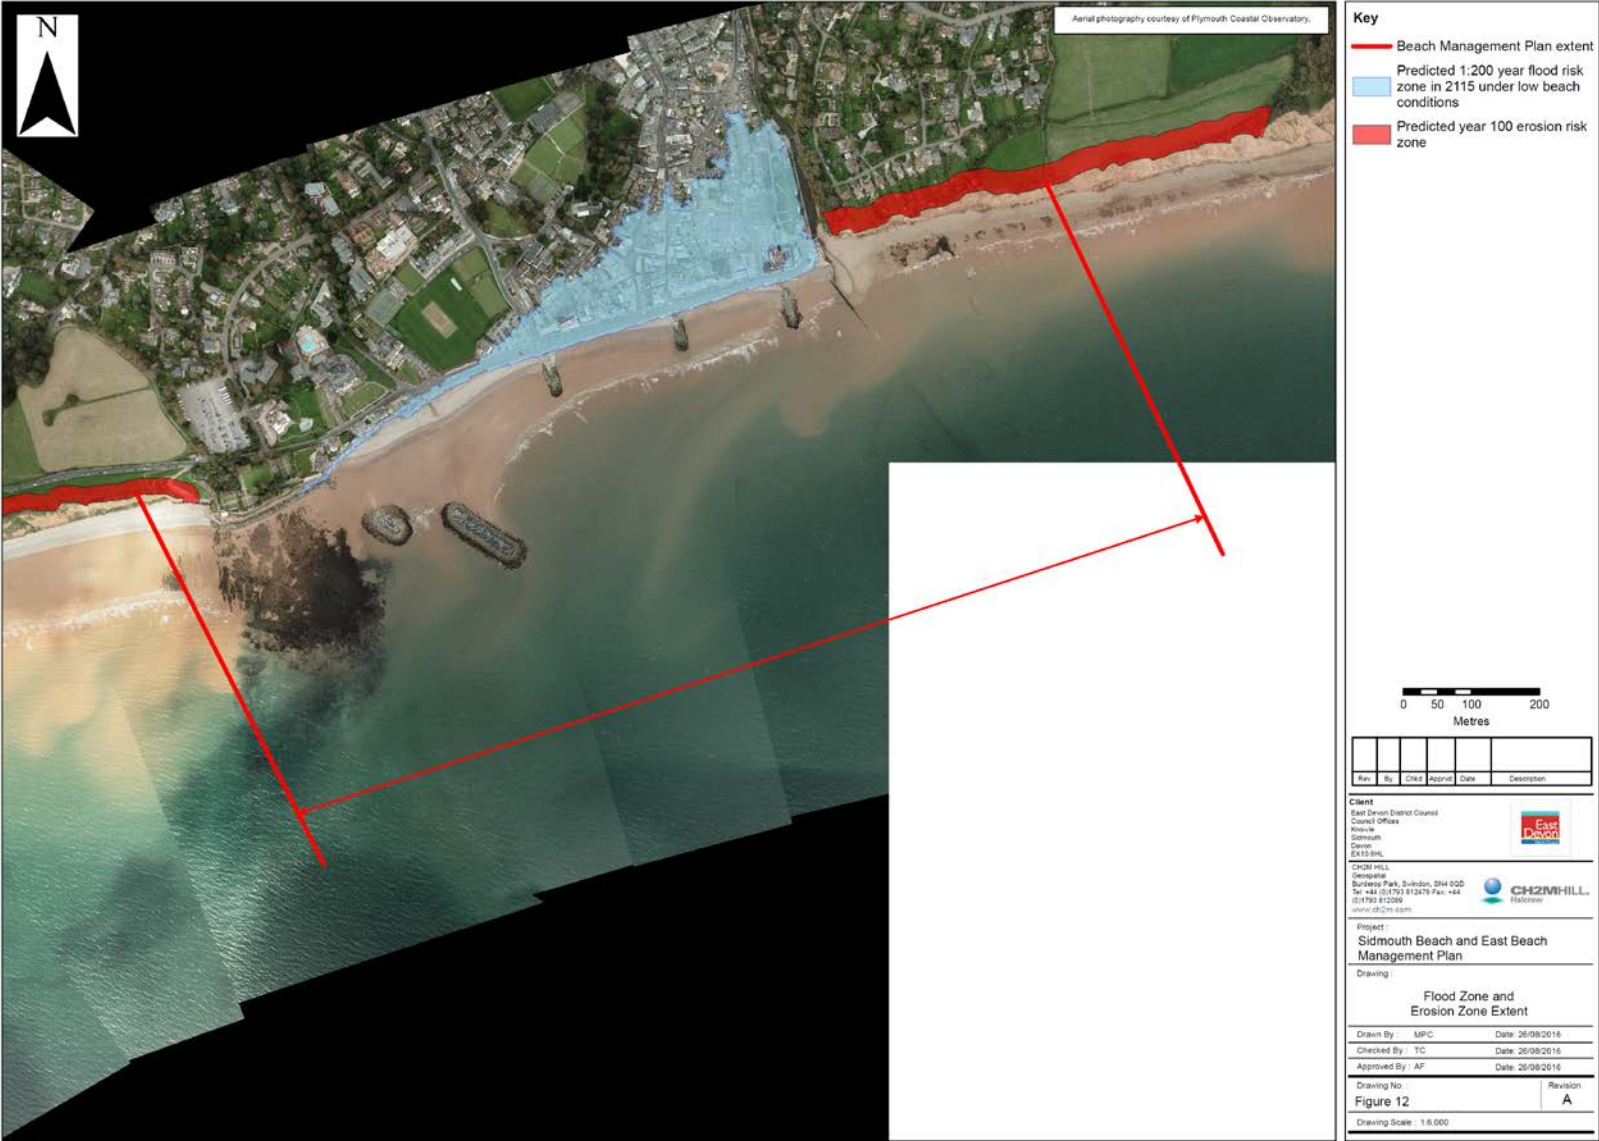
FIGURE 1-3
Flood and erosion risk along the BMP frontage

The beach and hard defences along the BMP frontage protect against the risk of coastal flooding and erosion (see **Figure 1-3**).

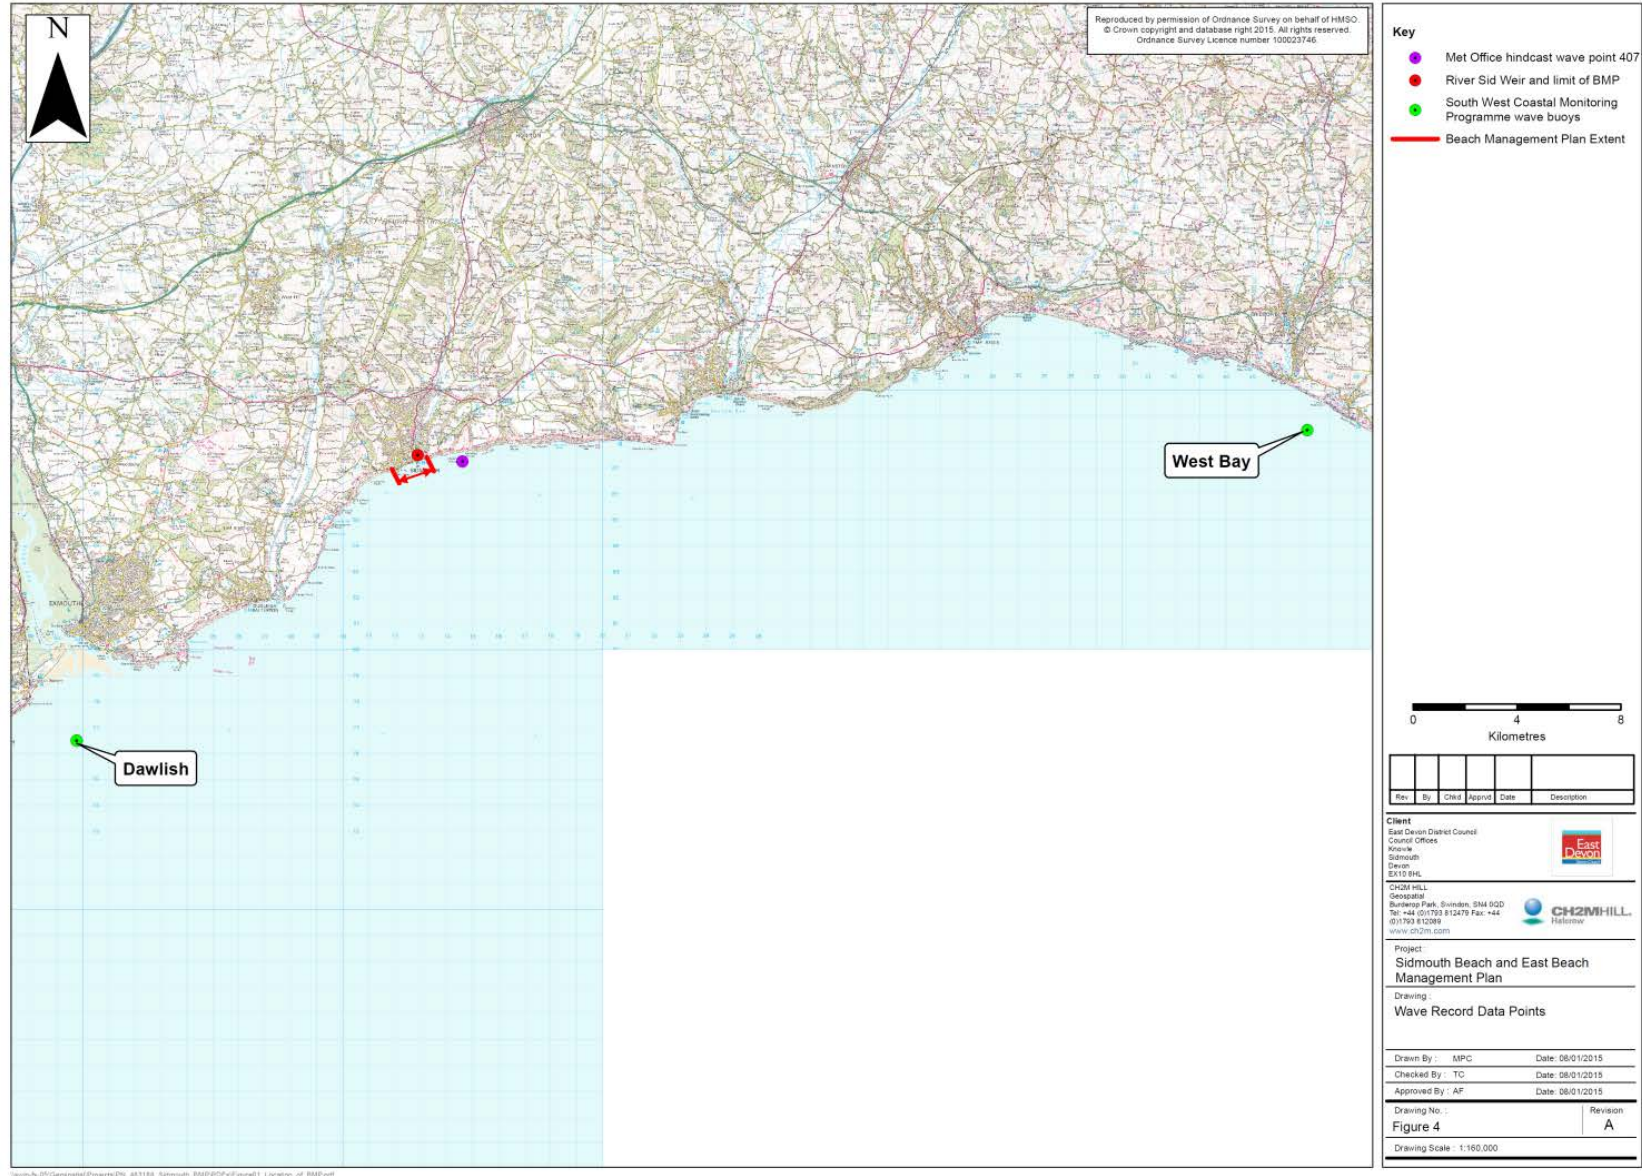
FIGURE 2-1
Map showing the locations of the wave data collection points.

The coastline between the Jacob's Ladder Beach and East Beach is orientated in a north-east to south-west direction. Various wave data sets are available relevant to this frontage (see **Figure 2-1** and **Table 2-1**); these all indicate that waves predominately approach this coastline from the south-west and south-east (refer to **Appendix B**).

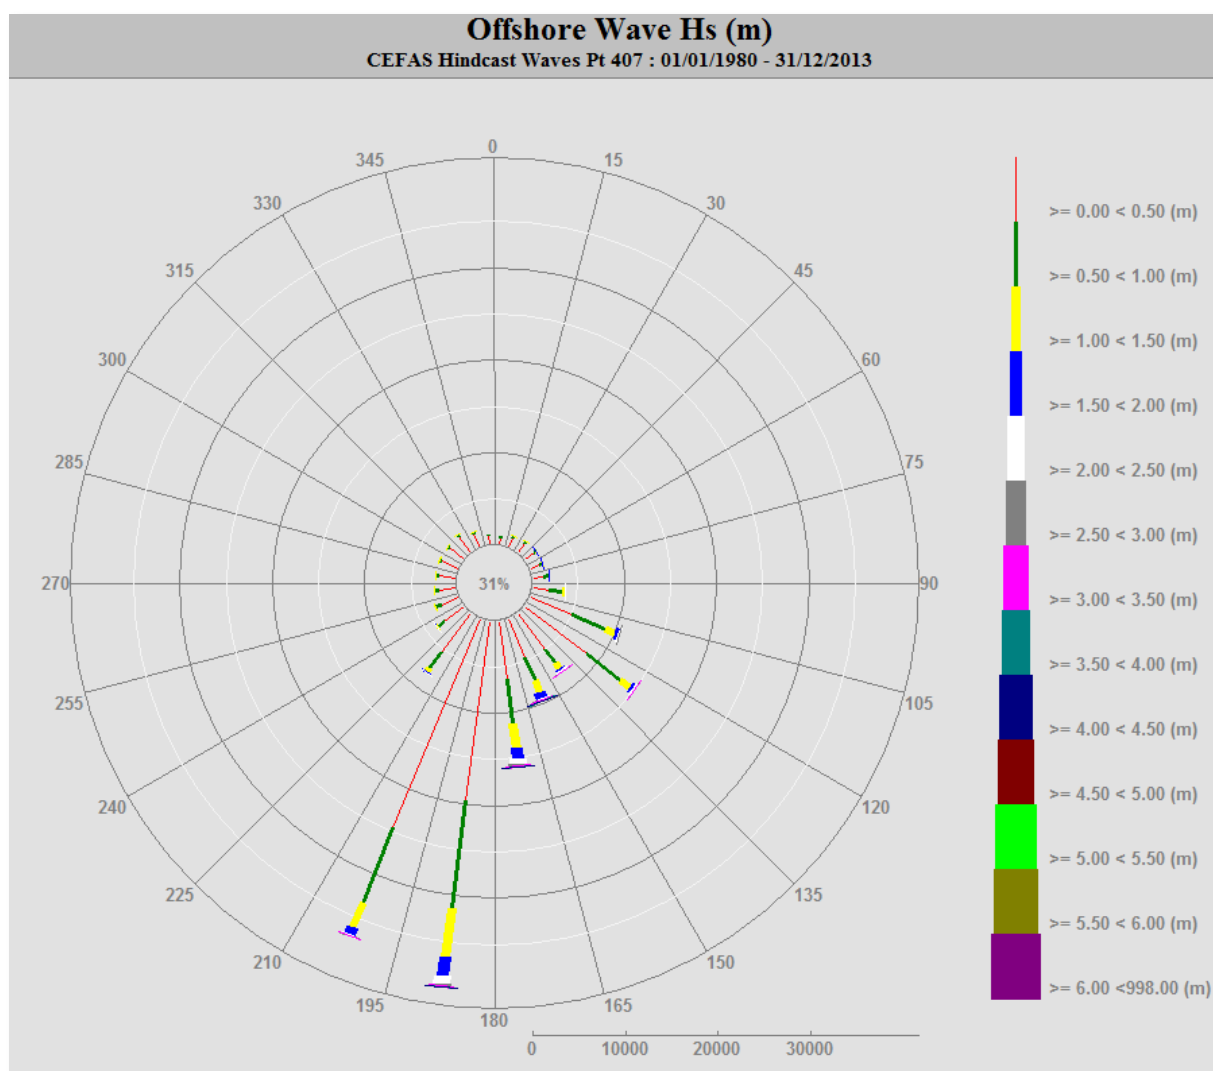
FIGURE 2-2

Met Office WaveWatch III hindcast wave record for location '407' between 1/1/1980 and 31/12/2013.

The Met Office hindcast wave data for location '407' (**Figure 2-2**) is closest to the BMP area and provides the longest record of data. This data set indicates that a predominant south-westerly wave regime along this coastline, but that south-easterly storm conditions occur throughout the year for days at a time.

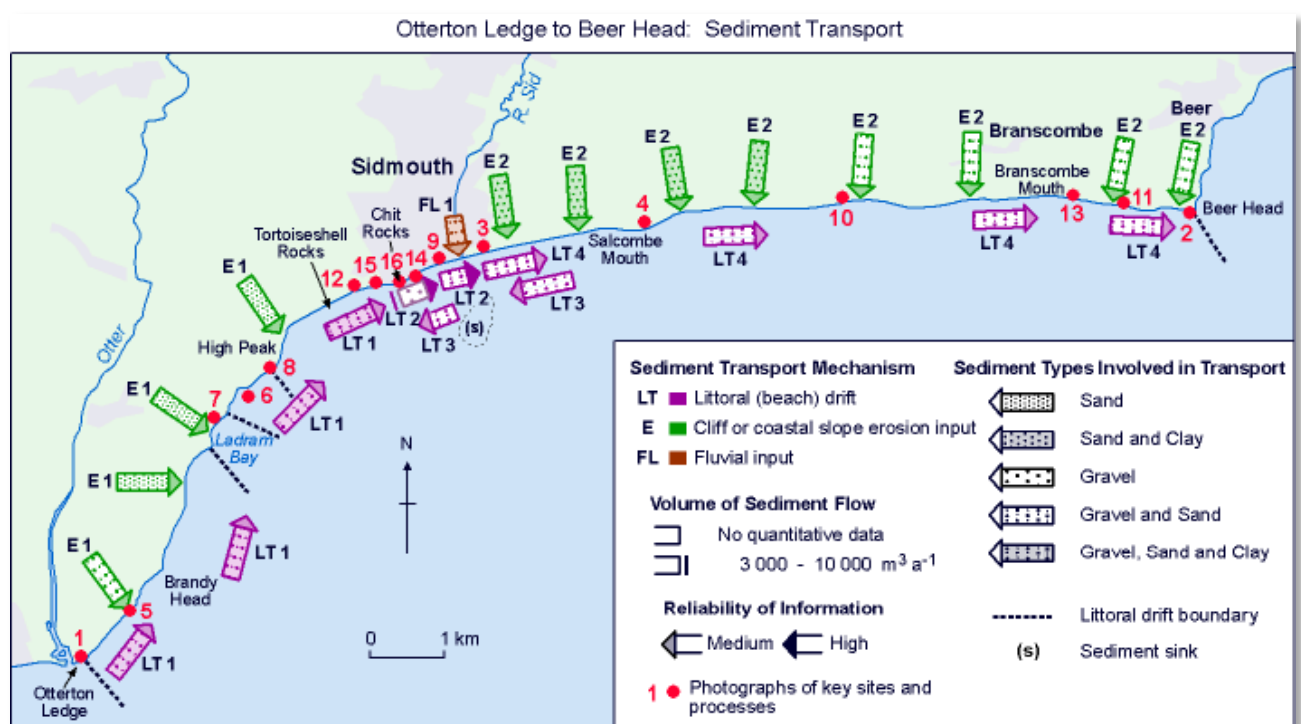
FIGURE 2-3
Sediment Transport for Sidmouth and the surrounding area (SCOPAC, 2004).

SCOPAC (2004) produced a map of the sediment transport mechanisms, for various sediment types, for the area between Otterton Ledge and Beer Head (see **Figure 2-3**). For the Sidmouth frontage this indicated that there is potential for gravel and sand to be transported in both directions. SCOPAC (2004) also reported a predominant weak west to east sediment transport pathway along the coast from Otterton Ledge to Beer Head, and at Sidmouth there is indirect evidence for east and south-east waves to create a short-term littoral drift reversal. The map also suggests a potential fluvial input to the frontage; however, this is believed to be low due to trapping by weirs within the River Sid upstream of the mouth.

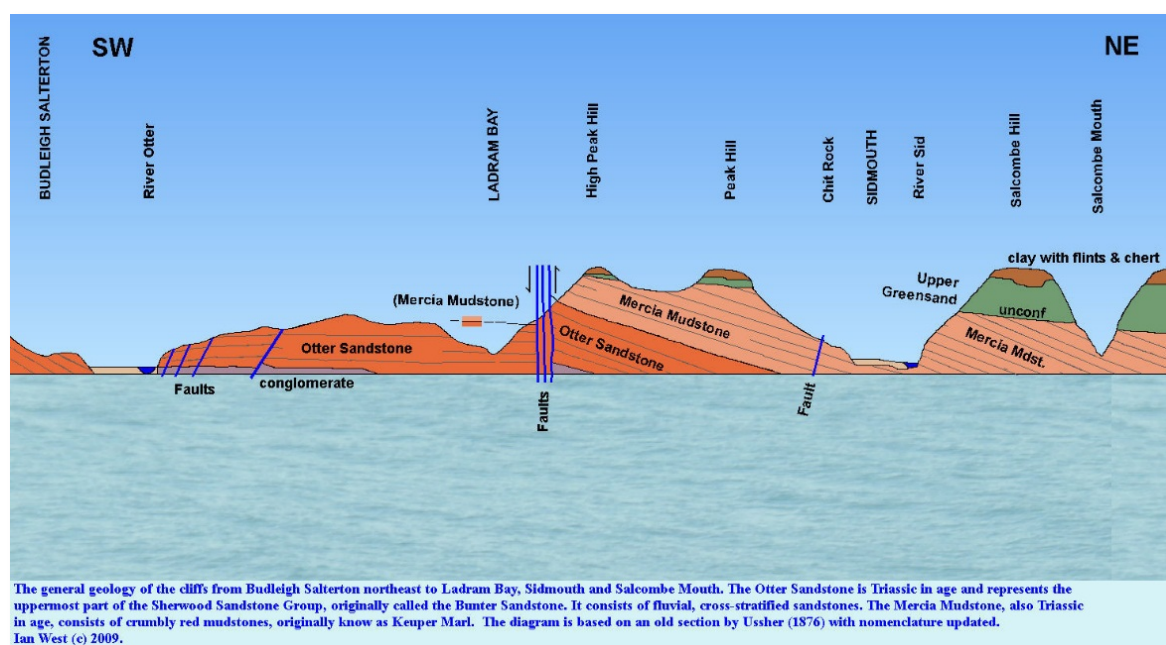
FIGURE 2-4

Diagrammatic geological cliff section of the coastline between Otterton Ledge and Salcombe Mouth (east of Sidmouth), looking inland from the sea (West, 2013). The Otter Sandstone outcrop at Chit Rocks and at the base of Pennington Point (NE of the River Sid), and faults in cliff east of River Sid have been omitted for clarity.

A diagrammatic geological cliff section of the coastline between Otterton Ledge and Salcombe Mouth (located just to the east of Sidmouth) is shown in **Figure 2-4**, whilst **Figure 2-5** shows the geology of the coastline between Big Picket Rock and Salcombe Hill (located just to the east of Sidmouth).

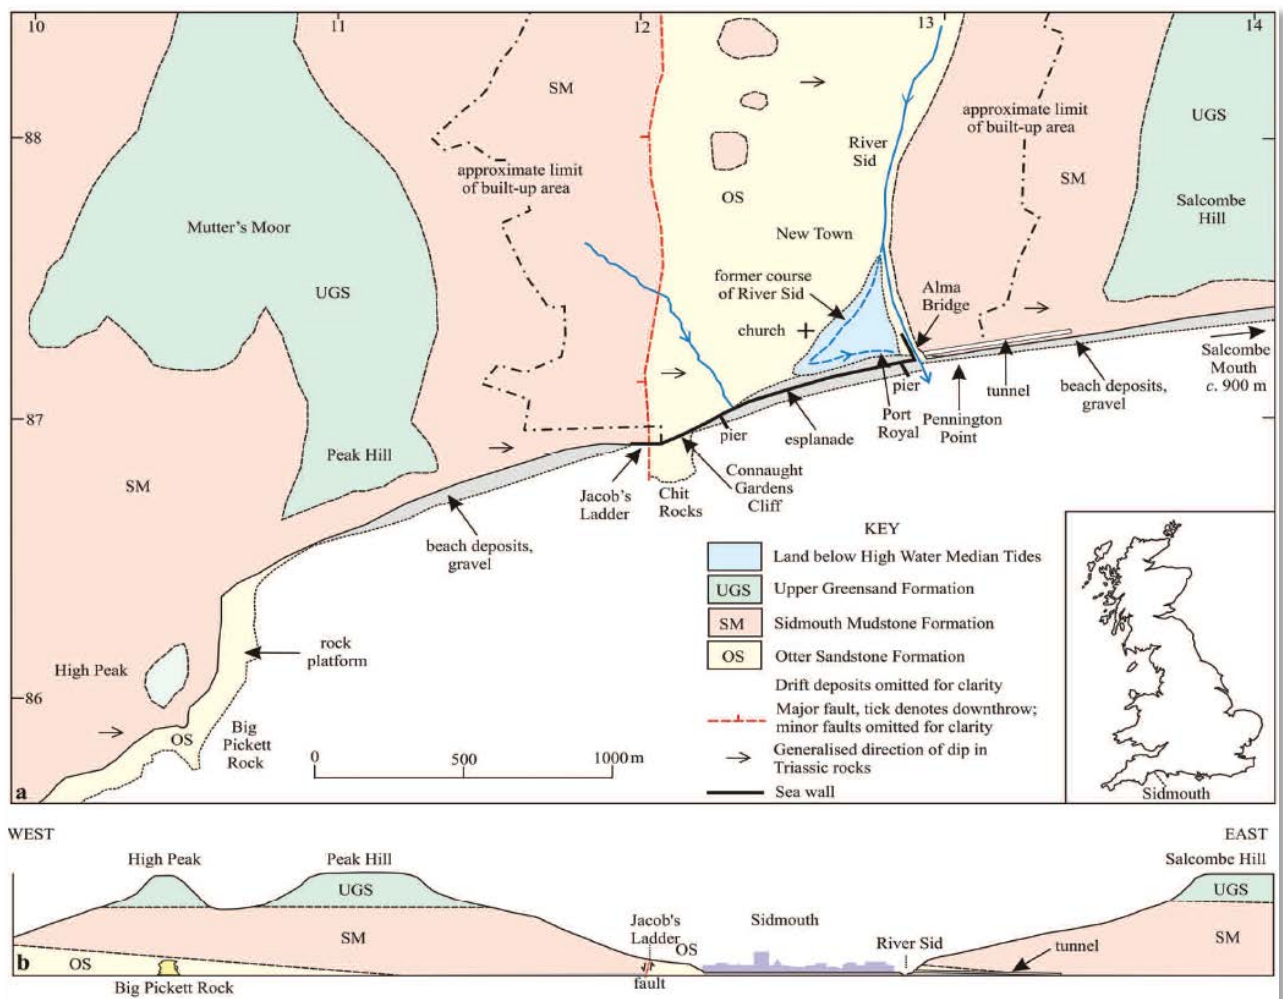
FIGURE 2-5
Above (a) Geological sketch map of Sidmouth and the adjacent area showing key locations. Geological data based on BGS 1:50,000 solid geology mapping. Below (b) Geological sketch section of the coast (Gallois, 2011).

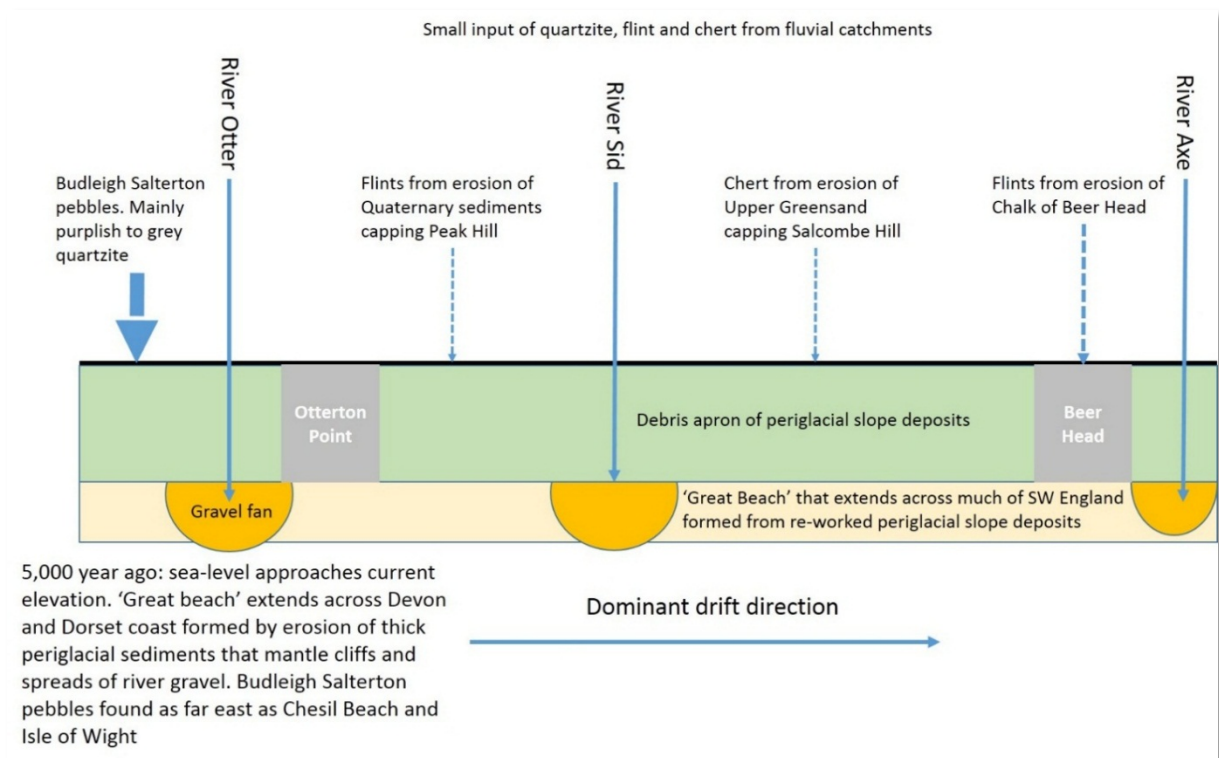
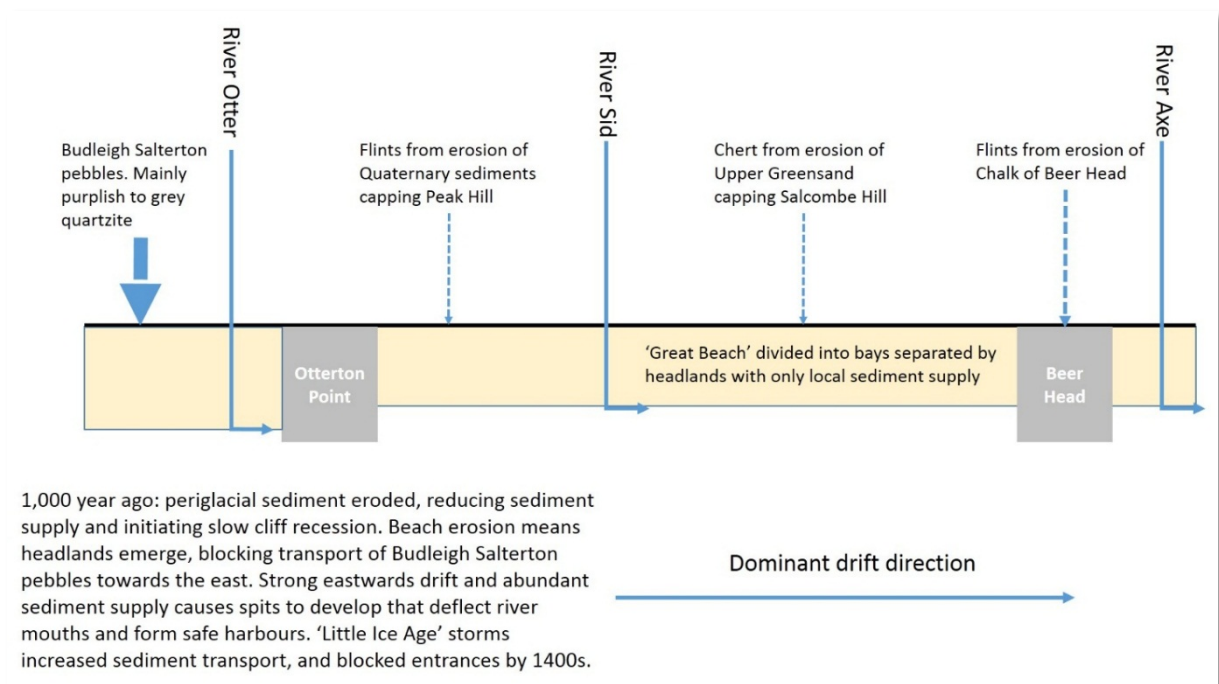
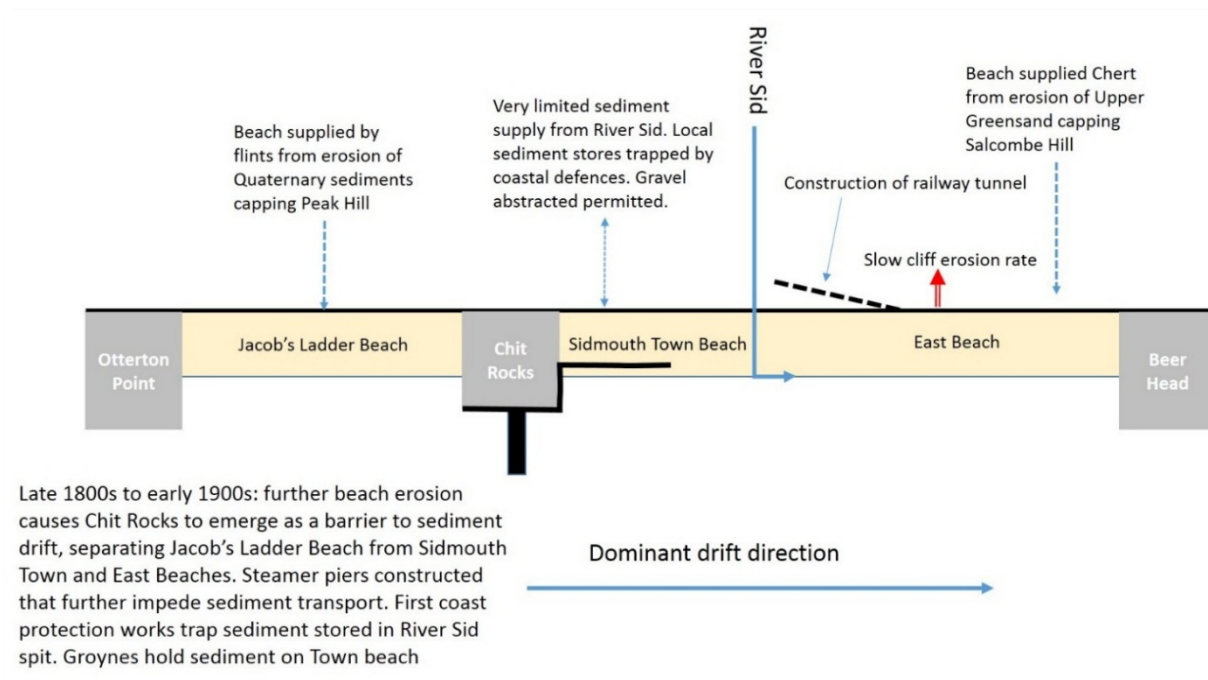
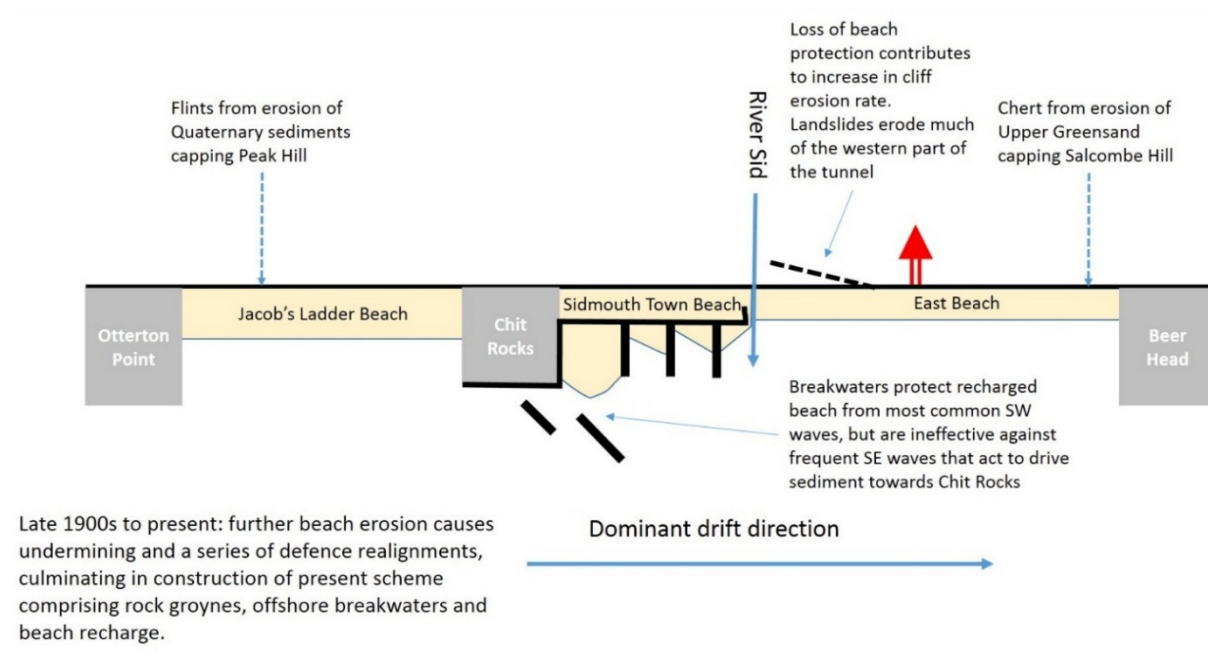
Sea-level rising to near current elevation around 5,000 years ago.

Establishment of headlands and bays around 1,000 years ago.

Initiation of first defences in response to declining sediment budget, around 100 years ago.

Additional defences in response to recent storms and on-going declining sediment budget.

FIGURE 2-6
Conceptual evolutionary model for the coastline between Otter Ledge and Beer Head.

A conceptual evolutionary model for the coastline between Otter Ledge and Beer Head is presented in **Figure 2-6**. Further details are provided in **Appendix B**.

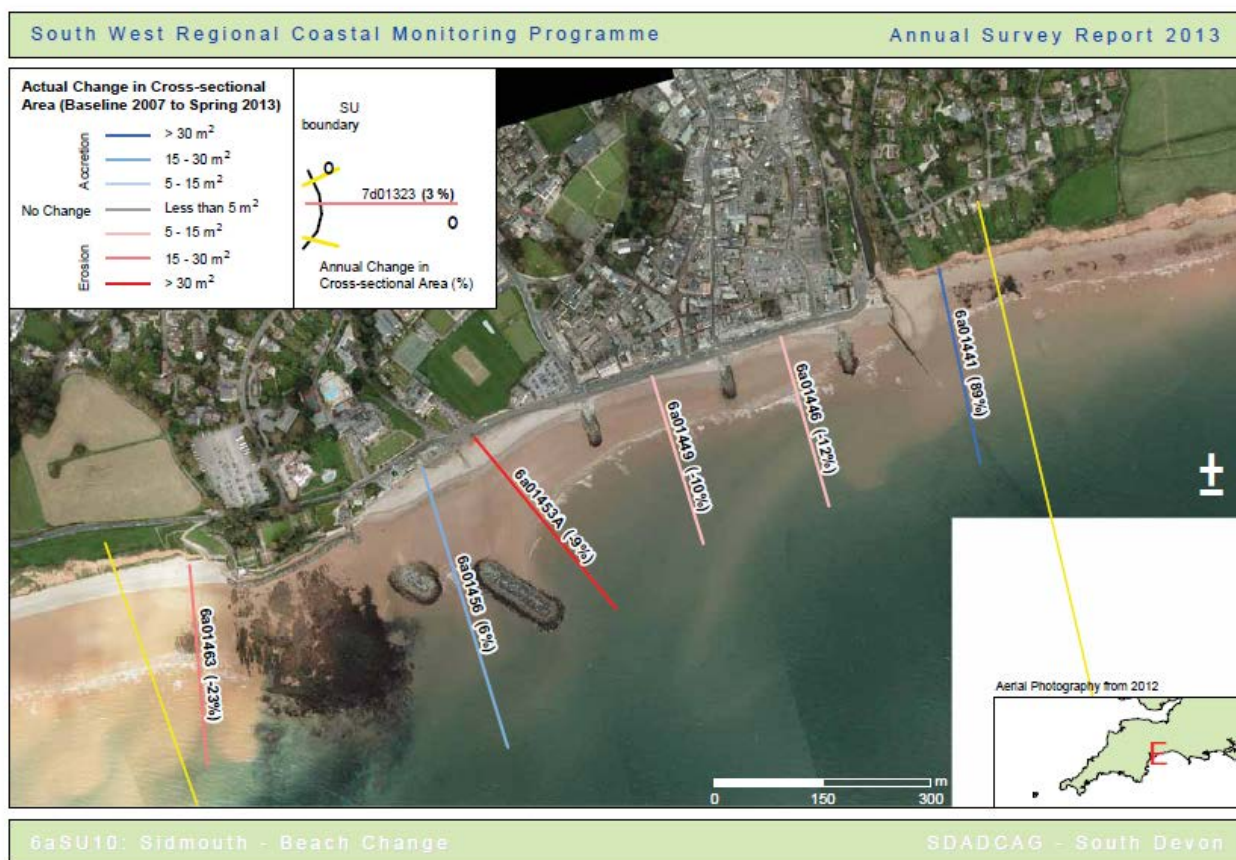
FIGURE 2-7
Change in cross-sectional area for the Sidmouth BMP frontage (from PCO, 2013).

Changes observed since 2007 are best summarised in the overview plot produced by Plymouth Coastal Observatory (PCO) for the SWRCMP (see **Figure 2-7**); this shows changes in cross-sectional area along a number of beach profiles along the Sidmouth BMP frontage between Spring 2007 and Spring 2013.

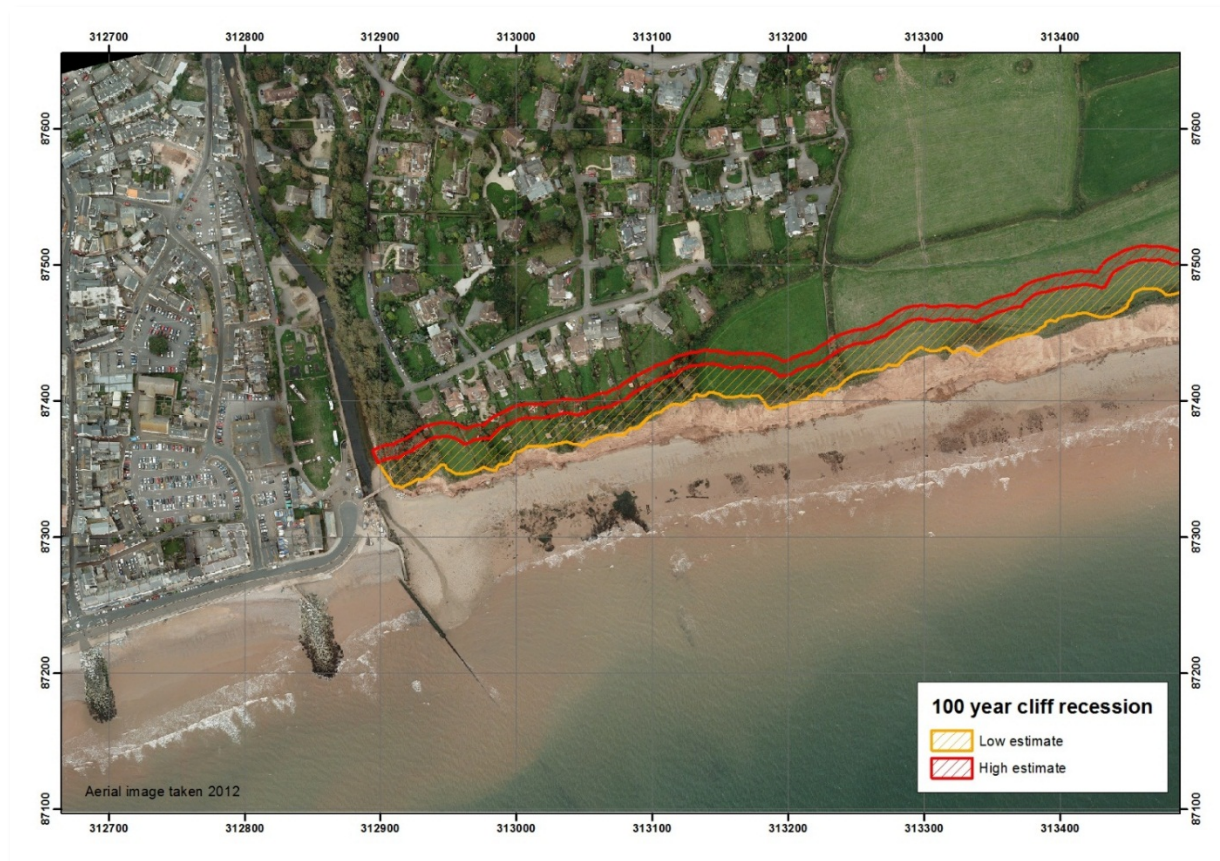
FIGURE 2-8

Cliff recession projection for 100 years at East Cliff. Note the projection is made from the 2015 cliff top, but are overlain on the 2012 image.

A 100 year projection is presented **Figure 2-8** and **Figure 2-9** for East Cliff and Peak Hill respectively. No attempt has been made to determine annual cliff losses or erosion rates. The actual erosion experienced in a given year is determined by the level of the beach, which is itself determined by the direction of waves that determines net drift direction; the timing, intensity and frequency of storms; and the amount of rainfall, none of which can be confidently predicted. Due to the current low beach levels, it is likely that the high rates of erosion seen in recent years will continue for several years, but that erosion will reduce in the near future once sediment has drifted back towards the west and a beach has accumulated.

It should also be noted that as East Cliff recedes over the next 100 years (as indicated in **Figure 2-8**), the Alma Bridge will become unsustainable in its current position in the near future, whilst the western wall of the River Sid, that provides fluvial flood defence at the present time, will become increasingly exposed to full coastal conditions (particularly during south-easterly storm events) in the medium to longer term. Such exposure, which will start to occur if East Cliff receded by about a further 10-15m from its 2015 position, will increase the likelihood of defence failure and thus incurrence of flood damages over time; this would also impact critical infrastructure located behind the western wall of the River Sid that serves the wider area, notably the Sewage Pumping Station operated by South West Water located immediately upstream of western Alma Bridge abutment. This serves to demonstrate that whilst measures along the Sidmouth Town frontage to reduce flood risk from wave overtopping are appropriate (i.e. reduce economic damages from flooding), this benefit would be for naught if the risk posed by outflanking from the east is not also addressed at the same time.

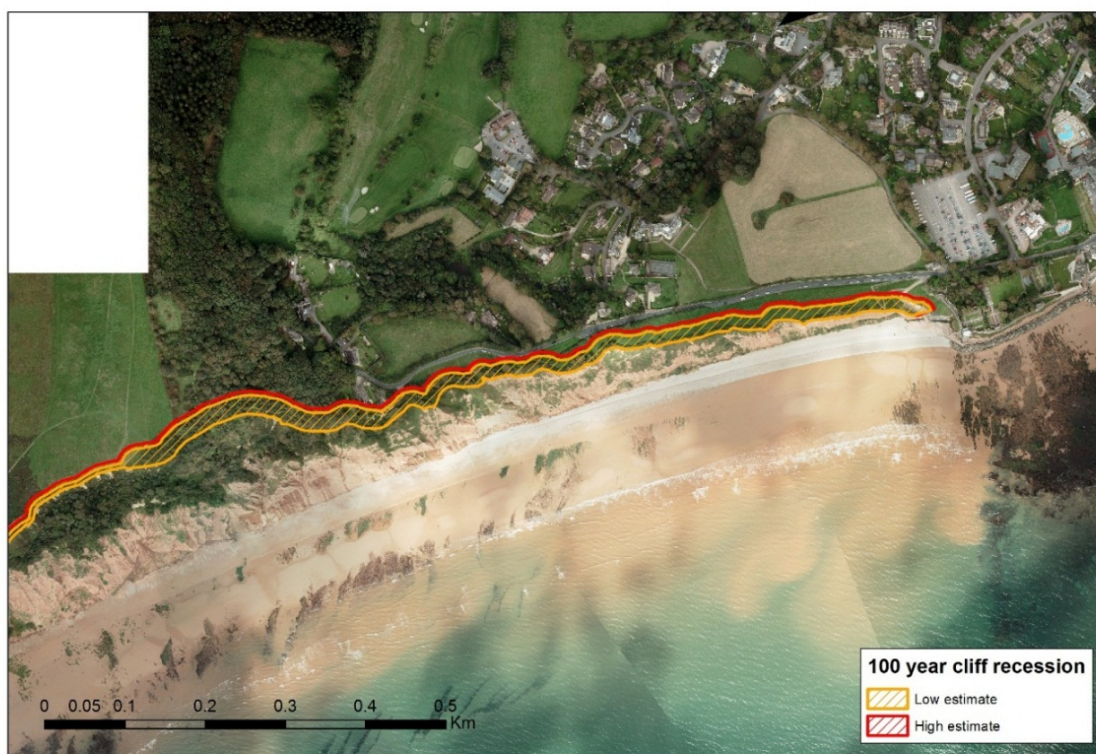
FIGURE 2-9

Cliff recession projection for 100 years at Peak Hill mapped. Note the projection is made from the 2012 cliff top and overlain on the 2012 image.

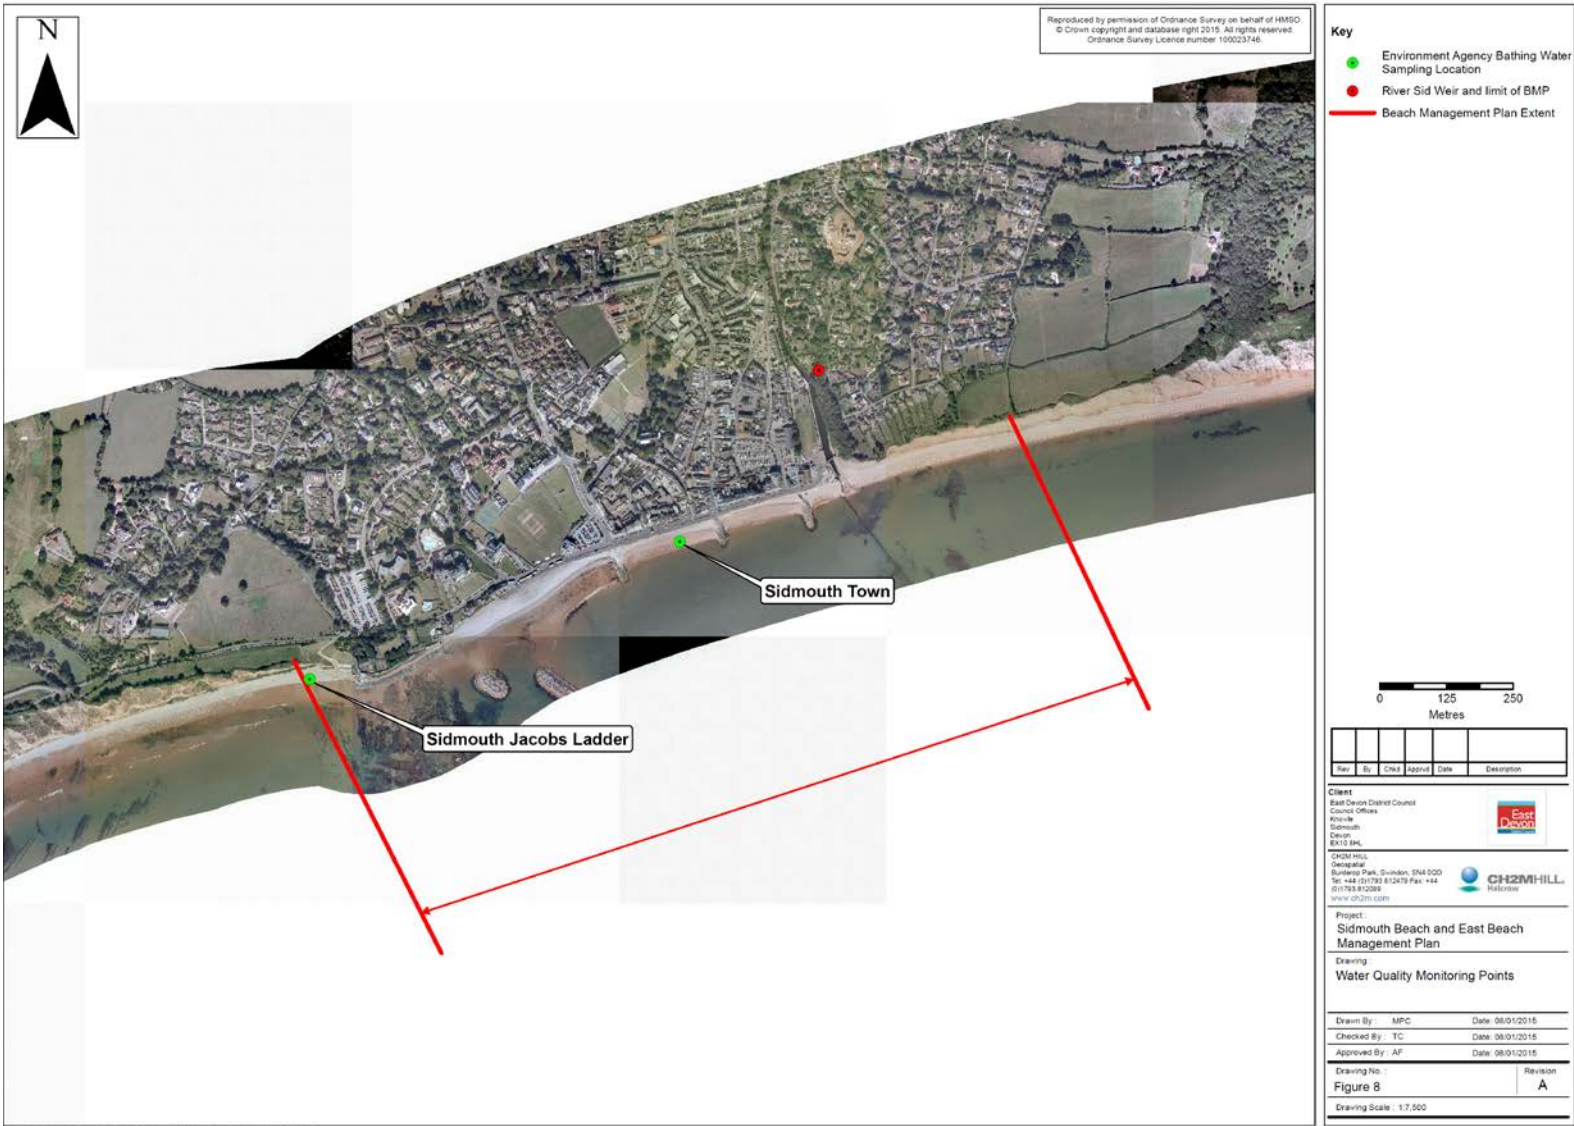
FIGURE 2-11
Bathing water quality monitoring points within the vicinity of Sidmouth BMP frontage

Figure 2-11 shows the location of the Environment Agency’s monitoring points in relation to the BMP area. The Sidmouth Town water sampling point has been monitored since 1988 in line with the Bathing Water Directive, (1976) and also with the Water Framework Directive, (2003) after 2006. In 2014 the results of the water sampling at “Sidmouth Town” and “Sidmouth Jacobs Ladder” recorded a measure of ‘meets higher standards’ (see **Table 2-7**). This means that the bathing water meets the 2006 Bathing Water Directive standards (NB: the standards for bathing water were tightened in 2015 but no data is yet published using these).

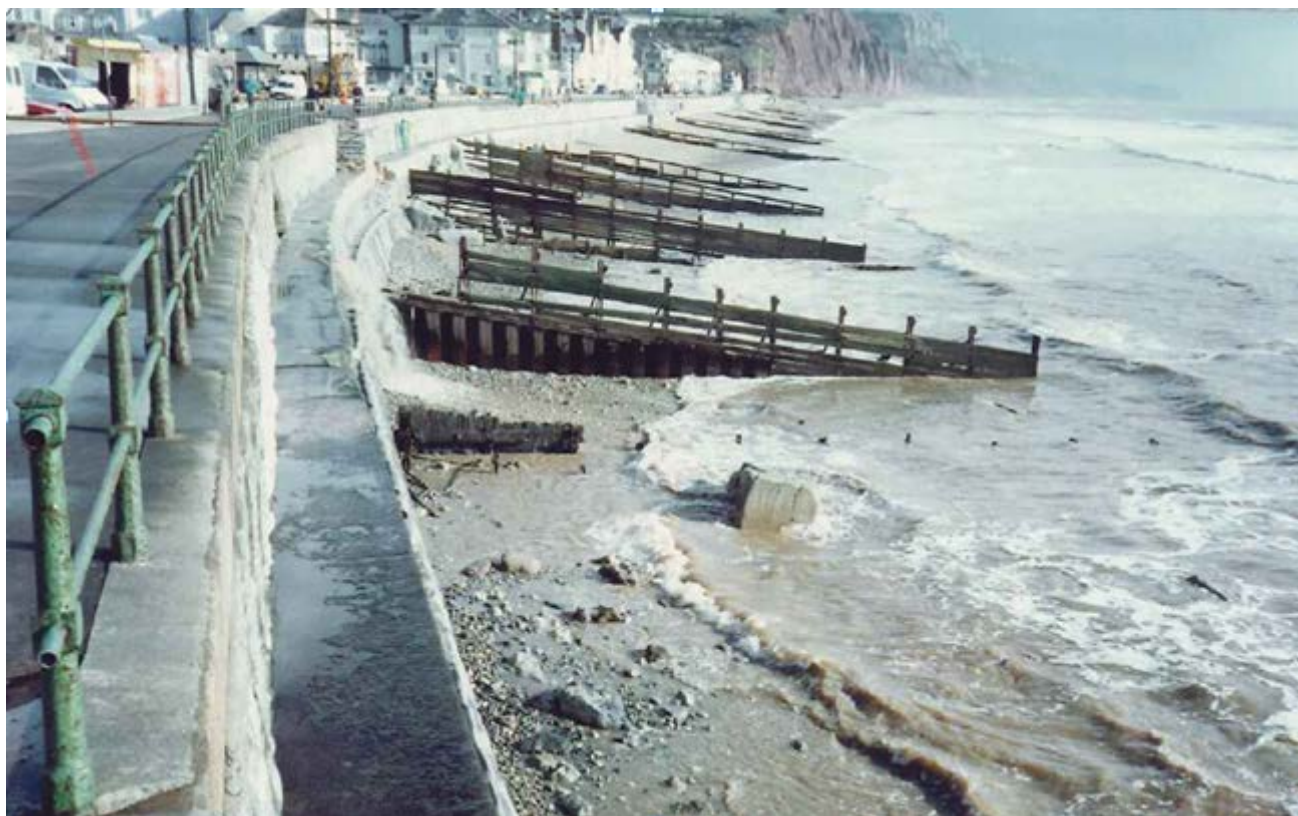
FIGURE 3-1
Sidmouth beach frontage after the 1990 storms (image from Posford Duvivier, 1990)

Following the series of storms there was extensive damage to the frontage. Substantial volumes of shingle moved to beaches to the east of Sidmouth and were drawn down seaward of the low water mark. The seawall was badly abraded in areas and masonry facing blocks were worn away exposing concrete. Some blocks have also been pulled away. The old wall was exposed in areas where breaches occurred and showed signs of weakness. In some areas, the seawall coping had been lifted. The lowering of the beach, which prior to the storms had been almost to the top of the seawall, also exposed derelict timber groynes. **Figure 3-1** shows the Sidmouth frontage following the storm event.
