Sidmouth & East Beach Management Plan

Prepared for
East Devon District Council

January 2017

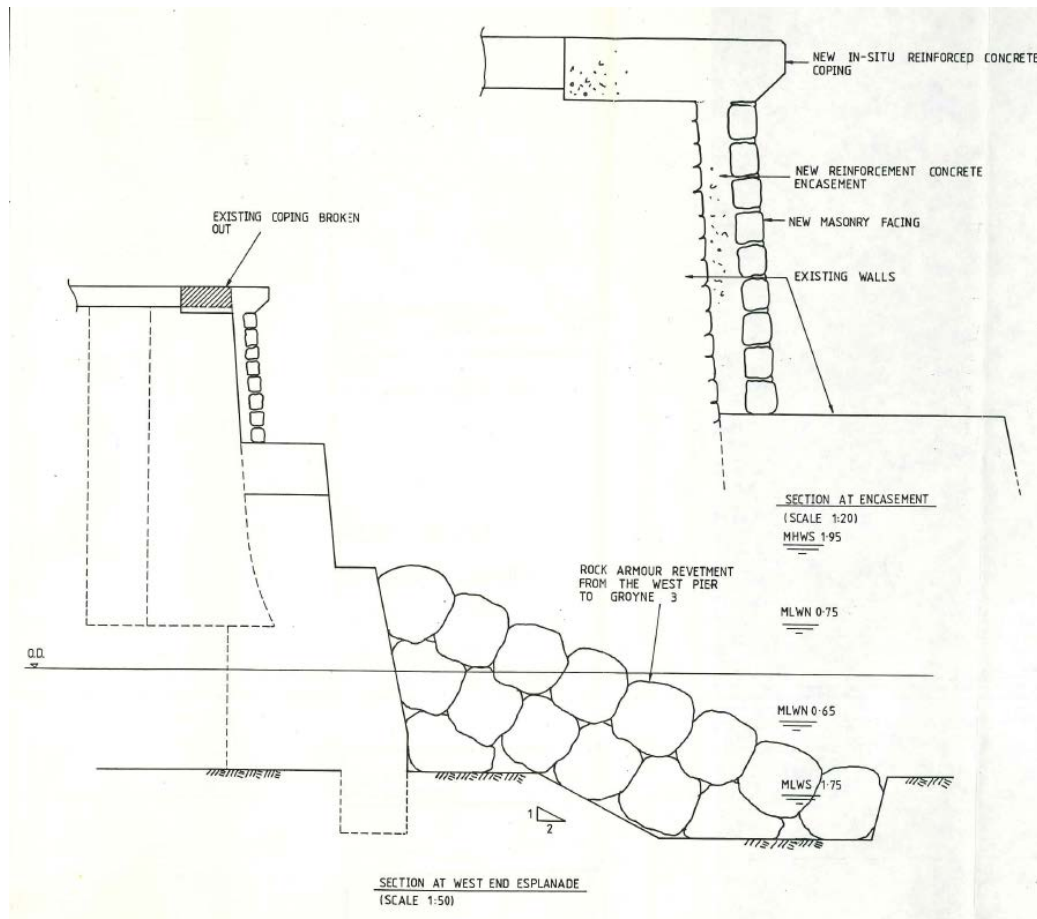
FIGURE 3-2
Phase I proposed repairs and improvements to the Esplanade seawall at Sidmouth (from Posford Duvivier, 1990)

- Encasing the remaining exposed sections of the original masonry seawall.
- Encasing the old wall (beach concrete) immediately west of the East Pier.
- Providing a low-level rock apron to the sea wall between groynes 1 and 3.
- Removing existing timber groynes 1 and 5 to 12.
- Securing the East Pier at its present length.
- Encasing the seaward end of the West Pier.

Details of these construction works are shown below in **Figure 3-2** and **Figure 3-3** showing the proposed seawall repairs/improvements and the groyne removal works respectively.

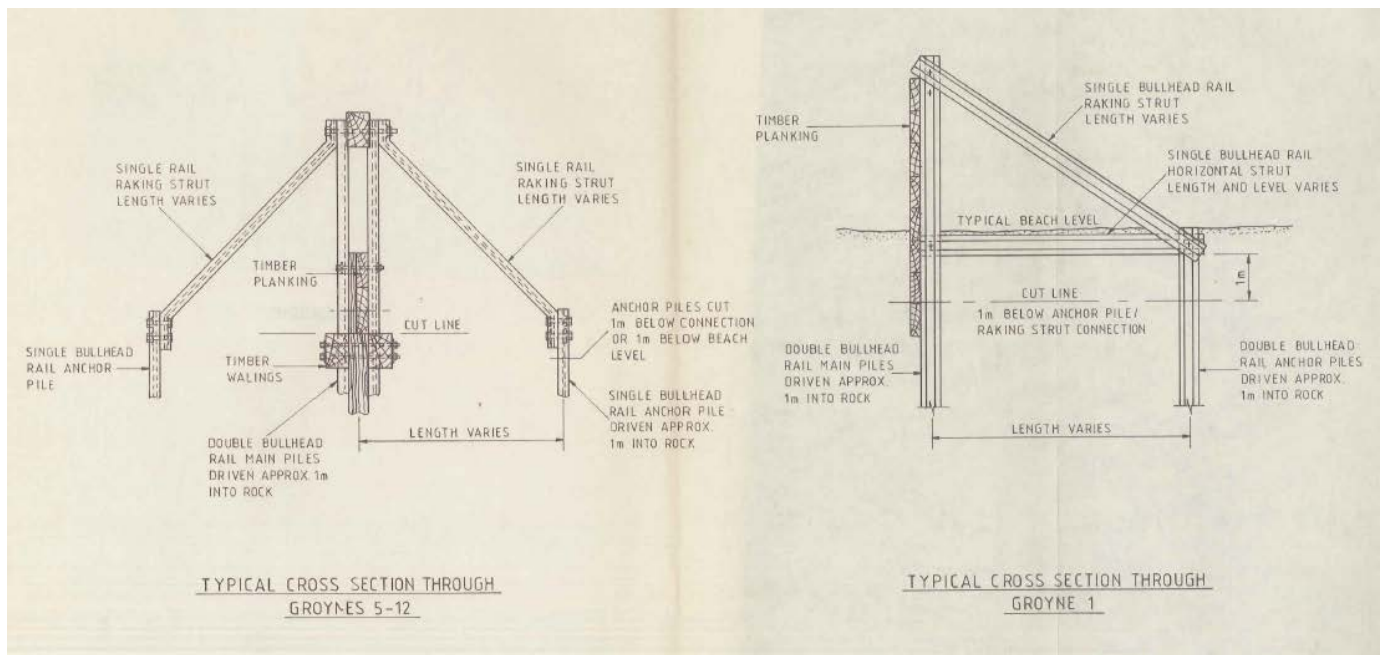
FIGURE 3-3
Phase I proposed groyne removal works at Sidmouth (from Posford Duvivier, 1992)

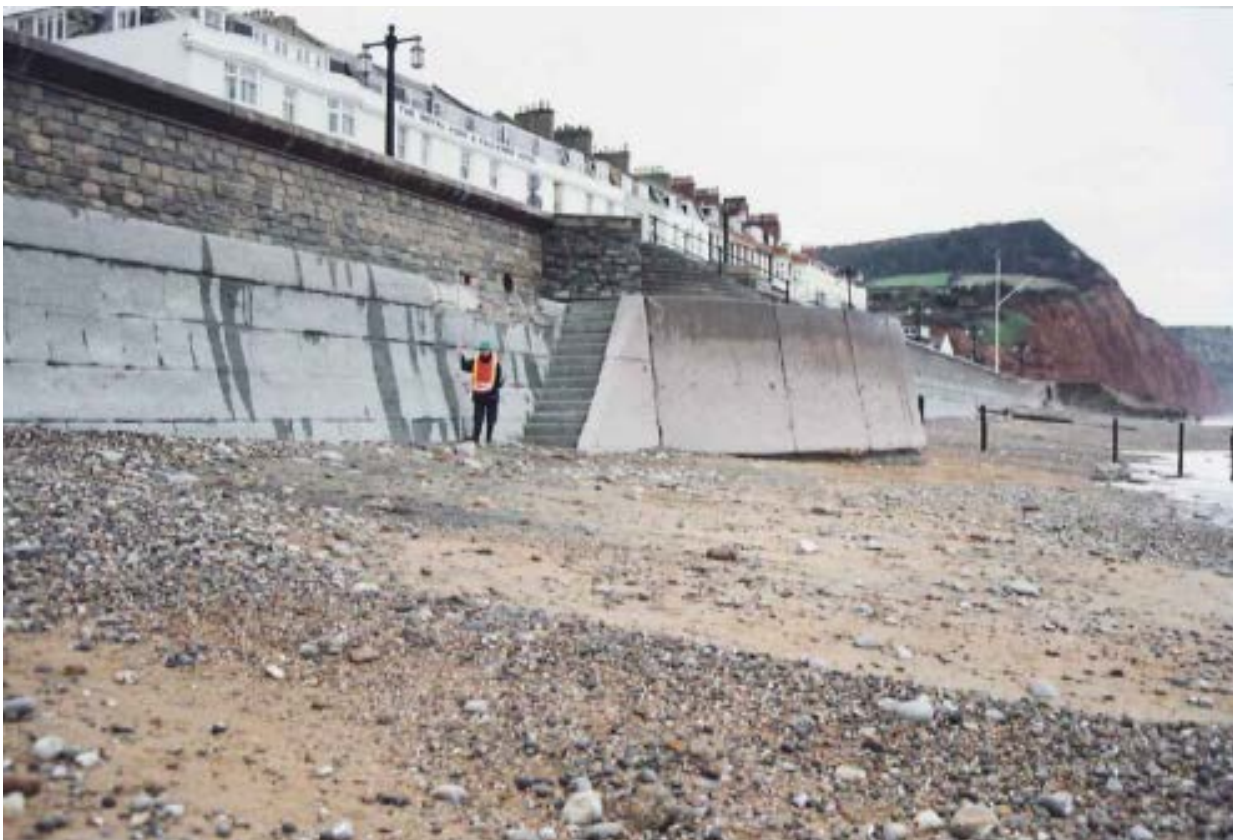
FIGURE 3-4
January 1993 following beach lowering at Sidmouth (from EDDC records).

In January 1993 further lowering of beach levels along the frontage occurred, prompting EDDC to take immediate measures to secure the sea wall from collapse. Posford Duvivier (1993) states that there were outstanding objections to the Phase II scheme (although does not provide details) which would have provided a solution to these issues, so 'Emergency Works' were required to be undertaken instead. The beach lowering can be seen below in Figure 3-4.

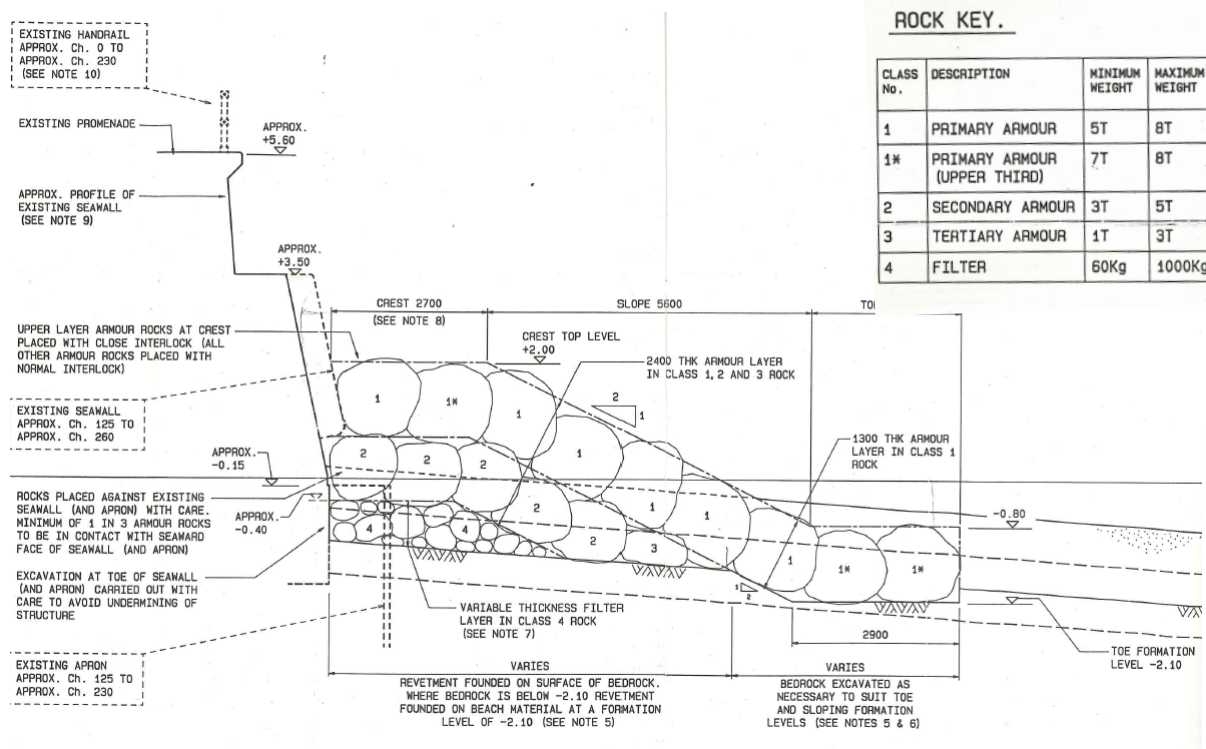
FIGURE 3-5
Revetment Details as part of the 1993 Emergency Works at Sidmouth (from Posford Duvivier, 1993).

The works consisted of a low level rock revetment at the foot of the seawall for approximately 400m extending between West Pier and York Steps. Concrete access steps were provided at the existing York, Bedford and Belmont step locations to maintain access for beach users. Repairs to the seawall were also undertaken, mainly pointing to the existing stonework.

A number of options were considered to provide protection to the base of the seawall, such as beach recharge, but due to various constraints the rock revetment was determined to be the preferred solution. The rock revetment would later be incorporated into the Phase II scheme by being buried below the beach recharge level constructed during that phase. This also meant the rock revetment reduced the beach recharge volumes required and thus the corresponding cost of the Phase II works. Details of the rock revetment can be seen below in **Figure 3-5**. Details on beach recharge levels are provided in **Figure 3-8** below.

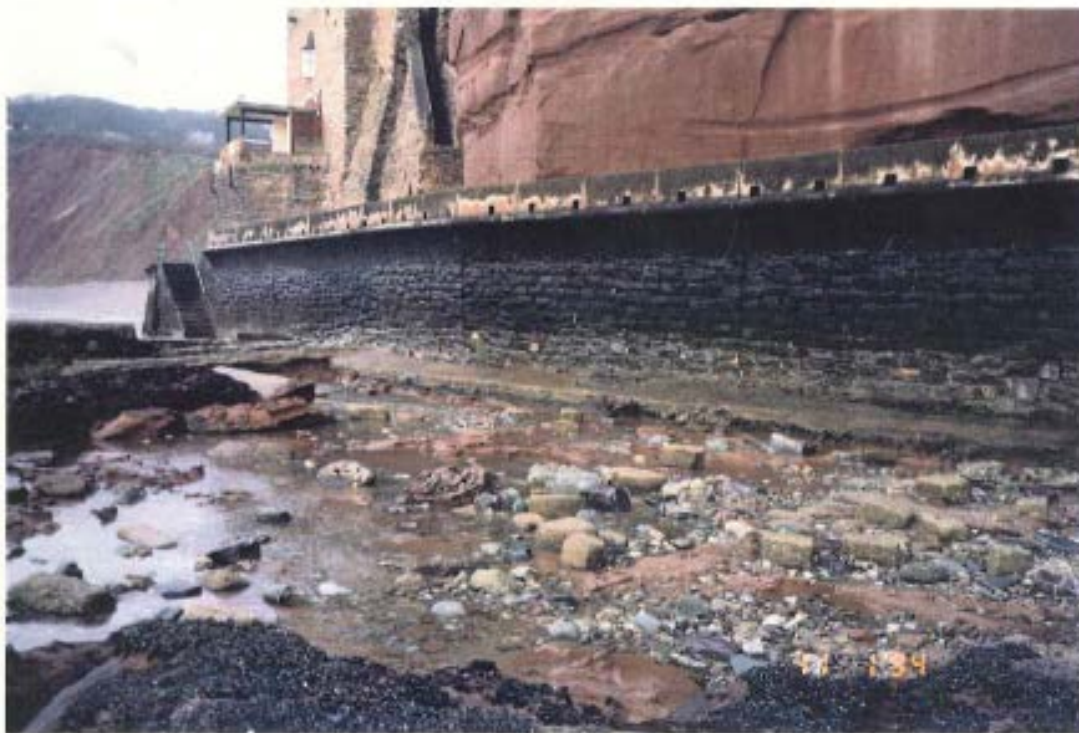
FIGURE 3-6
1957 seawall and the encountered erosion during the 1994 January inspection (from Posford Duvivier, 1994).

In January 1994 an inspection was carried out of the Connaught Gardens frontage which revealed that there was insufficient shingle and sand adjacent to the seawall to prevent erosion. Adjacent to the seawall, the rock platform known as Chit Rocks had lowered, exposing the foundations of the wall which consisted of a concrete apron along most of its length. There is evidence to show there was undermining of this apron. **Figure 3-6** below shows the 1957 seawall and the erosion observed during the January inspection (Posford Duvivier, 1994).

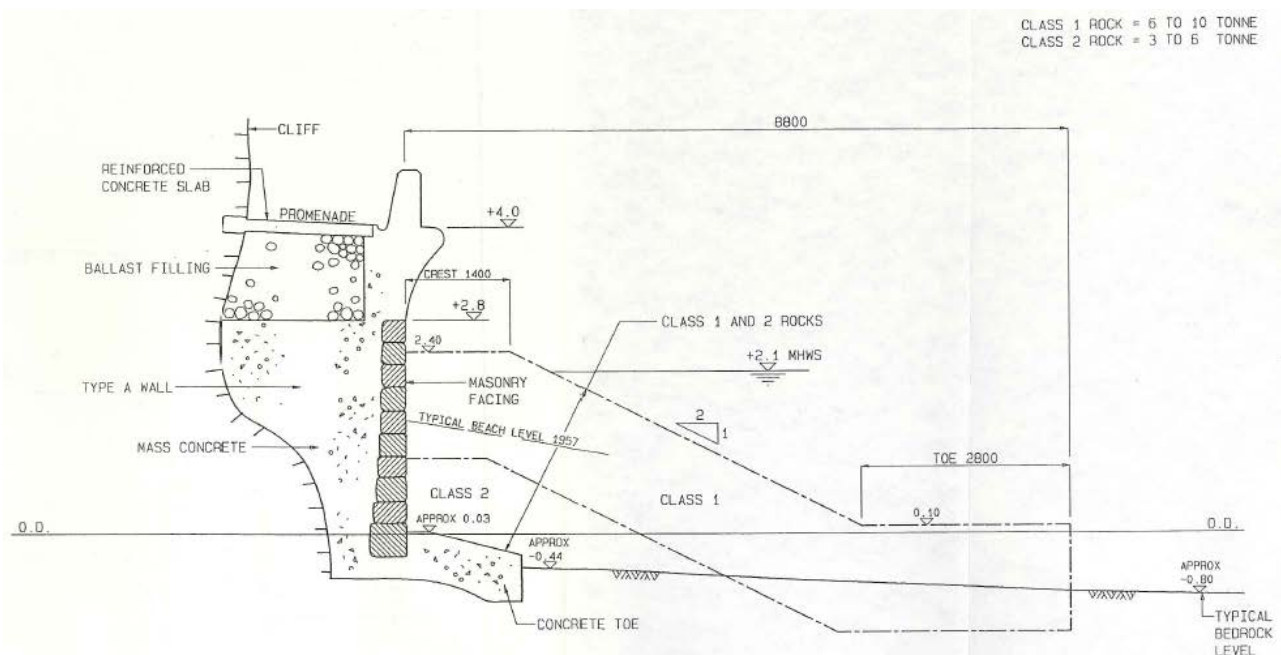
FIGURE 3-7
1957 seawall and the 1994 rock revetment construction details (from Posford Duvivier, 1994).

In 1994, a rock revetment was constructed in front of the 1957 seawall extending from the western end of the Phase II works (start of Clifton Walkway – see **Section 3.1.4**) for 155m to Jacobs Ladder beach. For amenity and technical reasons, a concrete apron was constructed to protect the seawall return into the adjacent bay to the west (Jacobs Ladder Beach return) for approximately 21m to protect the toe of the wall. In addition, stone repointing was undertaken to the existing seawall masonry. **Figure 3-7** shows the typical construction detail for the 1957 seawall and the rock revetment (Posford Duvivier, 1994).

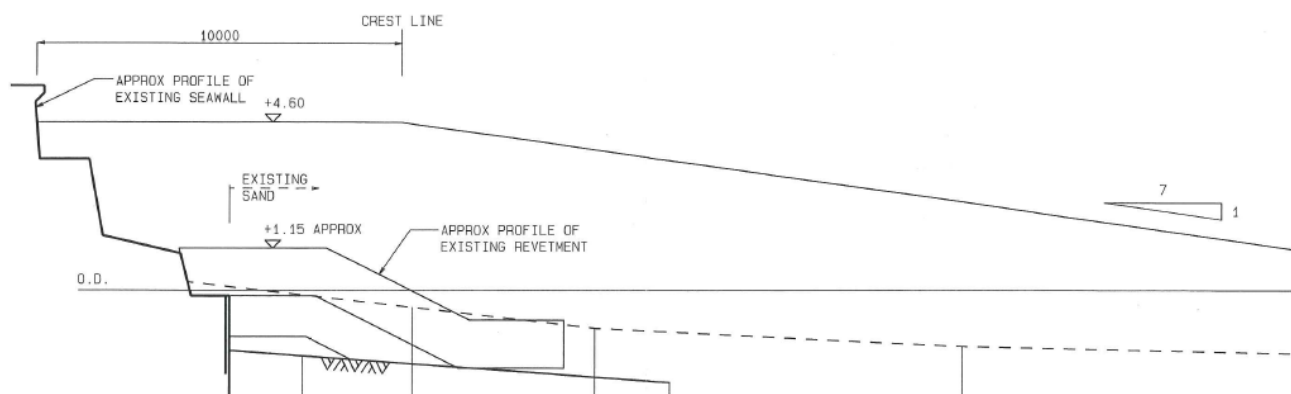
FIGURE 3-8
1993 rock revetment and beach recharge construction detail for the 1995 Phase II works (from Posford Duvivier, 1995).

Construction details of the works described above are shown in **Figures 3-8 to 3-12**.

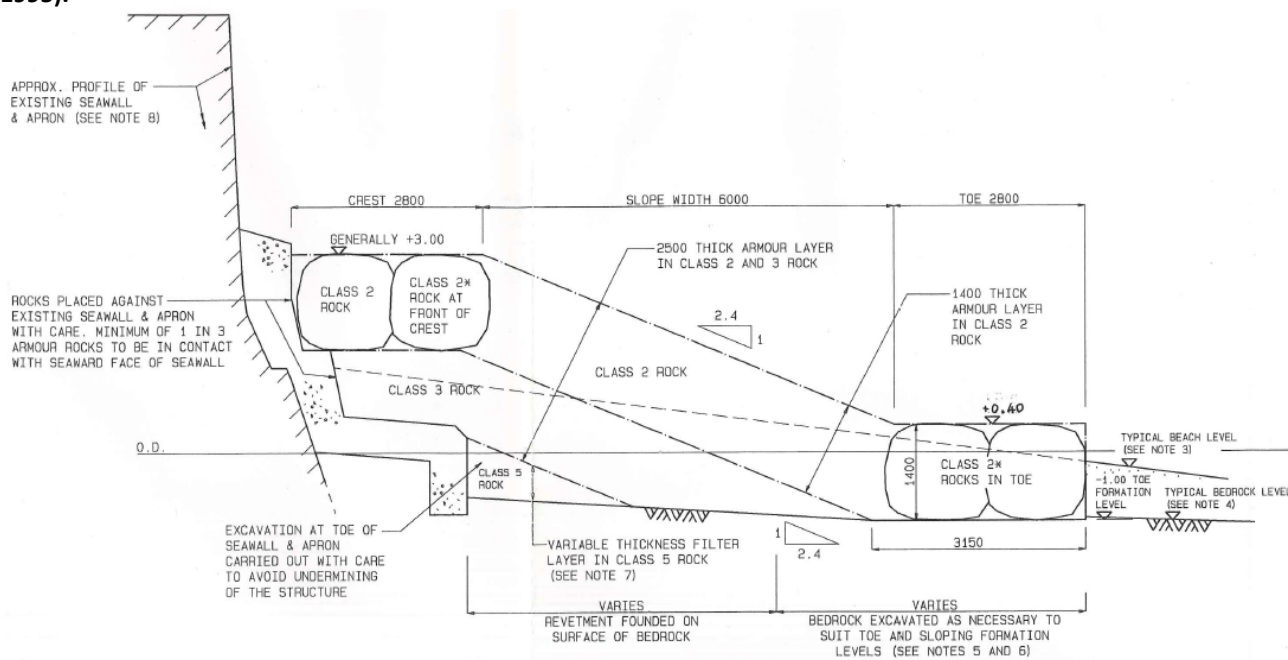
FIGURE 3-9
Clifton Beach rock revetment construction detail for the 1995 Phase II works (from Posford Duvivier, 1995).

- Flood gates were installed to span the gaps between the concrete toe wall which existed along the highway side of the promenade.
- Constructing a rock revetment at Clifton Beach extending from the 1994 Connaught Gardens coast protection scheme rock revetment through to west pier at the western extent of the esplanade seawall to reduce damage to the masonry seawall.

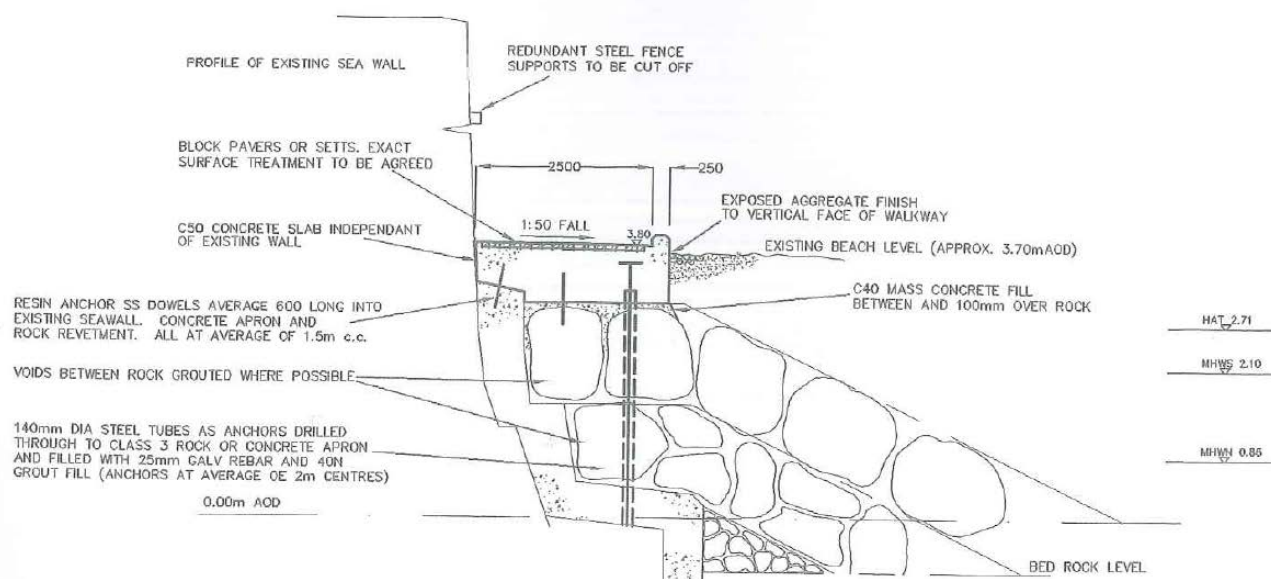
FIGURE 3-13

Drawing showing the construction details for Clifton Walkway 1999 (from Russell Corney, 2014).

In 1999, the construction of a walkway on top of the rock revetment was undertaken to provide connectivity from the 1957 seawall to the Esplanade. The walkway is a reinforced concrete slab with block paving pinned to the seawall on one side and supported by steel tubular piles the other side, such that if the rock revetment was undermined the walkway would remain stable. **Figure 3-13** shows the construction details for Clifton Walkway.
